## REPORT

Date: 20.12.2007  
SL Report: 2007/35

- Type and reg.: Eurocopter EC 135 P2, LN-OOD
- Manufacturing year: 2004
- Engine(s): 2 Pratt & Whitney Canada PWC206 B2

Type of occurrence: Aircraft accident, material damage during landing  
Type of flight: Commercial, ambulance flight (HEMS)  
Weather conditions: Wind: 010° approx. 5 kt. Visibility: 2-8 km. Overcast.  
Temperature: 0 °C. QNH: 990 hPa

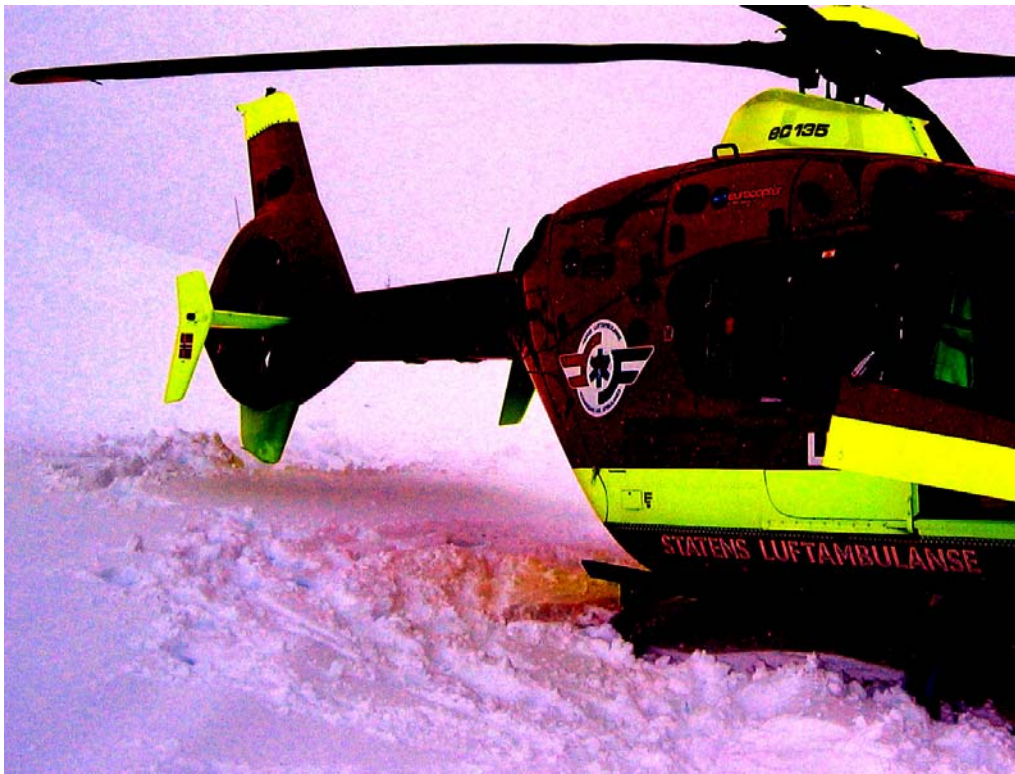
- There was a pile of loose snow on the ground to the right of the tail bumper/Fenestron.
- There were traces of snow spray on the ground on the left side of the Fenestron.

Fig. 1 Note the pile of snow to the right of the tail bumper (brightness/contrast adjusted to show details in snow)

The tracks at the landing site show that the helicopter's nose attitude immediately prior to landing was high enough to allow contact between the tail bumper and the snow-covered terrain. The tracks also show that the bumper ploughed up loose snow, which collected on the right side of the tail and was sucked through the Fenestron.

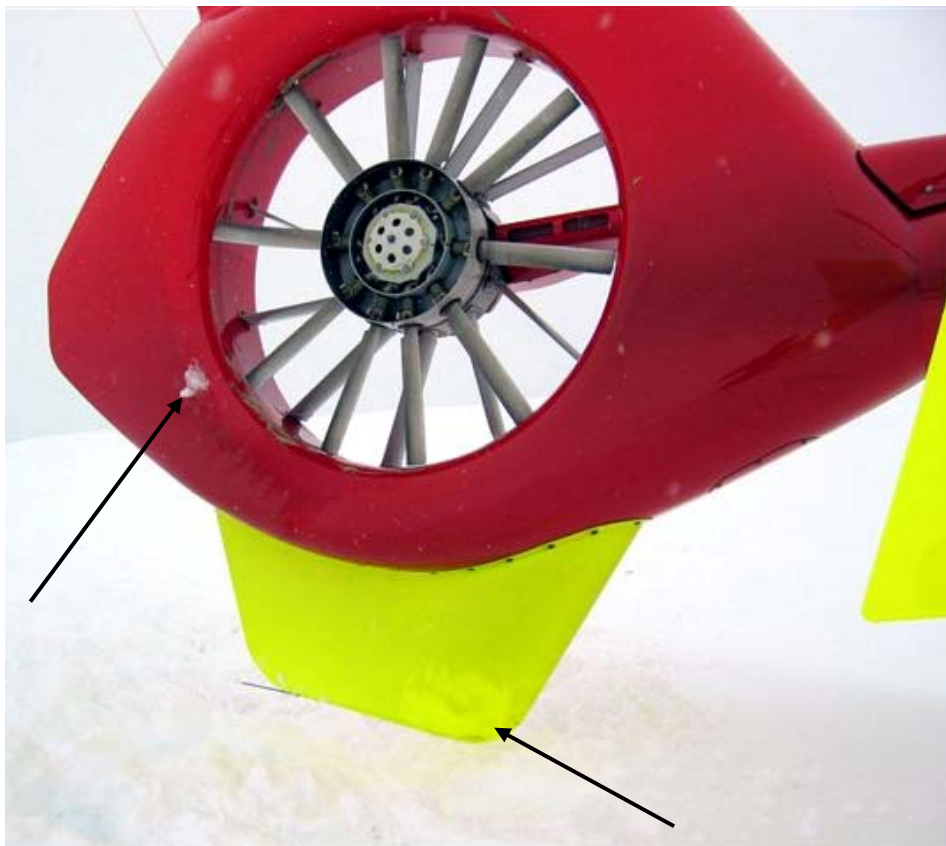
They had landed across a hard packed snowmobile track with approx. 25 cm of loose snow on top of it. The HEMS crew member jumped out and checked that the helicopter was standing secure. He noticed that the tail bumper had come into contact with the ground during the landing, but did not observe any damage. The engines were now pulled back to idle and the collective lever was lowered. The HEMS crew member and doctor went straight to the patient, while the commander spent a short time completing his work in the helicopter before stopping the engines and joining them. As he left the helicopter, he looked back to ensure it was standing secure. At that moment he realised that something was wrong. The cover of the hub in the Fenestron was missing and when he came closer he saw considerable damage to the Fenestron and the surrounding tunnel (fig. 2). Parts of the cover were scattered on the snow on both sides of the Fenestron.

- There was a snow mark a little way up on the right side of the Fenestron.

Fig. 2 Fenestron. Note the missing hub cover, the snow mark on the side and "clean" marks on the bumper

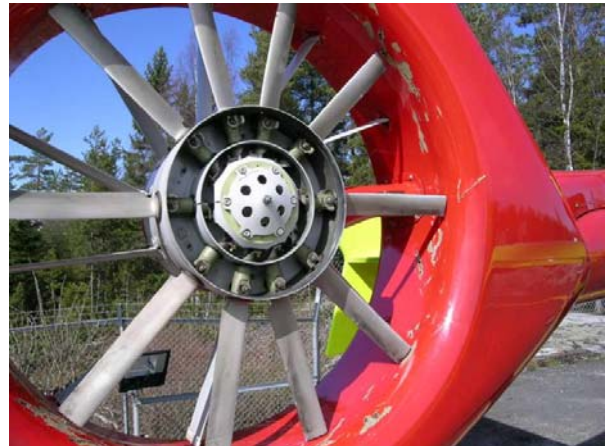
- There was various chipping and damage to several of the stator and rotor blades in the Fenestron.
- The tips of all ten rotor blades were deformed (bent out to the right by 1-3 cm).

- The two rotor blades positioned “singly” between the groups of four suffered most bending.
- The composite structure in the tunnel surrounding the Fenestron had various holes and gashes.

Fig. 4 Damaged tunnel and deformed blade tips

The AIBN has concluded that a considerable amount of snow passed through the lower part of the Fenestron during landing, resulting in permanent deformation of all the rotor blades. The phenomenon is well known in cases where a rotating propeller suddenly operates in a medium which is denser than air – water or snow, for example. The tips are then bent forward. In this case the snow only passed through the lower part of the Fenestron, which meant that the loads were very uneven, and a pulsating force could be generated.

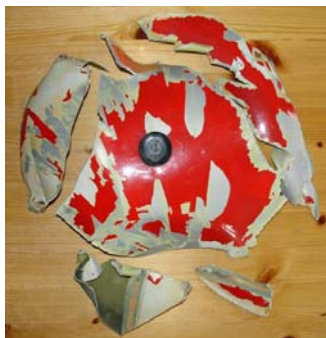
- The hub cover in the Fenestron had loosened and been sucked into the fan where it was cut into bits.
- All or parts of four of the six clips with bolts holding the cover in place were found at the site. All the clips had rubber coating and the bolts were tightened.

Fig. 5a Pieces of the hub cover

Available information indicates that the hub cover was fixed as required. It is AIBN's opinion that the dislodging of the cover can be explained by the identified flexibility in the hub. The pulsating forces that bent the blades were transferred to the hub, which assumed an oval shape. The clips then become disengaged from the edge in rapid succession and the correctly mounted cover "popped" out of the Fenestron hub. The cover was sucked into the rotor where it was chopped to bits, causing extensive damage to the blades and surrounding tunnel.

The accident has revealed that the hub cover of the Fenestron on EC 135 can loosen when the rotor tips are bent out. A loosened cover will be sucked through the Fenestron and cause extensive damage. AIBN recommends that Eurocopter consider whether the fixing mechanism between the cover and hub could be changed to prevent loosening.

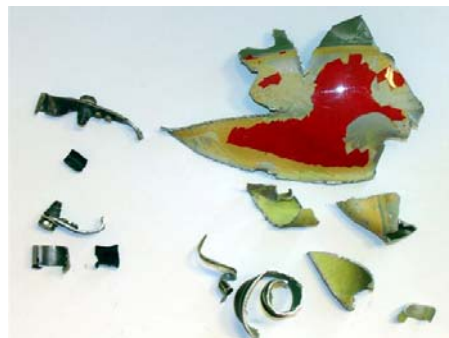
Fig. 5b More pieces of the cover and clips with bolts

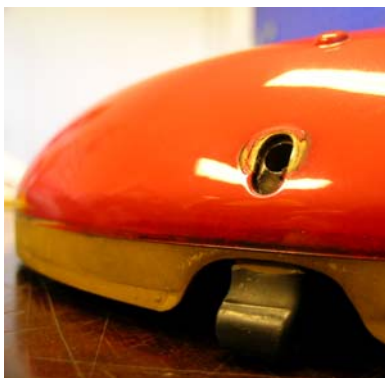
The hub cover was held in place by six retaining clips in a lip around the inner circumference of the Fenestron hub (ref. fig. 5-6). The clips are tightened with bolts. The commander was sure that the cover had been in the correct position and had not rotated in relation to the hub when he made his routine inspection prior to take-off. A painted-on guiding mark makes it easy to see any rotation.

Fig. 6a Illustration photo: Cover with retaining clips (bolt not mounted)

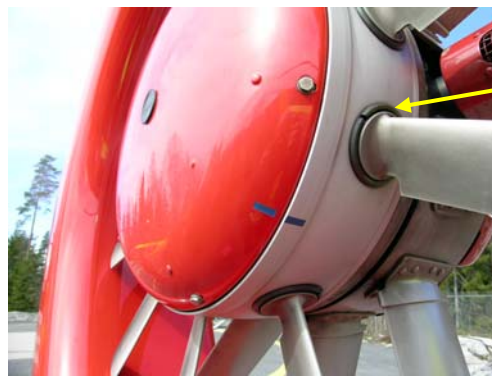
Bushing on the hub

Fig. 6b Illustration photo: Undamaged mounted cover with guiding mark
