Cessna Aircraft Company Aircraft Incident/Accident Technical Report

Aircraft and Incident/Accident Information			
Year: 2002	Model: 208B	Serial number: 208B1002	Registration: N687MA
Location: Kalaupapa, Molokai, HI		Date: 12-11-13	Time: 1522 HAST
Aircraft Owner		Aircraft Operator	
Leis Air, LLC C/O Hawaii Premier Realty 2265 Hoonee PI Ste 110 Honolulu, HI 96819		Makani Kai Air 130 Iolana PI Honolulu, HI 96819	
Report Information			
Senior Air Safety Investigator: Henry J. Soderlund		Report #: 14-CZIN-T	Report date: 05-19-14

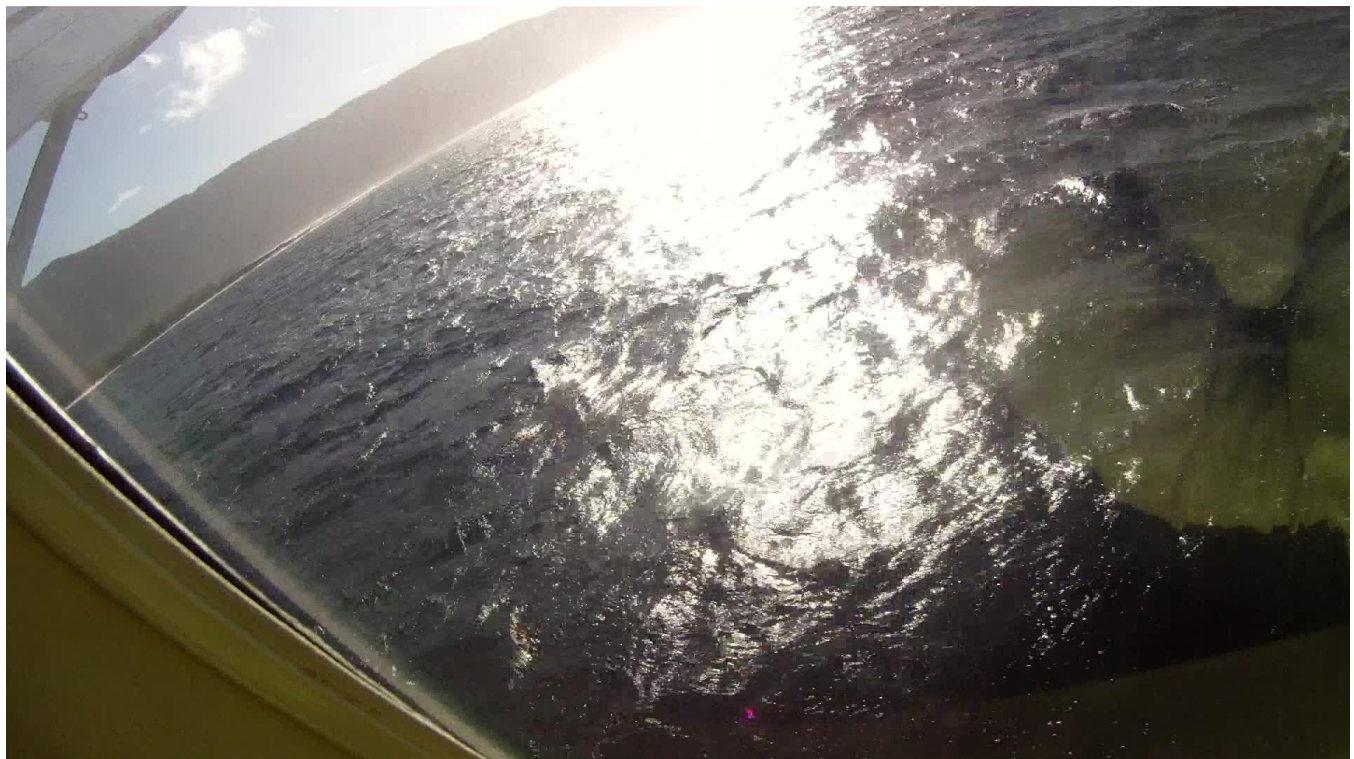
Video taken by a passenger shows the aircraft impacting the water in a wings level, slight nose-high attitude. The nose of the aircraft slowly lowered after the aircraft came to rest and the occupants exited out the rear passenger door. The aircraft remained intact after contacting the water. The aircraft subsequently sank and the occupants were rescued. The aircraft was substantially damaged by repeated contact with the ocean floor between the time it sank and the time it was recovered.

Still image from video taken by Ferdinand Puentes
