NATIONAL TRANSPORTATION SAFETY BOARD
Office of Aviation Safety
Washington, D.C. 20594

HELICOPTER SPECIALIST'S FACTUAL REPORT

NTSB No: CEN15LA395

Operator: Roberts Ranch and Investments, LLC
Aircraft: Bell Helicopter 429, Registration N428AR
Location: Port O'Connor, Texas
Date: August 22, 2015
Time: Unknown time

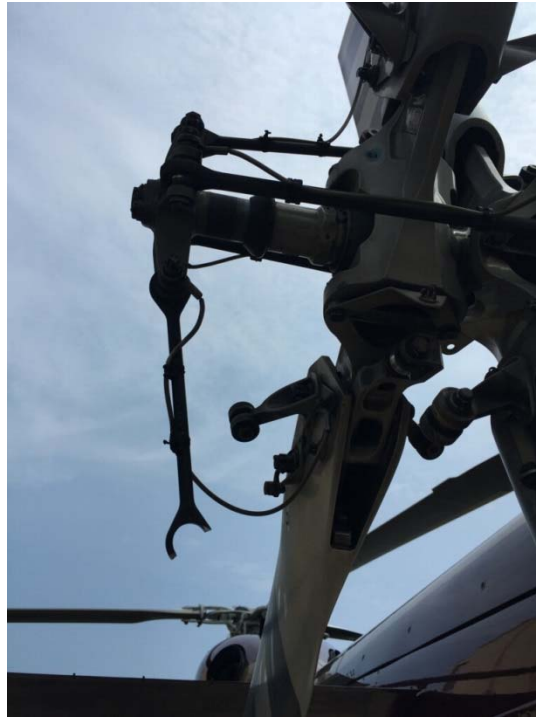
The tail rotor PCL assembly comprises a single-piece forged aluminum body with two circular ends (also known as the "banjo end"), each containing a spherical bearing (also known as a "mono-ball bearing"). One end of the tail rotor PCL is attached to the pitch change crosshead; the other PCL end is attached to its respective tail rotor blade pitch change horn. A total of four PCLs are installed on the four-bladed tail rotor of the Bell Helicopter 429: two short-length PCLs, identified as "inboard" PCLs, and two long-length PCLs, identified as the "outboard" PCLs, are used to accommodate the stacked rotor blade configuration. A photograph provided by the operator showed the fractured PCL remained attached to the crosshead and the spherical bearing and remnant circular end remained attached to the tail rotor blade pitch horn ([Photo 1](#)).

Photo 1. Photo of the fractured tail rotor PCL still installed on N429AR. (photo courtesy of Bell Helicopter)

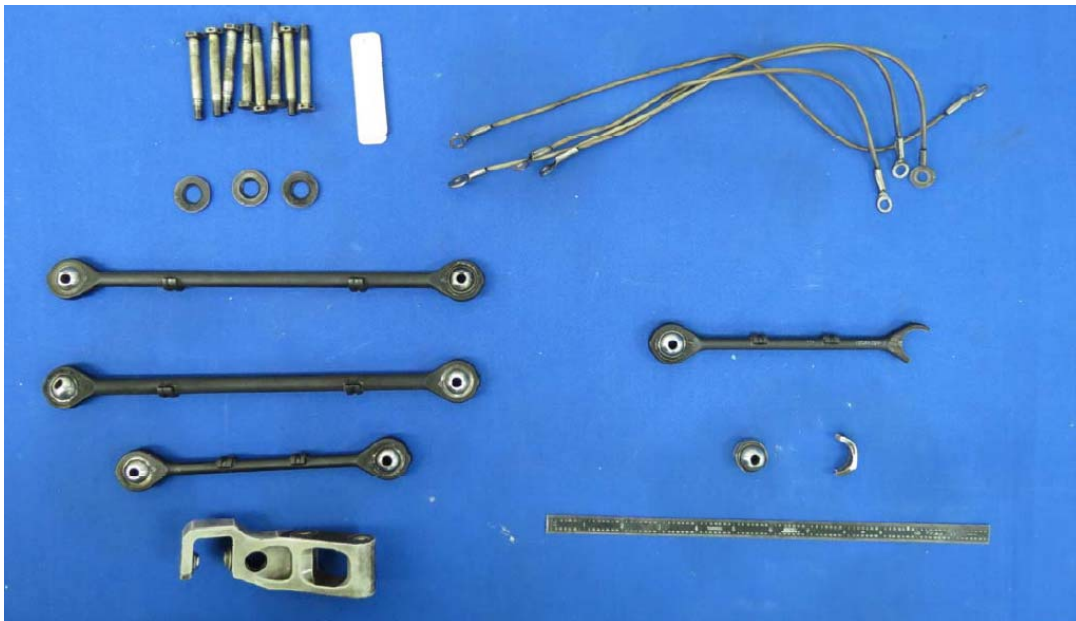
On September 2, 2015, representatives from the FAA and Bell Helicopter convened at Bell Helicopter facilities in Hurst, TX to examine the fractured tail rotor PCL, the pitch horn associated with the fractured PCL, and the remaining three tail rotor PCLs (**Photo 2**). The fractured PCL, one of the two inboard PCLs, was identified as serial number (S/N) TE-0168 (**Photo 3**). The remaining three PCLs were identified as S/N TE-0363 (inboard PCL), TE-0076 (outboard PCL), and TE-0088 (outboard PCL).

Photo 2. The tail rotor directional control components received at Bell Helicopter facilities. (photo courtesy of Bell Helicopter)

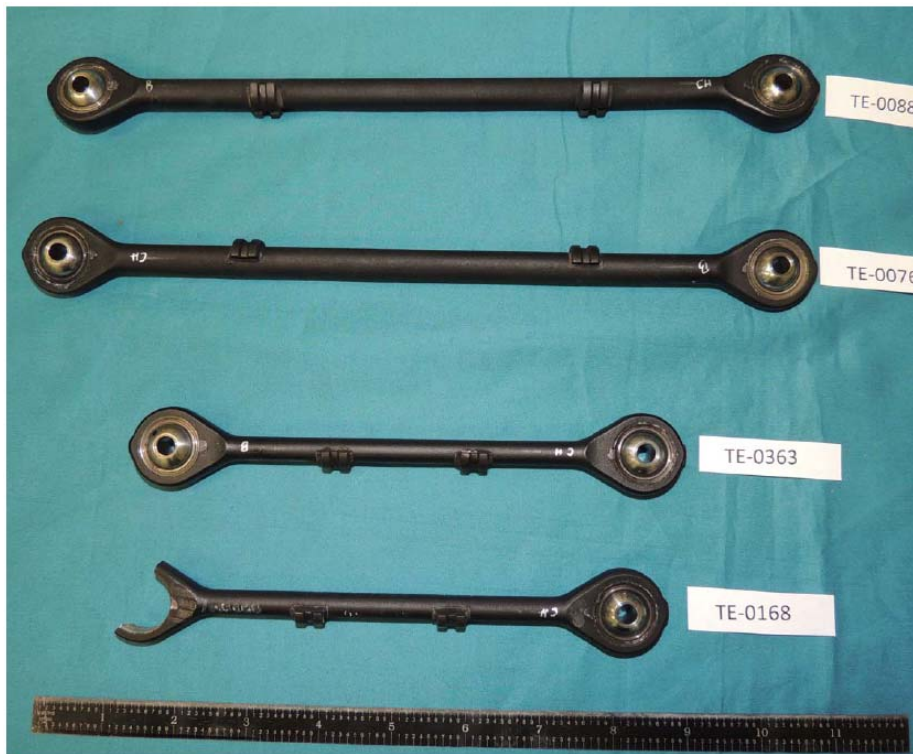
Photo 3. The tail rotor PCLs identified by S/N. (photo courtesy of Bell Helicopter)

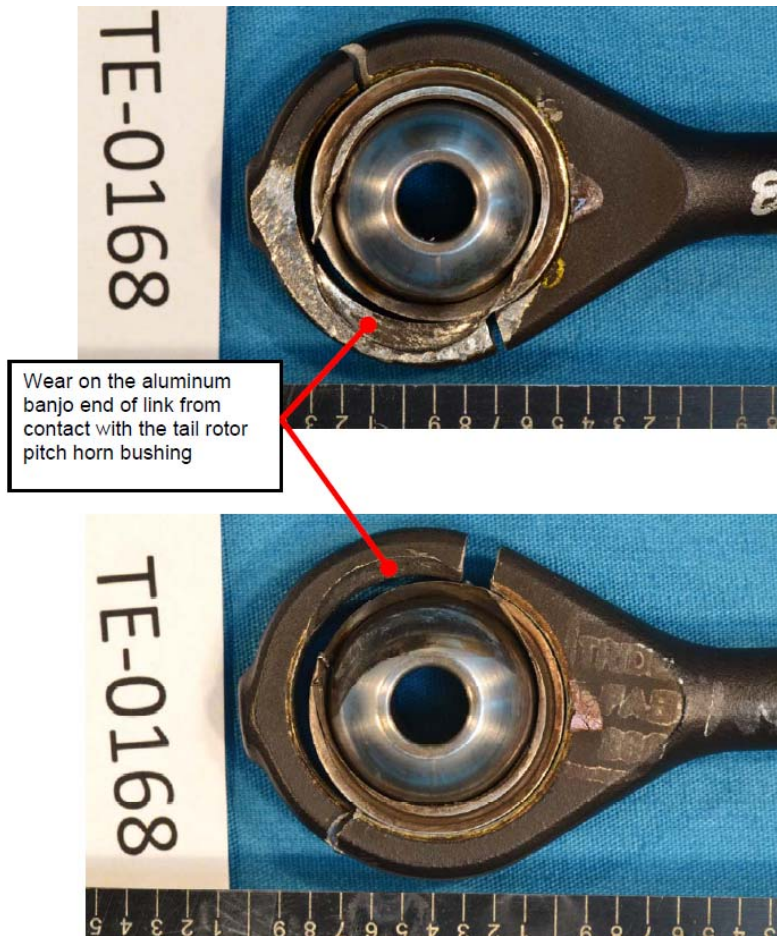
Tail rotor PCL S/N TE-0168 exhibited fractures through two areas of the pitch horn-side circular end (housing the spherical bearing), with the two fractures about 180 degrees opposed to each other (**Photo 4**). The primary fracture surface exhibited fatigue through the bulk of the cross-section of the circular end (**Photo 5**). The secondary fracture surface exhibited evidence of fatigue through about half of the cross-section, with the remaining cross-section exhibiting signatures consistent with overload. Both fatigue fractures initiated on the same chamfer on the circular end of the link; the chamfer is used to stake the bearing into PCL circular end. Evidence of pitting corrosion was observed at the fatigue fracture origins of the fracture surfaces. The depth of the pitting corrosion at the primary fracture, in an area that did not sustain mechanical damage, was about 0.005 inches (**Photo 6**). The depth of pitting corrosion at the secondary fracture was about 0.007 inches (**Photo 7**).

Photo 4. The fractures observed on the pitch horn-side circular end of PCL S/N TE-0168.
(photo courtesy of Bell Helicopter)

On December 7, 2015, Bell Helicopter released ASB No. 429-15-26 which introduced an inspection of tail rotor PCLs, P/Ns 429-012-112-101 and -103, for corrosion and application of sealant between the spherical bearing and its housing. The ASB also introduced a 50-hour recurrent inspection of this sealant. FAA AD No. 2016-02-06, dated February 6, 2016, required inspection of tail rotor PCLs, P/Ns 429-012-112-101, -101FM, -103, and -103FM, for corrosion. The AD also required application of sealant between the spherical bearing and its housing, and a recurrent inspection of this sealant at a 50-hour interval.

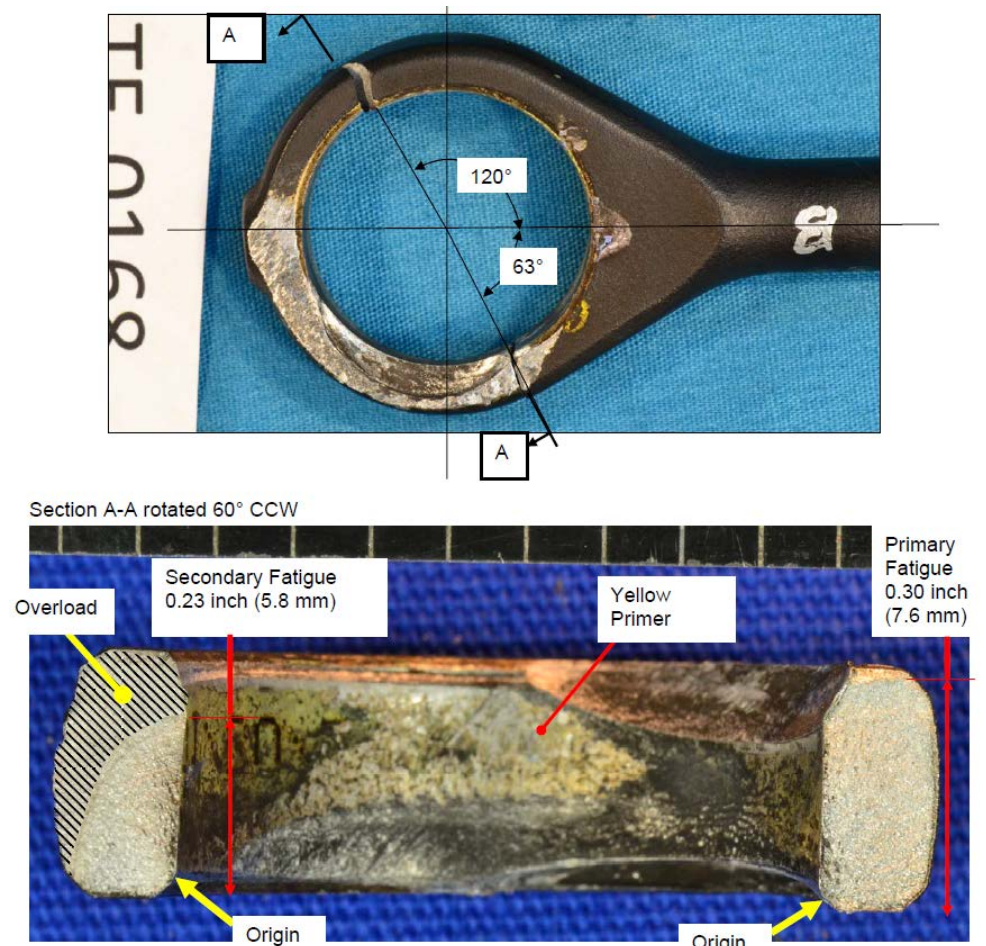
Photo 5. Cross-section view of the pitch horn-side circular end fracture of PCL S/N TE-0168. (photo courtesy of Bell Helicopter)

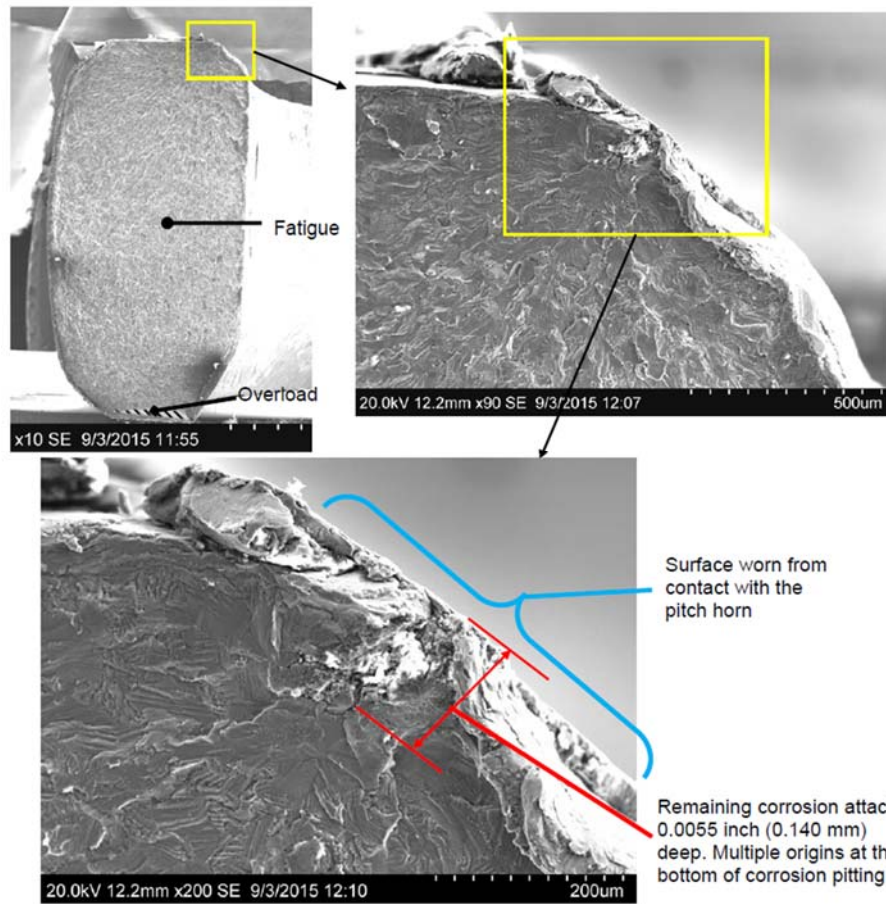
Photo 6. Corrosion observed at the primary fatigue origin of PCL S/N TE-0168. (photo courtesy of Bell Helicopter)

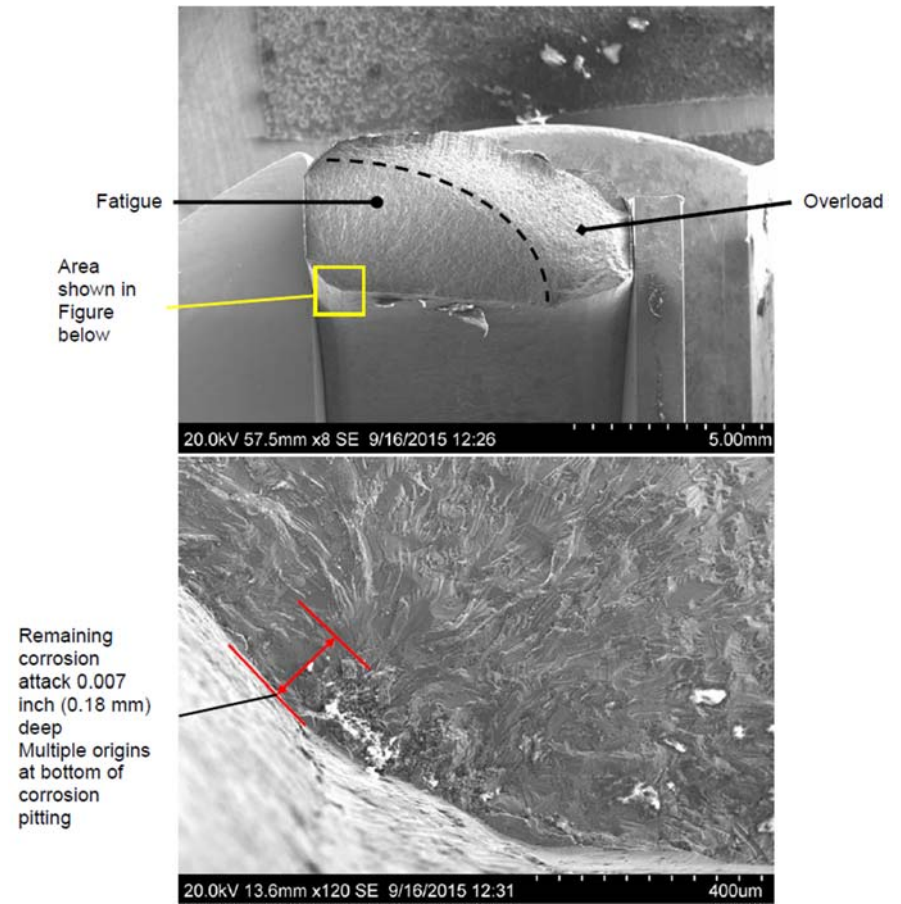
Photo 7. Corrosion observed at the secondary fatigue origin of PCL S/N TE-0168. (photo courtesy of Bell Helicopter)

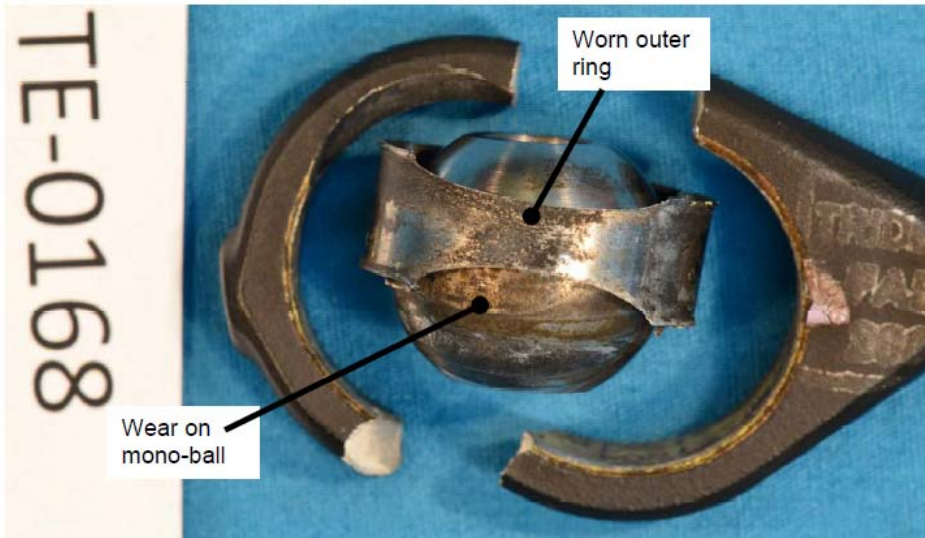
Material composition analysis of the PCL revealed no anomalous findings. The hardness and conductivity of the aluminum PCL met engineering drawing requirements. Microstructure and chemical analysis via scanning electron microscope showed results typical of the aluminum alloy specified in the engineering drawing. A yellow-colored substance, chemically analyzed to be consistent with epoxy polyamide primer, was observed on the inner diameter surfaces of [fractured] circular end. Both the separated circular end and the pitch change horn bushing exhibited evidence of mechanical contact wear. The blade pitch horn-side spherical bearing exhibited wear through a portion of its outer ring and wear on the surface of the spherical ball (**Photo 8**). Examination of the crosshead-side of the PCL revealed evidence of corrosion on the staking chamfer (**Photo 9**). Removal of the crosshead-side spherical bearing revealed evidence of fretting and wear on both the bearing outer ring and adjacent to the staking chamfer (**Photo 10**).

Photo 8. Mechanical contact wear observed on the spherical ball and outer ring of the pitch horn-side spherical bearing of PCL S/N TE-0168. (photo courtesy of Bell Helicopter)

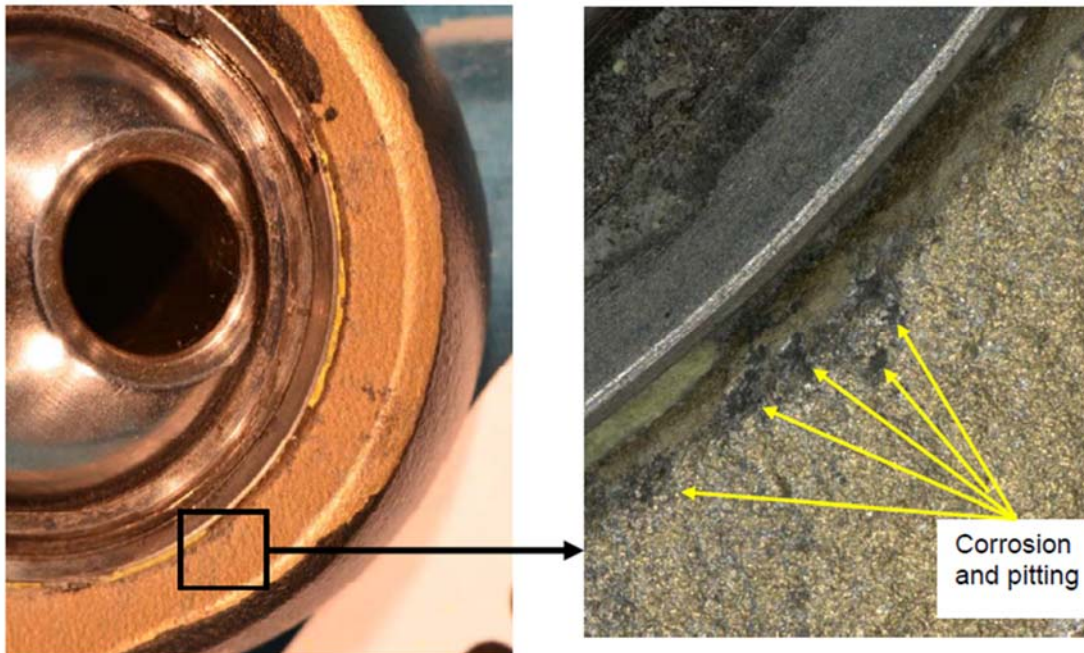
Photo 9. Corrosion and pitting observed on the chamfer of the crosshead-side spherical bearing of PCL S/N TE-0168. (photo courtesy of Bell Helicopter)

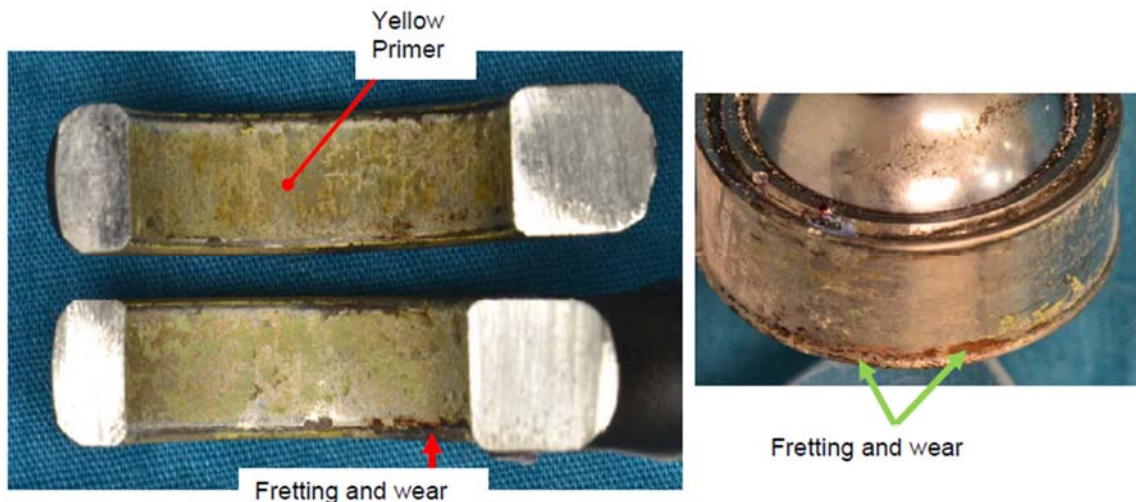
Photo 10. Fretting and wear observed on the chamfer and spherical bearing outer ring of the crosshead-side of PCL S/N TE-0168. (photo courtesy of Bell Helicopter)
