ALERT SERVICE BULLETIN

429-15-26
7000000141
7 December 2015

MODEL AFFECTED: 429

SUBJECT: TAIL ROTOR PITCH LINK CORROSION
INSPECTION, INTRODUCTION OF

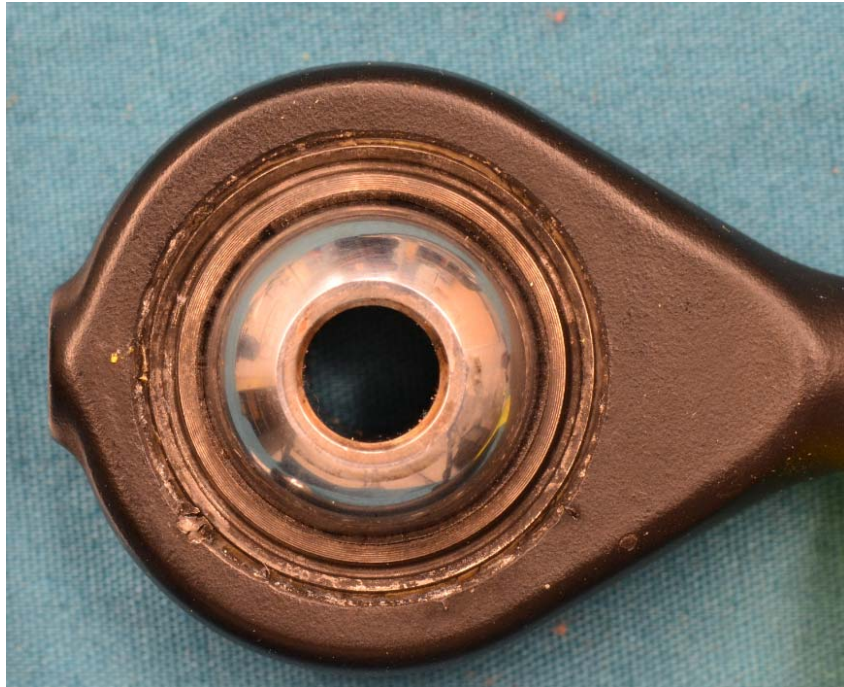
Figure 1 - Pitch Link Corrosion

Bell Helicopter has received reports of corrosion on tail rotor pitch links present between the roll staked lip of the 429-312-107-103 bearing and the beveled edge of the 429-012-112-101/-103 tail rotor pitch link. **Part I** of this bulletin introduces an inspection for corrosion and the application of sealant. **Part II** of this bulletin introduces

3. Use 10X magnification to inspect all eight tail rotor pitch link bearing bores for corrosion evident by the presence of aluminum oxide extruding from between the roll staked lip of the bearing outer race and the pitch link bearing bore (Figure 1). If corrosion is found, replace the affected pitch link.

4. If no corrosion is found in the previous step, clean the area thoroughly with isopropyl alcohol (C-285) and inspect using 10X magnification. If corrosion is found, replace the affected pitch link.
