**NATIONAL TRANSPORTATION SAFETY BOARD**  
Vehicle Recorder Division  
Washington, D.C. 20594

## **Personal Electronic Devices and Cameras**

### **Group Chairman's Factual Report By Bill Tuccio, Ph.D.**

Location: Ketchikan, Alaska  
Date: June 25, 2015  
Aircraft: de Havilland DHC-3  
Registration: N270PA  
Operator: Promech Air, Inc.  
NTSB Number: ANC15MA041

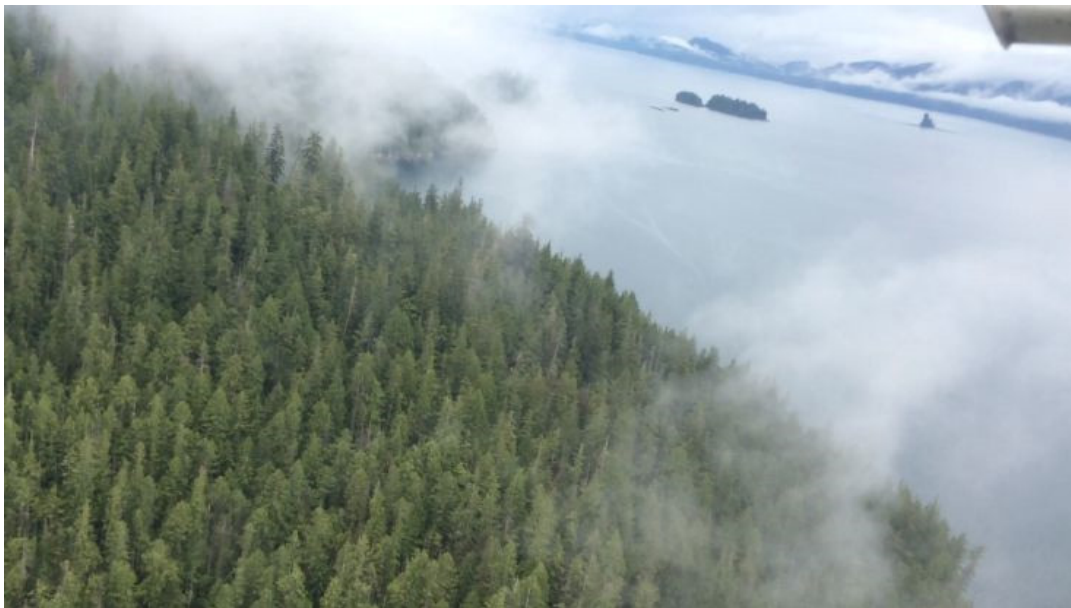
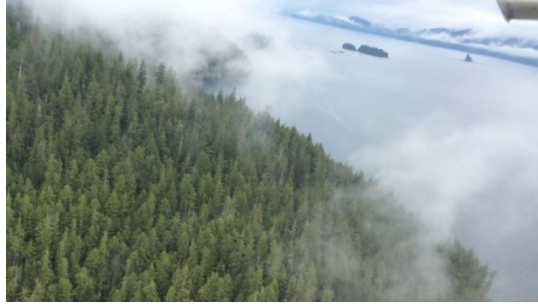
**Figure 15. Frame at 1209:53 AKDT (frame 00-05-22.19.jpg).**

1209:53: As N270PA approached the channel, the west side of the channel was visible. Visibility was estimated to be at least 5 miles (figure 15).

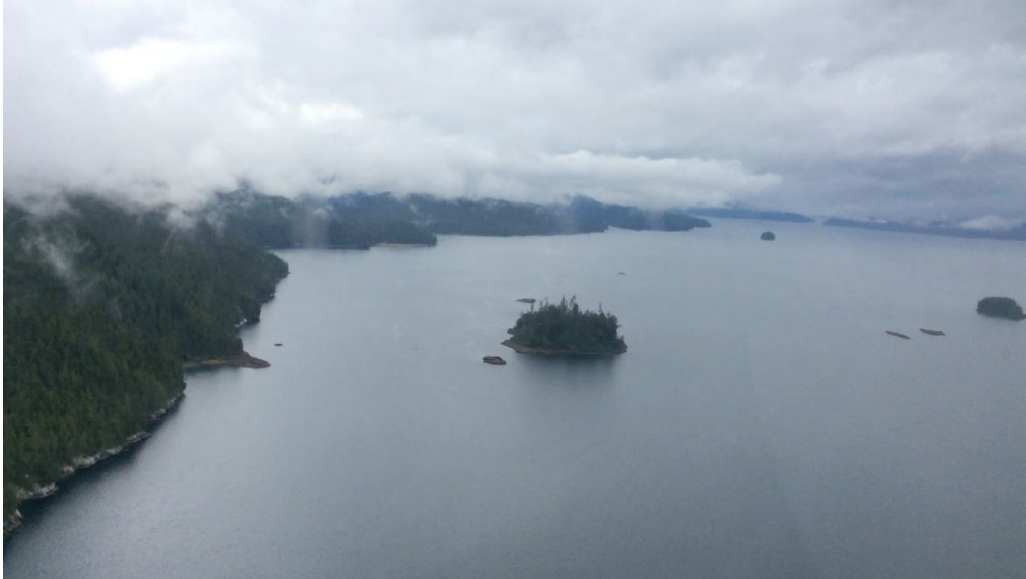
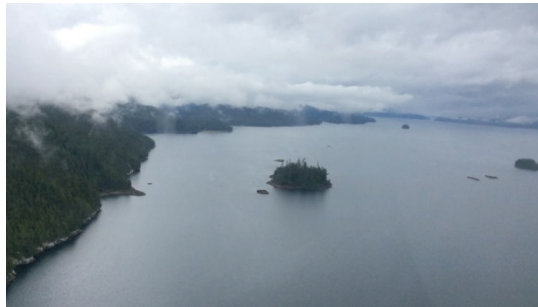
**Figure 16. Frame at 1210:19 AKDT (frame 00-05-48.15.jpg).**

1210:19: Figure 16 shows a video frame at this time from the camera. The frame shows the southwest part of the channel relative to N270PA's track. There were lower scattered scud clouds on the east and west sides of the channel, and obscuring the higher peaks.

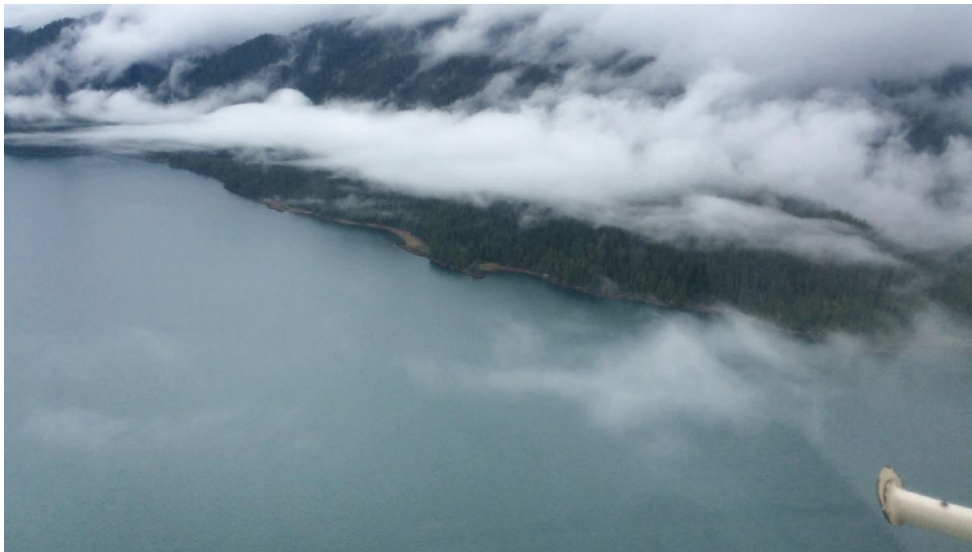
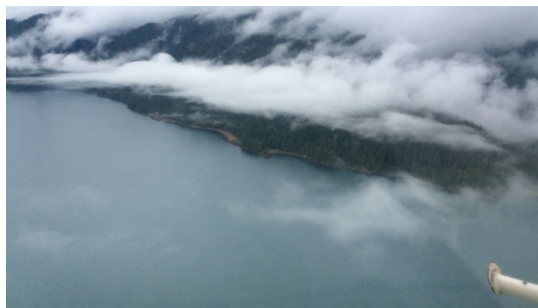
**Figure 17. Frame at 1212:23 AKDT (frame 00-07-53.13.jpg).**

1212:23: Figure 17 shows a video frame at this time from the camera. The frame shows the west part of the channel, slightly left of the future track of the aircraft. Lower scud clouds give way to denser clouds to the west, obscuring the higher terrain.

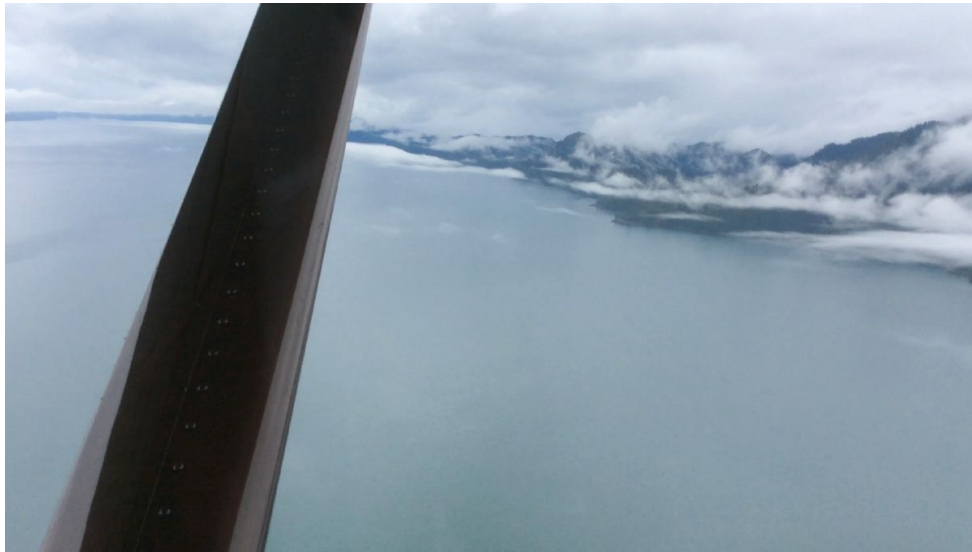
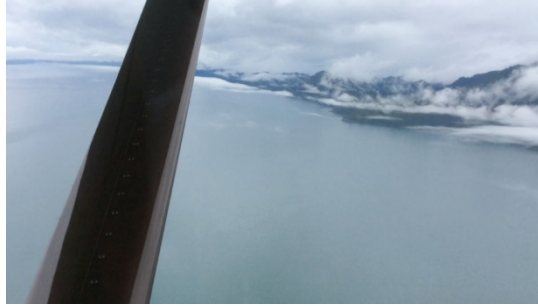
**Figure 18. Frame at 1212:31 AKDT (frame 00-08-01.06.jpg).**

1212:31: Figure 18 shows a video frame at this time from the camera (the camera had panned south southeast). The frame shows the south part of Behm Canal free of significant low-level cloud cover and visibility greater than 5 miles.

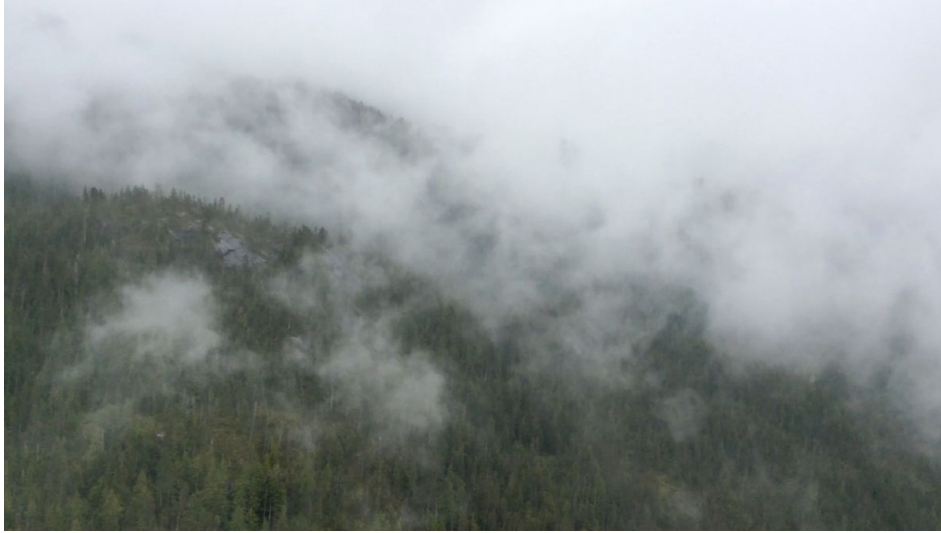
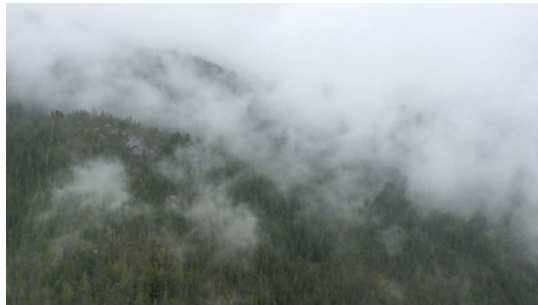
**Figure 19. Frame at 1214:20 AKDT (frame 00-09-50.10.jpg).**

1214:20: Figure 19 shows a video frame at this time from the camera (the camera had panned up slightly). The camera was pointed towards the south. Broken clouds were visible at about the height of the airplane and extended to the top of the video frame. Higher terrain off the aircraft's left was obscured by clouds.

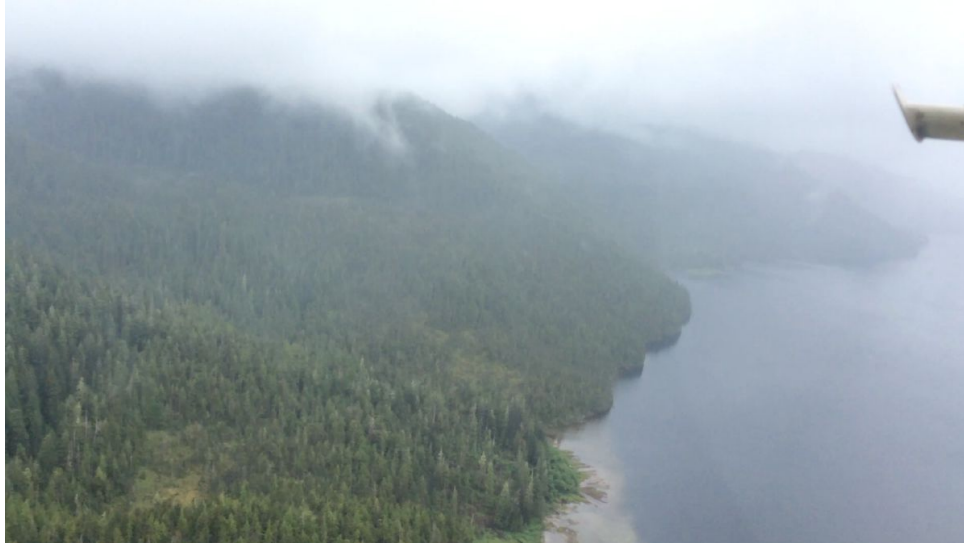
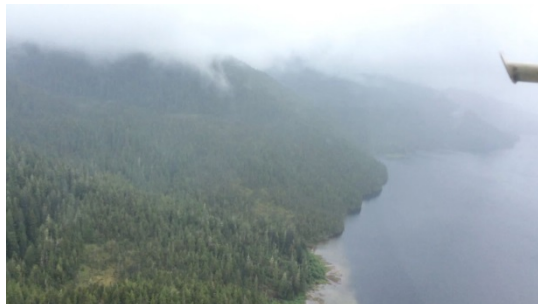
**Figure 20. Frame at 1214:57 AKDT (frame 00-10-27.08.jpg).**

1214:57: N270PA had reached the northeast corner of Ella Lake (just beyond the end of Ella Narrows). Figure 20 shows a video frame at this time from the camera. The camera was pointed left-forward, clouds were visible in contact with the hills just above the height of the aircraft, and they obscured the higher terrain. Forward of the aircraft, a ridgeline was visible (through obscured visibility), about 3 statute miles forward of the aircraft. A portion of the south shore of Lake Ella was also visible through the obscured visibility. The obscuration to visibility could not be determined, but may have been rain, drizzle, mist, fog, and/or haze.

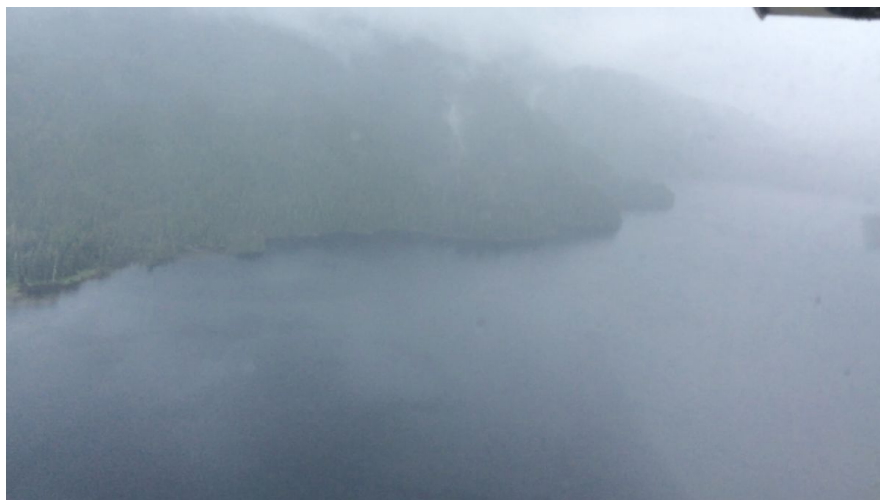
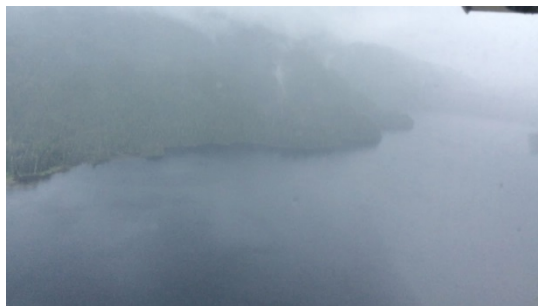
**Figure 21. Frame at 1215:32 AKDT (frame 00-11-01.28.jpg).**

1215:32: Figure 21 shows a video frame at this time from the camera. The camera was pointing forward enough to include the arc of the propeller. The cloud bases forward were obscuring the terrain and to the left were slightly above the aircraft. Objects were visible, obscured by light rain, about 2 statute miles forward of the aircraft.

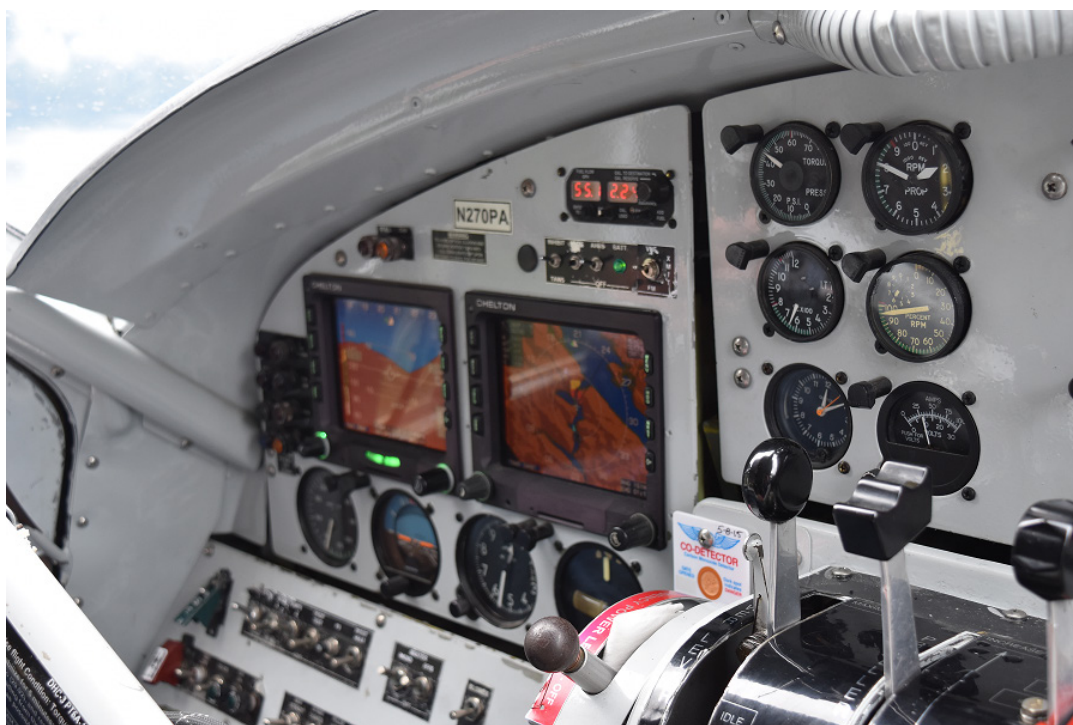
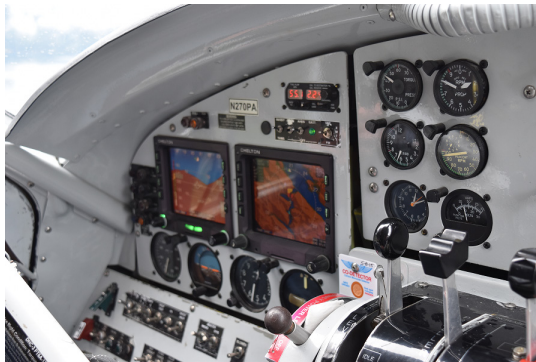
Figure 22. Photo at 1208:35 AKDT. DSC\_0709.JPG.

Filename	Time (AKDT)	Description
DSC_0709.JPG	1208:35	Image of cockpit. Left Chelton IDU configured as PFD with terrain features displayed. Right Chelton IDU configured as a moving map with red and yellow terrain color highlighting ahead of the aircraft position on either side of the Ruyard Bay displayed on the unit. Fuel flow 55.1 gallons per hour. Standby altimeter read about 550 feet. TAWS inhibit switch was set to inhibit. Torque read 44 psi. RPM read 1,800. ITT read 650 (undetermined units). N1 read 96%. Analog clock read about 1209:06. Amps/Volt gauge was positioned at about 26 Amps (undetermined if gauge was reading Amps or Volts). Analog airspeed read about 135 mph. There was a "CO-DETECTOR" below the clock with a date of "5-8-15" written on it. See figure 22.

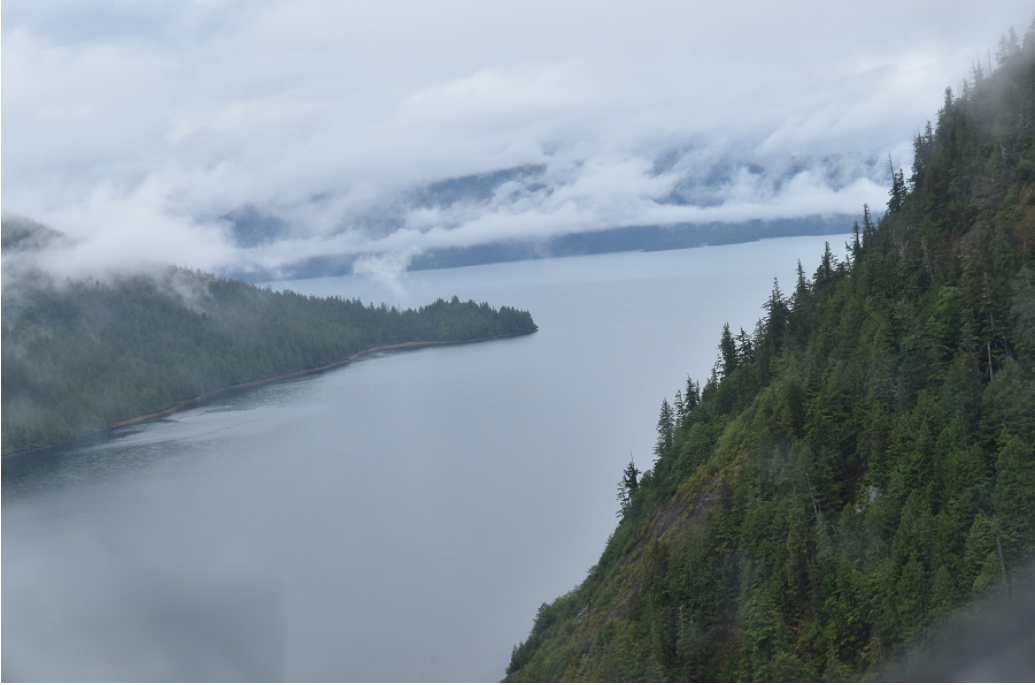
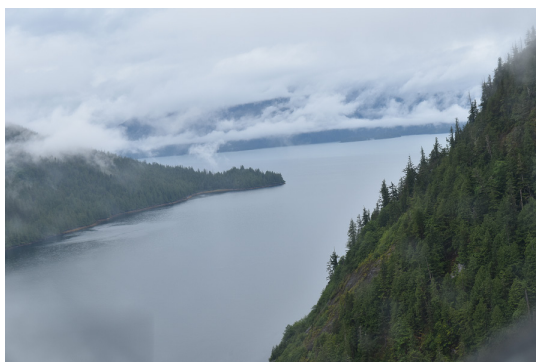
**Figure 23. Photo at 1208:57 AKDT. Photo DSC\_0710.JPG.**

Filename	Time (AKDT)	Description
DSC_0710.JPG	1208:57	Forward view across the channel. Mountains on the west side of the channel (where the aircraft would be at about 1212:43 AKDT) were partially obscured. There was a lower scattered scud layer to the aircraft's left (partially obscuring terrain) and another scattered scud layer towards the west side of Behm Canal; the scud layers extended from at or below the aircraft and continued vertically into a higher overcast. See figure 23.

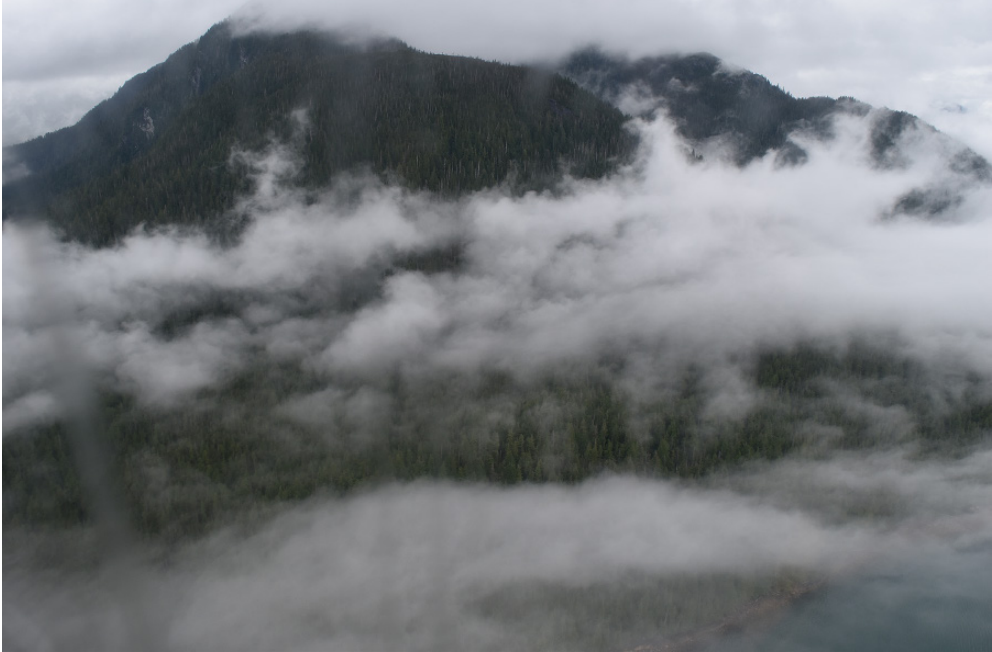
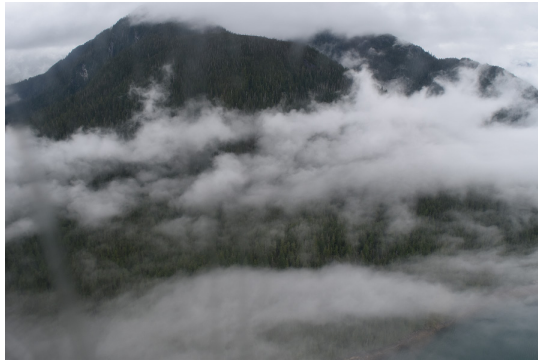
**Figure 24. Photo at 1212:48 AKDT. Photo DSC\_0719.JPG.**

<b>Filename</b>	<b>Time (AKDT)</b>	<b>Description</b>
DSC_0719.JPG	1212:48	View of partially obscured mountain tops above the aircraft and scattered scud clouds below the aircraft. See figure 24.

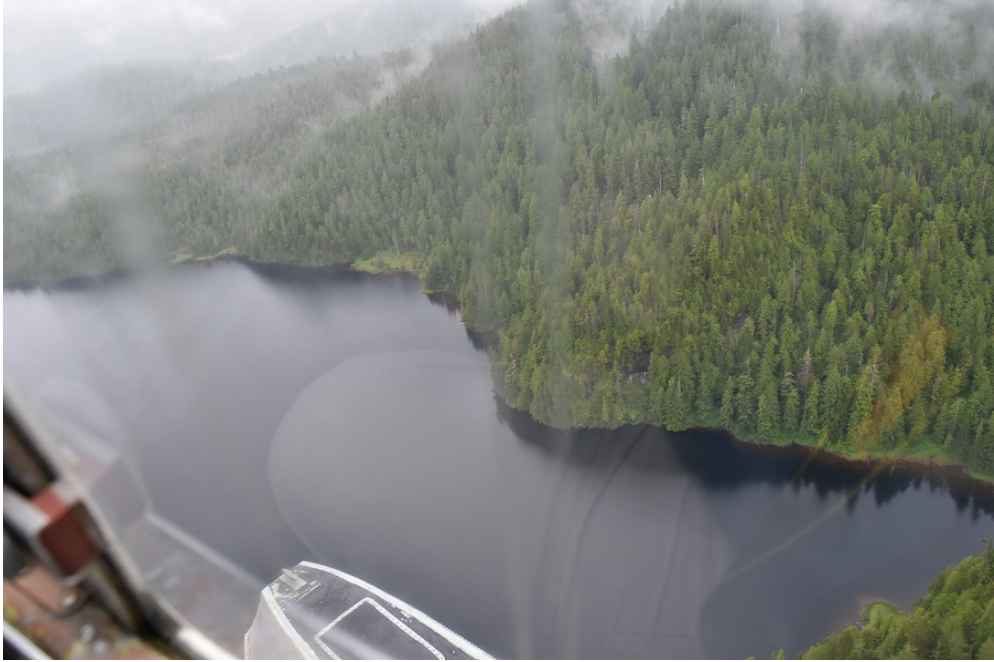
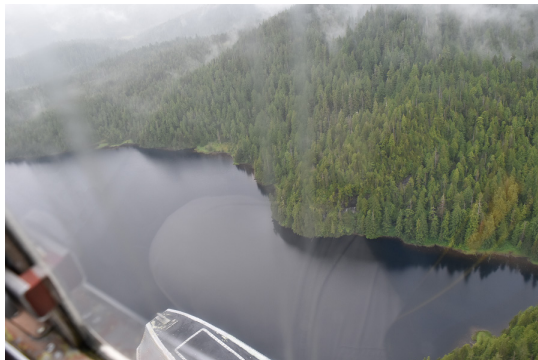
Figure 25. Photo at 1213:47 AKDT. Photo DSC\_0721.JPG.

Filename	Time (AKDT)	Description
DSC_0721.JPG	1213:47	Downward oriented photo, includes forward part of right float. Lower Ella Lake visible. Visibility in the direction of the flight path had deteriorated relative to the visibility crossing Behm Canal (i.e., greying out). Scattered scud clouds in hills to the north were in contact with trees. See figure 25.

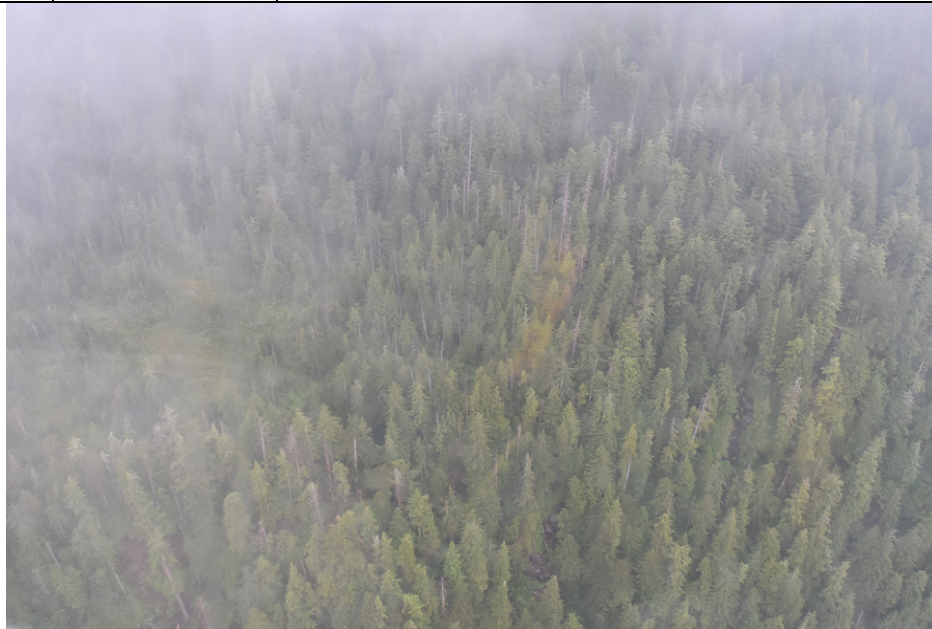
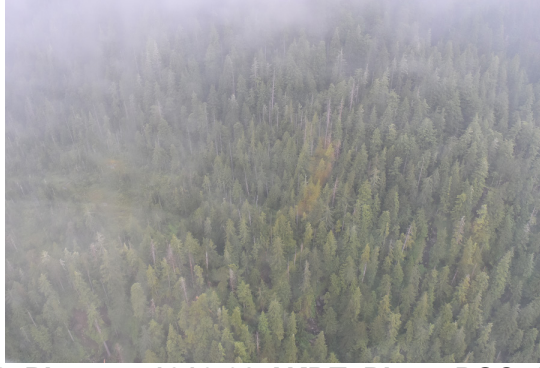
**Figure 26. Photo at 1216:08 AKDT. Photo DSC\_0725.JPG.**

<b>Filename</b>	<b>Time (AKDT)</b>	<b>Description</b>
DSC_0725.JPG	1216:08	Photo showing evergreen trees. Visibility partially obstructed by thin cloud cover. Vantage point is downward. See figure 26.

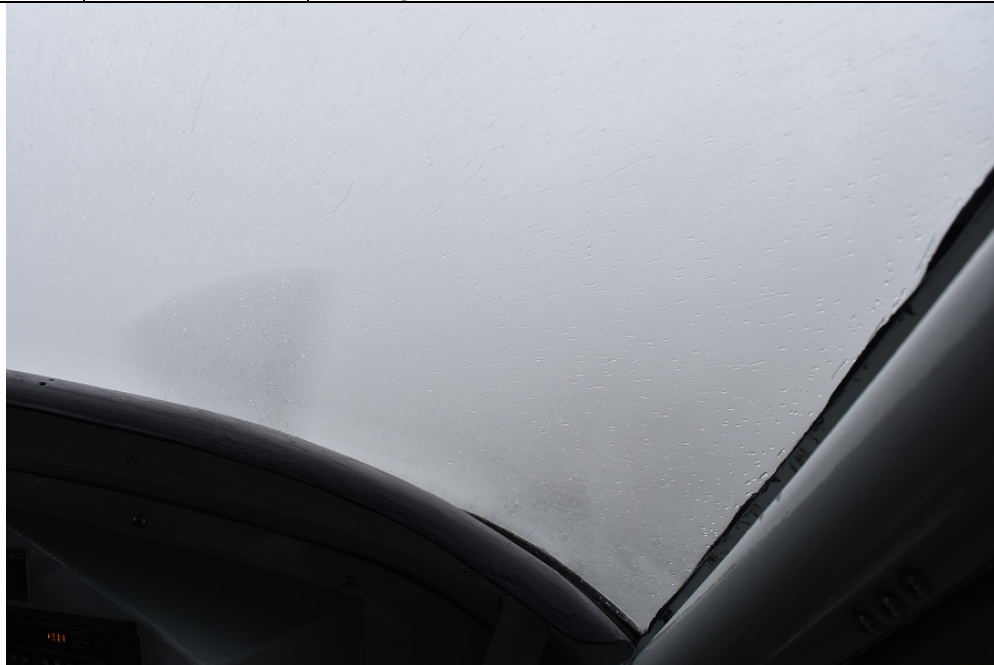
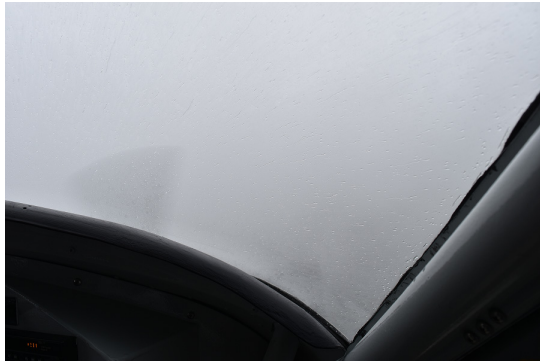
Figure 27. Photo at 1216:15 AKDT. Photo DSC\_0726.JPG.

Filename	Time (AKDT)	Description
DSC_0726.JPG	1216:15	Last image from N270PA. Part of right cockpit windscreen was visible. Rain on windscreen, no forward visibility. Propeller arc visible. Lower right portion of windscreen contained a darker area, similar to mostly obscured terrain. See figure 27.

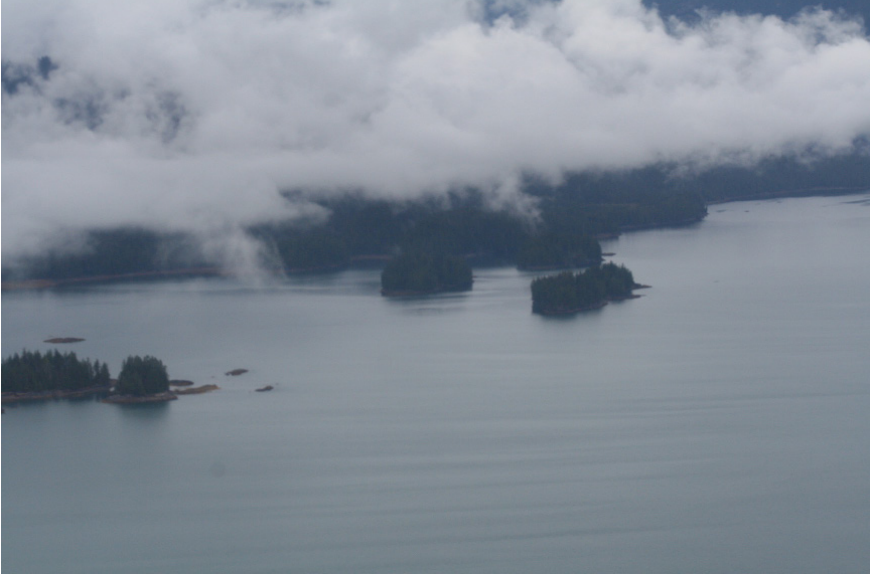
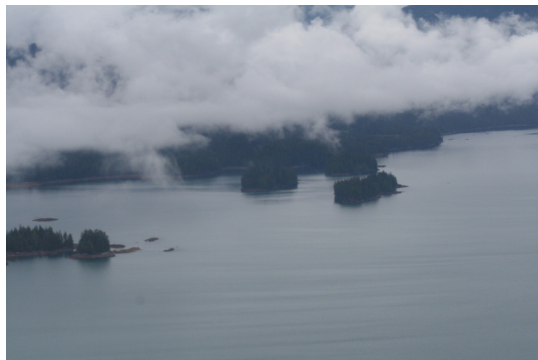
**Figure 28. Photo at 1212:07 AKDT. Photo IMG\_1264.JPG.**

Filename	Time (AKDT)	Description
IMG_1264.JPG	1212:07	Northwesterly view of west side of Behm Canal. Scattered scud clouds below the altitude of the airplane along the coastline. See figure 28.

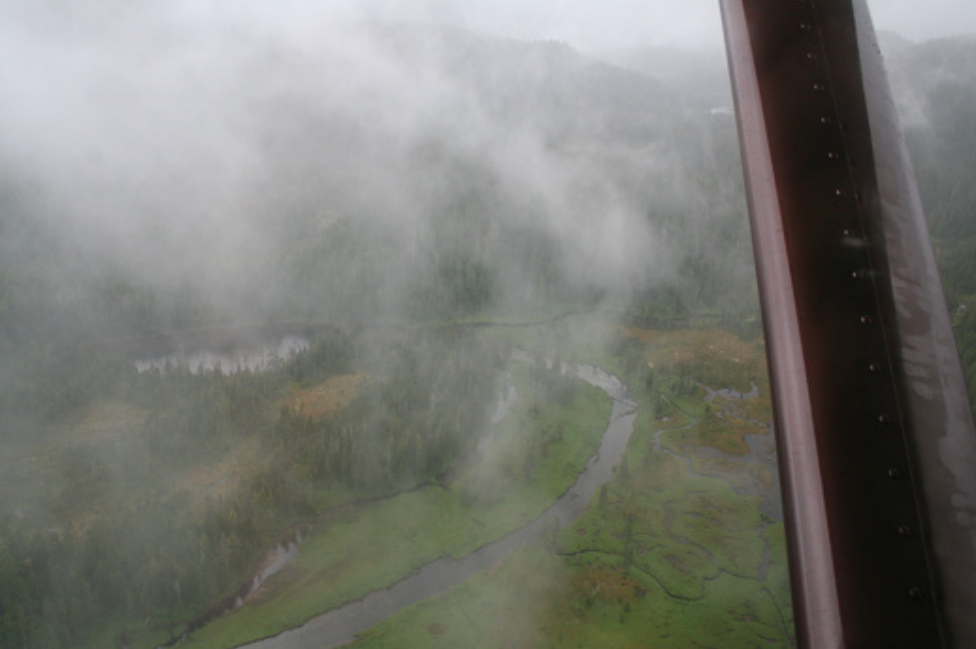
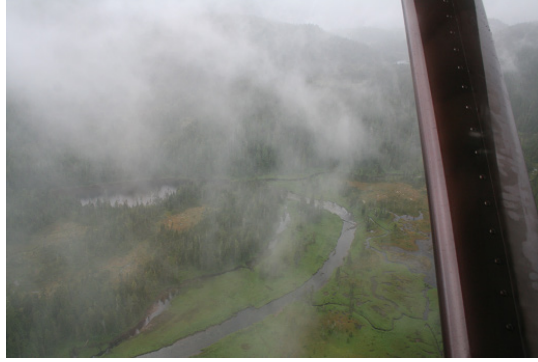
<p data-bbox="451 1780 1170 1814"><b>Figure 29. Photo at 1214:06 AKDT. Photo IMG_1265.JPG.</b></p>

<p data-bbox="451 961 1170 995"><b>Figure 28. Photo at 1212:07 AKDT. Photo IMG_1264.JPG.</b></p>		
IMG_1265.JPG	1214:06	Downward facing photo. Scud clouds below the plane partially obscure the terrain below and to the sides of N270PA. See figure 29.

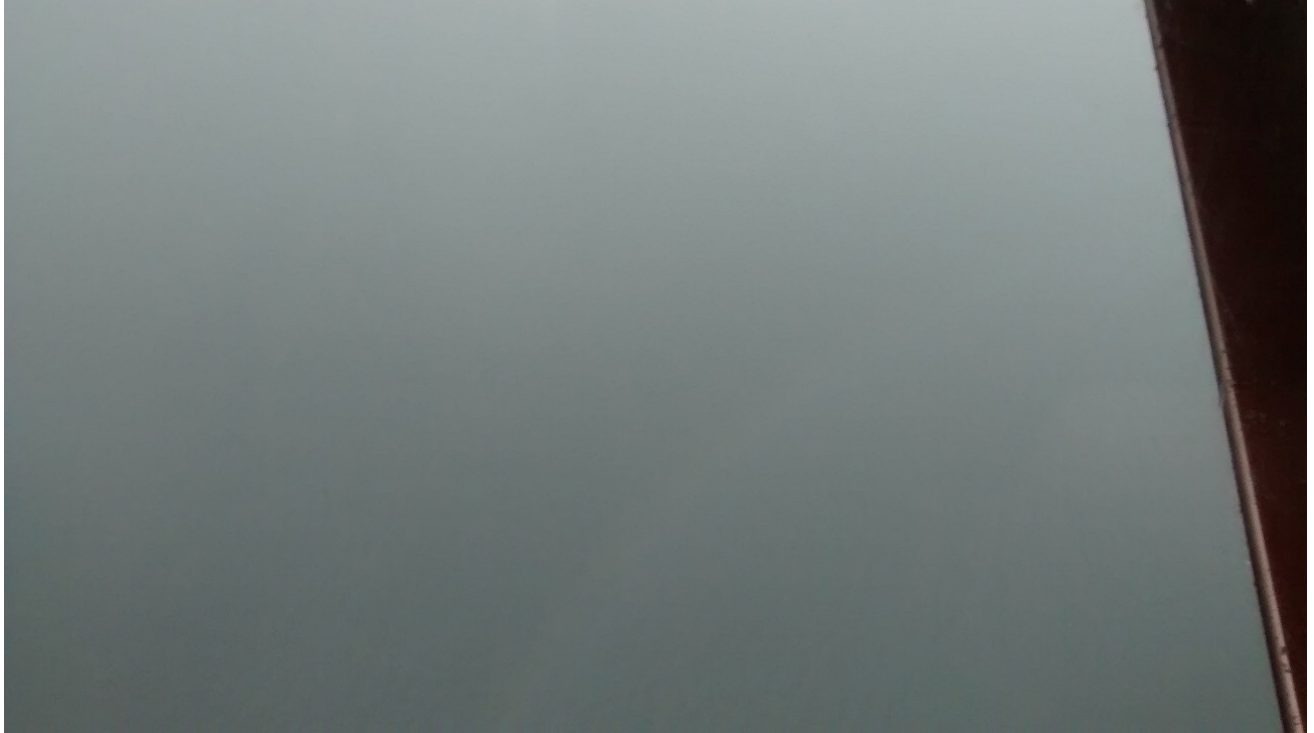
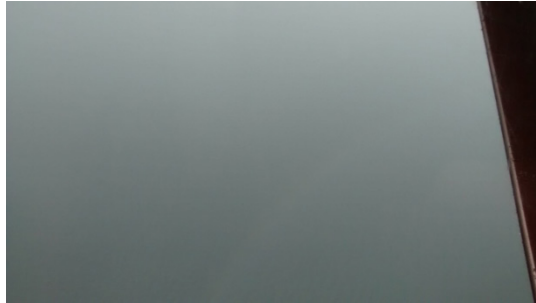
**Figure 30. Prior flight photo at 2342 on June 25, 2015.**

- From 2326 to 2327, visibility greater than 5 miles, below an overcast.
- At 2342, reduced visibility, below or in bases of clouds.
- At 2342, with no clearly identifiable visual landmarks, as shown in figure 30.
