NATIONAL TRANSPORTATION SAFETY BOARD
Vehicle Recorder Division
Washington, DC 20594

Onboard Image Recorder

Specialist's Factual Report
By Bill Tuccio, Ph.D.

Location:	Panhandle, Texas
Date:	June 28, 2016
Locomotives:	Locomotive, Eastbound Train, BNSF 5162 ¹ Locomotive, Siding Train, BNSF 5451 Locomotive, Westbound Train, BNSF 7553 Locomotive, Westbound Train, BNSF 7907 Locomotive, Westbound Train, BNSF 8191 Locomotive, Siding Train, BNSF 7911
Operator:	BNSF Railway
NTSB Number:	DCA16FR008

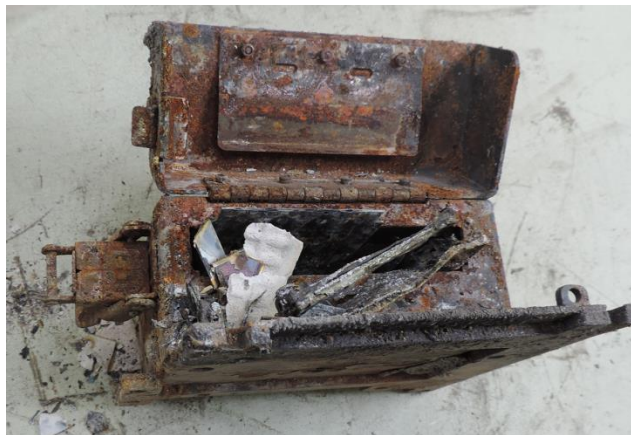
Figure 1. Onboard image recorder from BNSF 5162.

The recorder from the lead locomotive of the Eastbound train, BNSF 5162, suffered extreme heat damage, as shown in figure 1. Damage to non-volatile memory³ destroyed all recorded information.

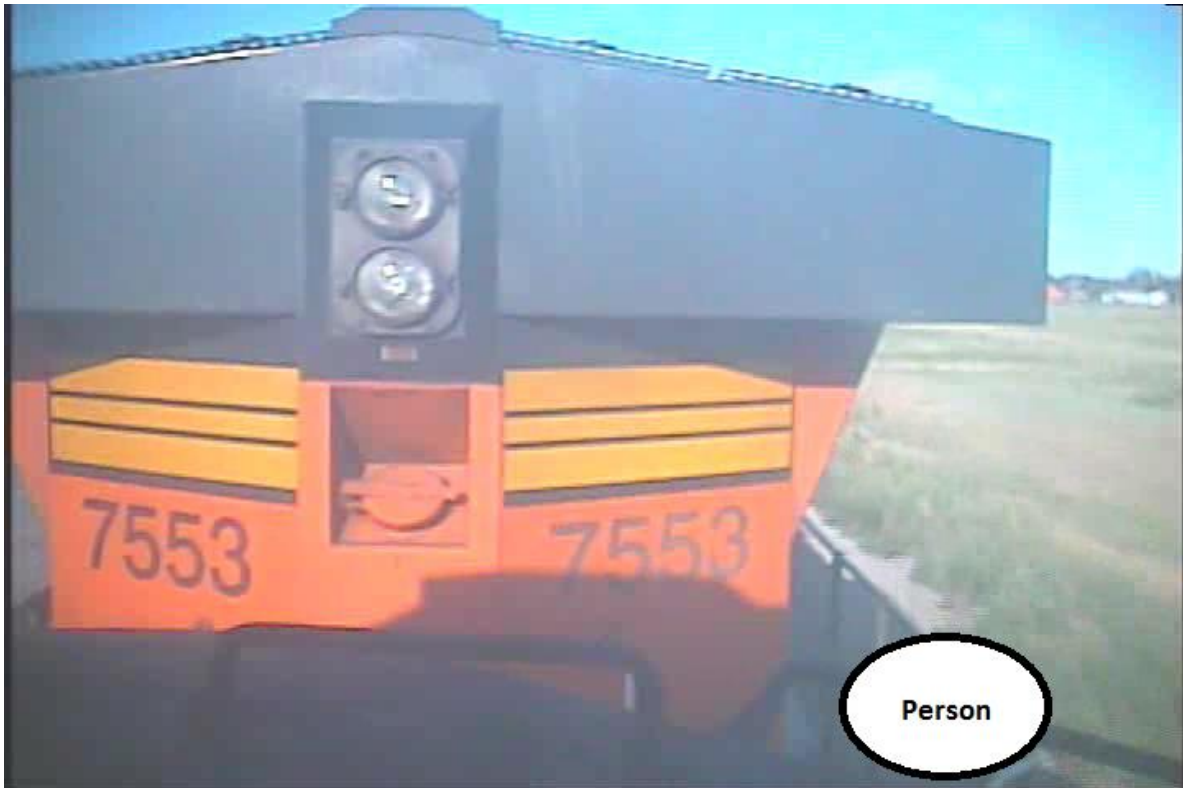
Figure 2. BNSF 7907 at 0820:51 CDT.

At 0820:51 CDT, a person, image redacted, was visible to the right of BNSF 7907, as shown in figure 2.

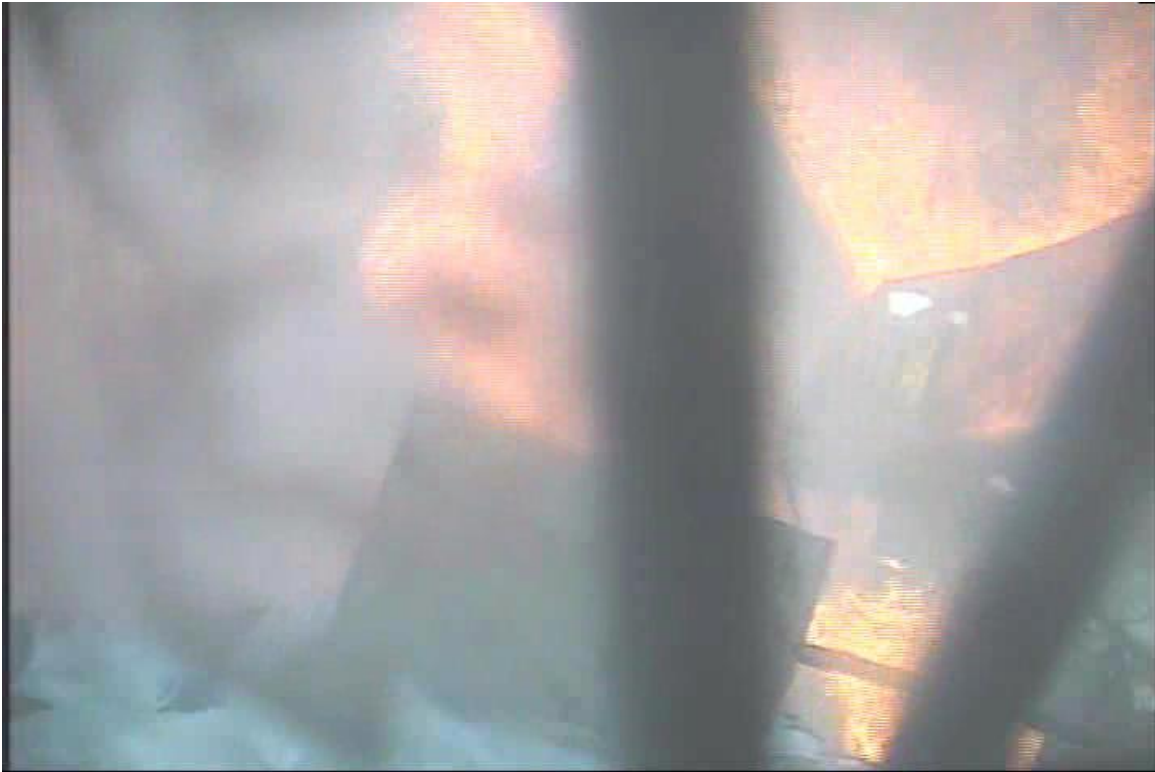
Figure 3. BNSF 7907 at 0821:15 CDT.

By 0821:15 CDT, BNSF 7907 had come to a stop and fire was visible in the recorded imagery, as shown in figure 3.

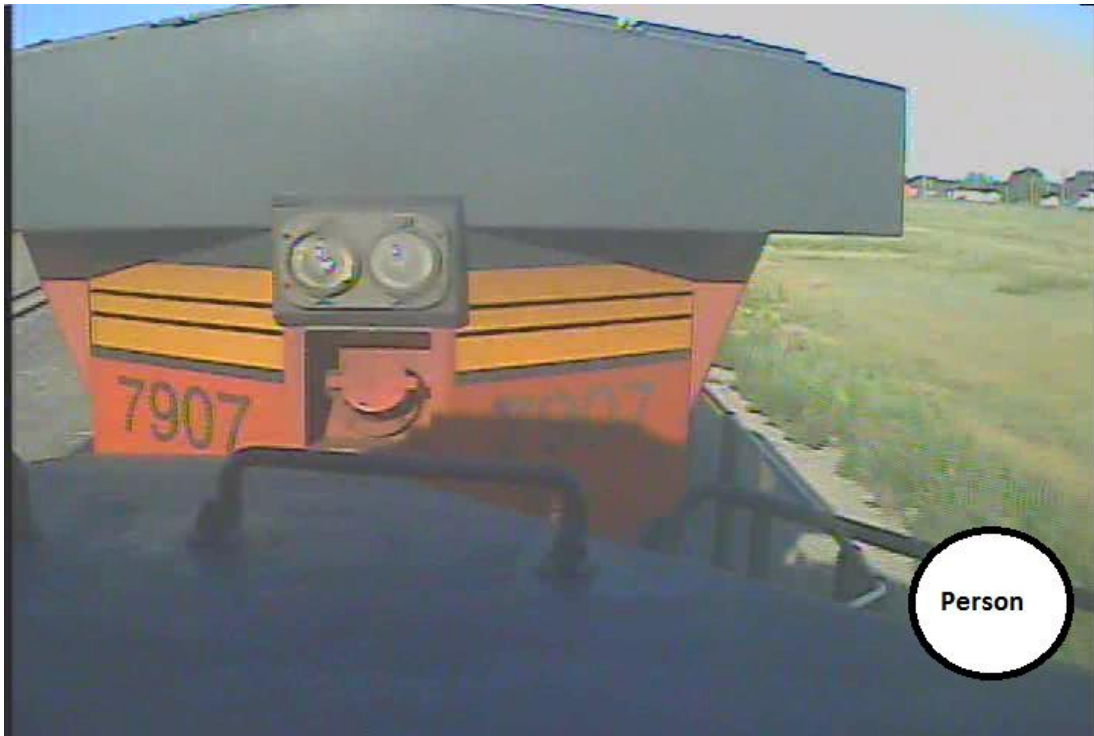
Figure 4. BNSF 8191 at 0820:53 CDT.

At 0820:53 CDT, a person, image redacted, was visible to the right of BNSF 8191, as shown in figure 4.

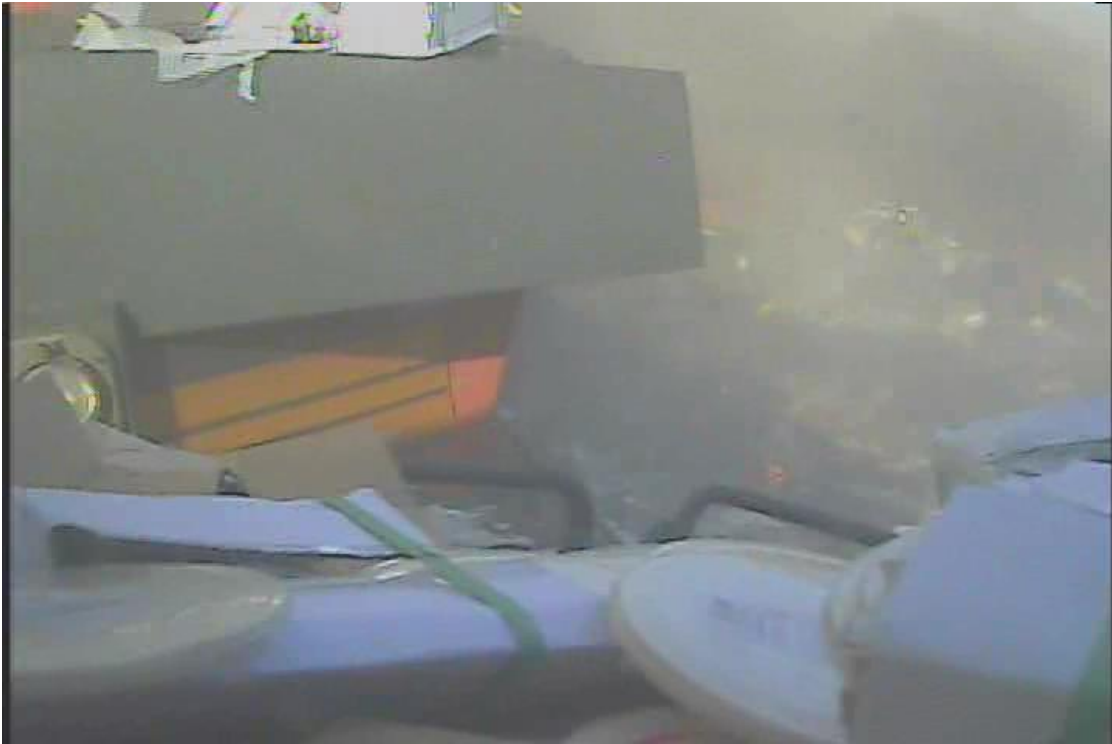
Figure 5. BNSF 8191 at 0821:15 CDT.

By 0821:15 CDT, BNSF 8191 had come to a stop and fire and smoke were visible in the recorded imagery, as shown in figure 5.

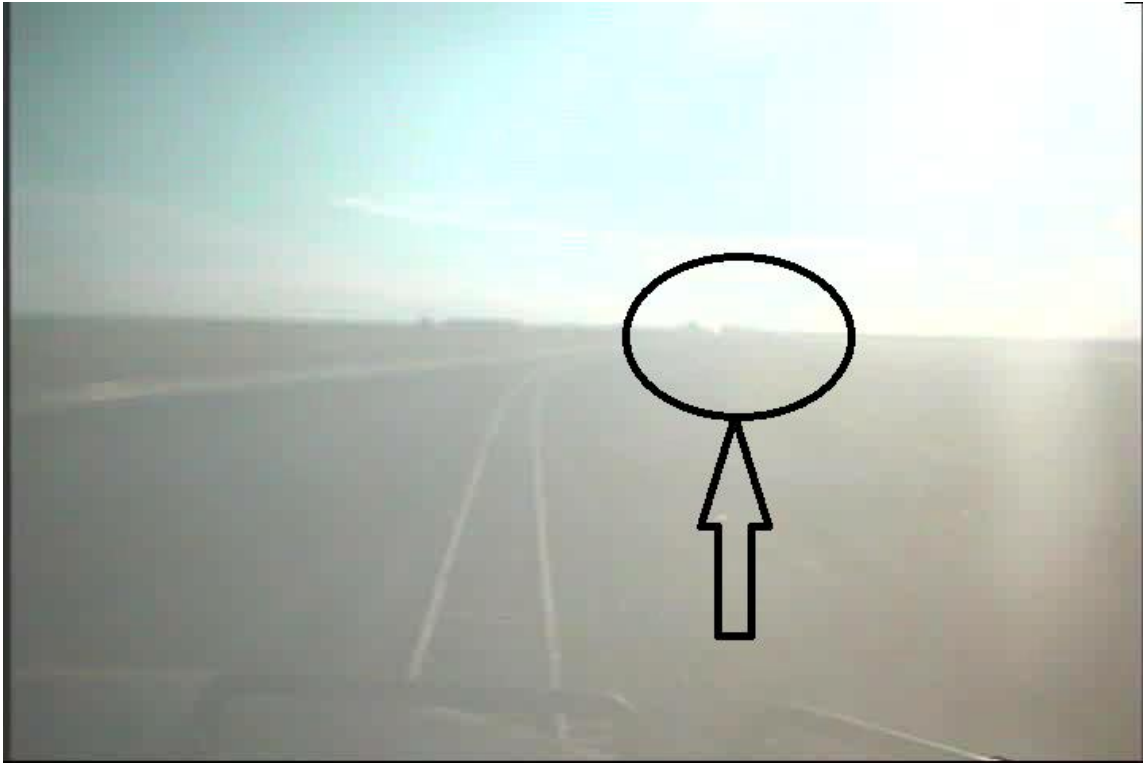
Figure 6. BNSF 7911 at 0820:10 CDT.

By 0820:10 CDT, the westbound train was visible to BNSF 7911, as shown in figure 6. The westbound train was coming in the direction of BNSF 7911 on a different track; the annotated arrow and circle highlight the position of the train.

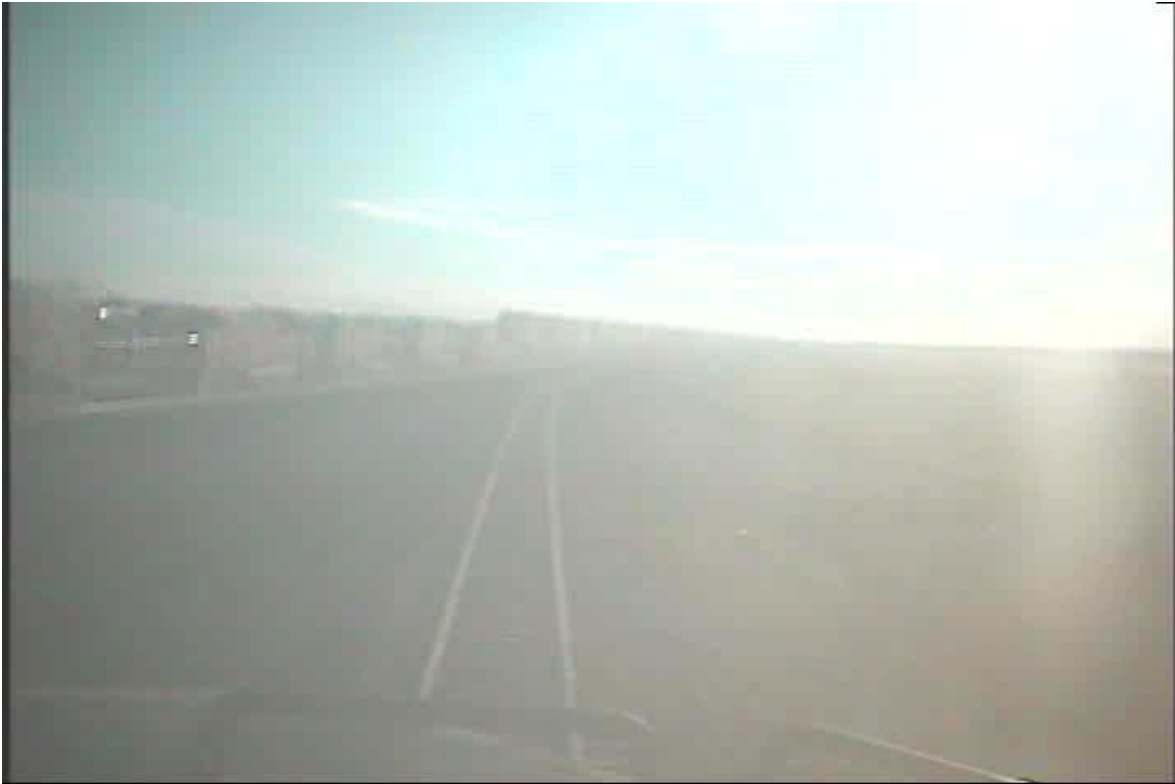
Figure 7. BNSF 7911 at 0820:55 CDT.

At 0820:55 CDT, the westbound train collided with the eastbound train. Figure 7 shows the westbound train at the moment of collision. The eastbound train was not within the field of view of BNSF 7911 at the time of the collision, but subsequent to 0820:55 CDT, parts of the eastbound train entered the field of view, along with fire and debris.

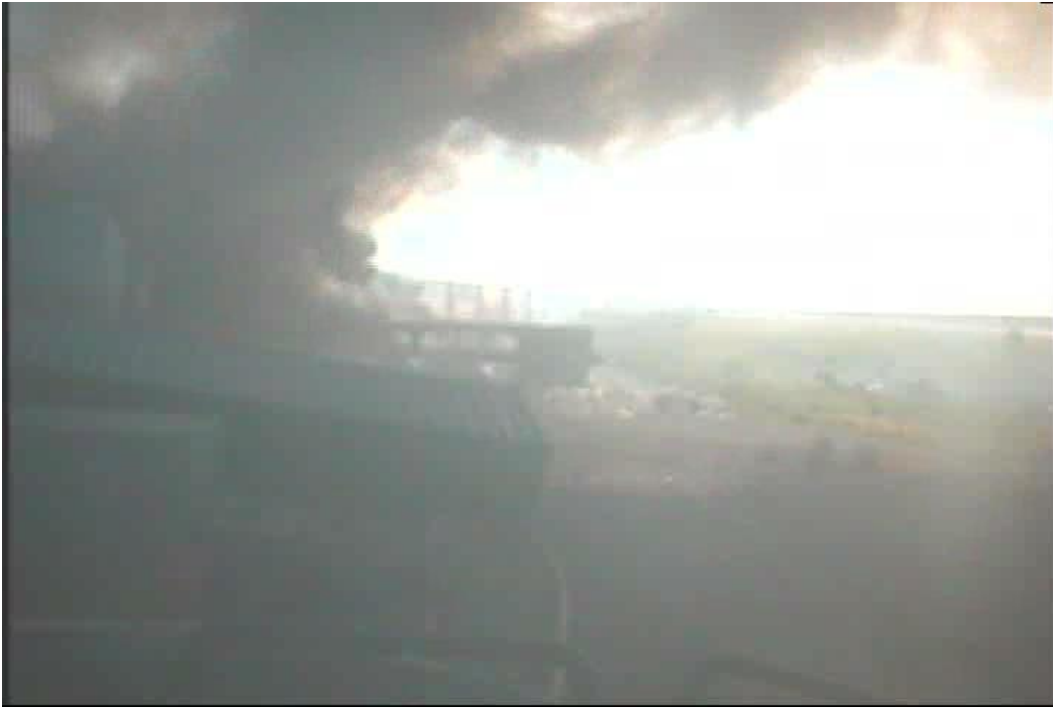
Figure 8. BNSF 7911 at 0822:49 CDT.

By 0822:49 CDT, unintelligible voices were recorded on BNSF 7911's external microphone and the smoke had cleared, as shown in figure 8.
