Collision with Terrain  
Promech Air, Inc.  
de Havilland DHC-3, N270PA  
Ketchikan, Alaska  
June 25, 2015

NTSB/AAR-17/02  
PB2017-102178

# Aircraft Accident Report

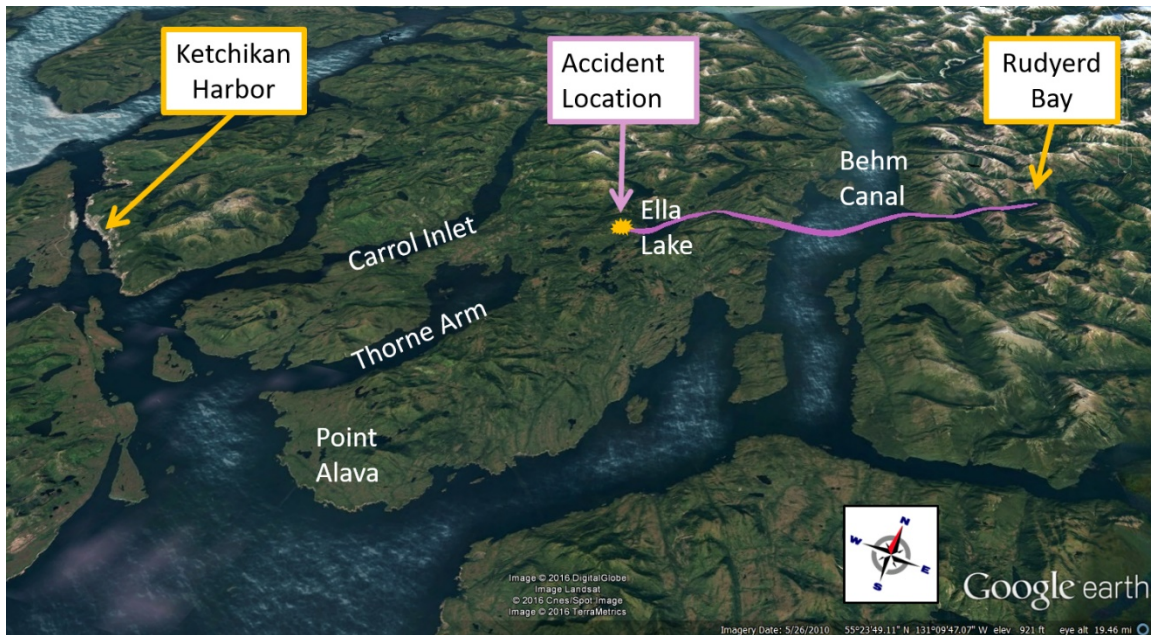
**Figure 2.** Map showing the accident flightpath and wreckage location.

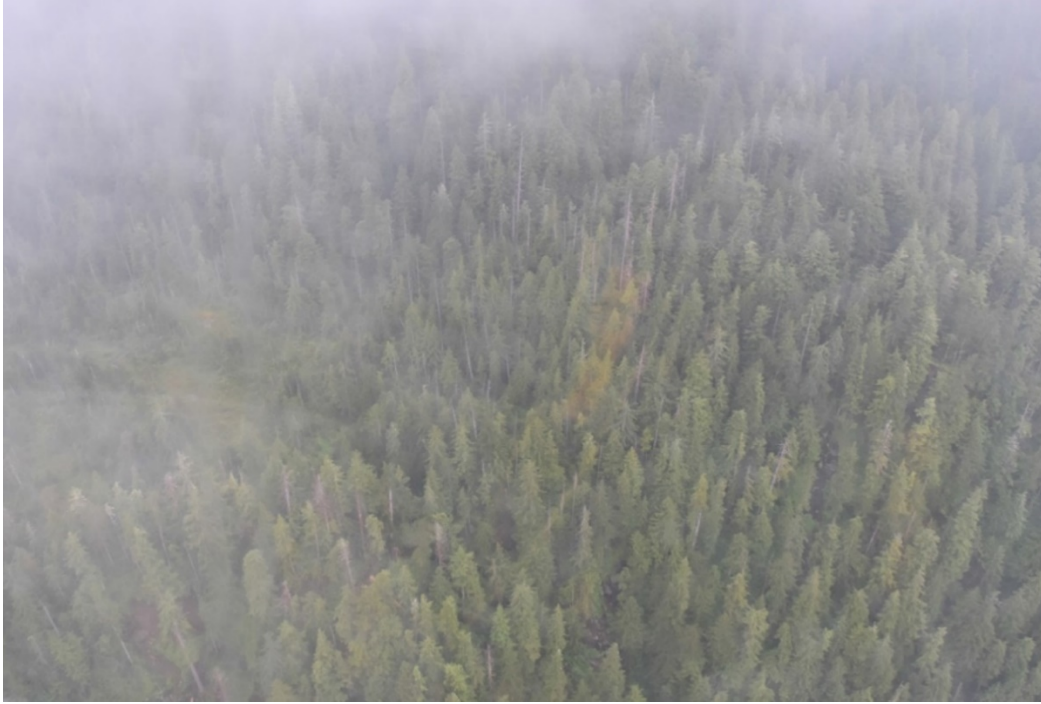
**Figure 3.** Downward-looking photograph showing evergreen trees and visibility that is partially obstructed by thin cloud cover.

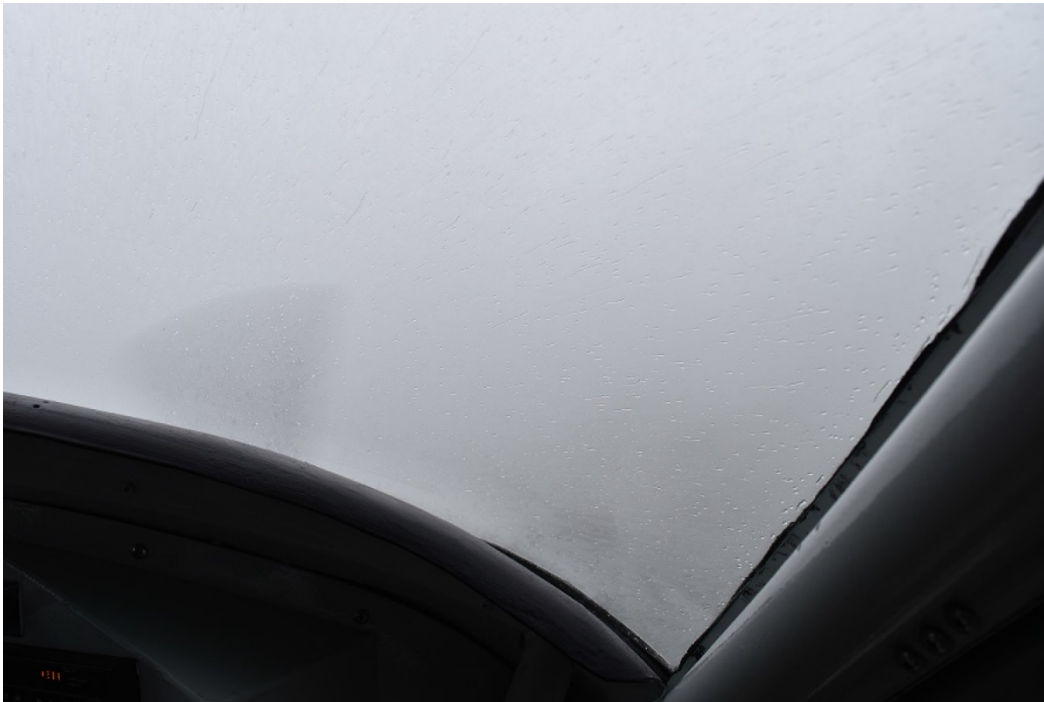
**Figure 4.** Forward-looking photograph through part of right cockpit windscreen. Rain on the windscreen and the propeller arc are visible. The lower right portion of windscreen shows a darker area, similar to mostly obscured terrain.

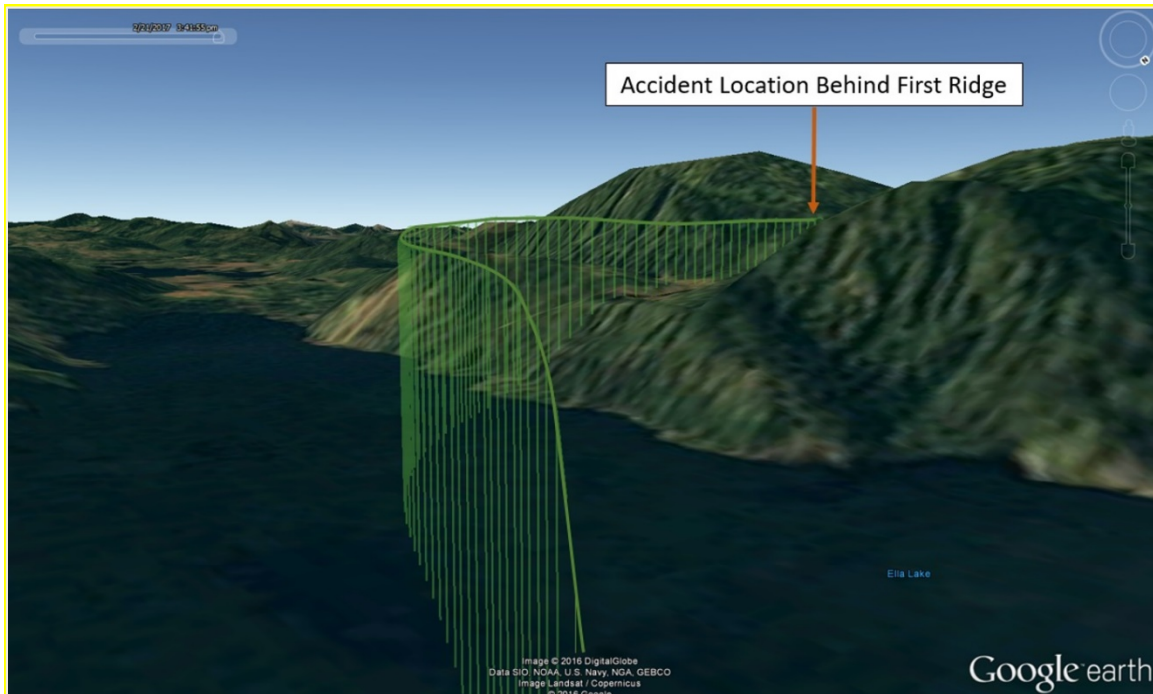
After crossing the ridge, the airplane continued on a relatively constant heading between 1,400 ft and 1,500 ft msl for about 30 seconds. Data from the Chelton EFIS showed that, about 2 seconds before the collision, the airplane began to pitch up rapidly, experiencing about +2 Gs of vertical acceleration and climbing before it collided with terrain.<sup>9</sup> The airplane struck the terrain at an elevation of about 1,600 ft msl. The accident flight's west turn over the lake differed from the standard route, which would have continued past the high terrain before turning west (see figure 5).

**Figure 5.** The path flown by the accident airplane (green), viewed from the approximate altitude of the accident airplane, is shown turning to the west (right) toward high terrain.

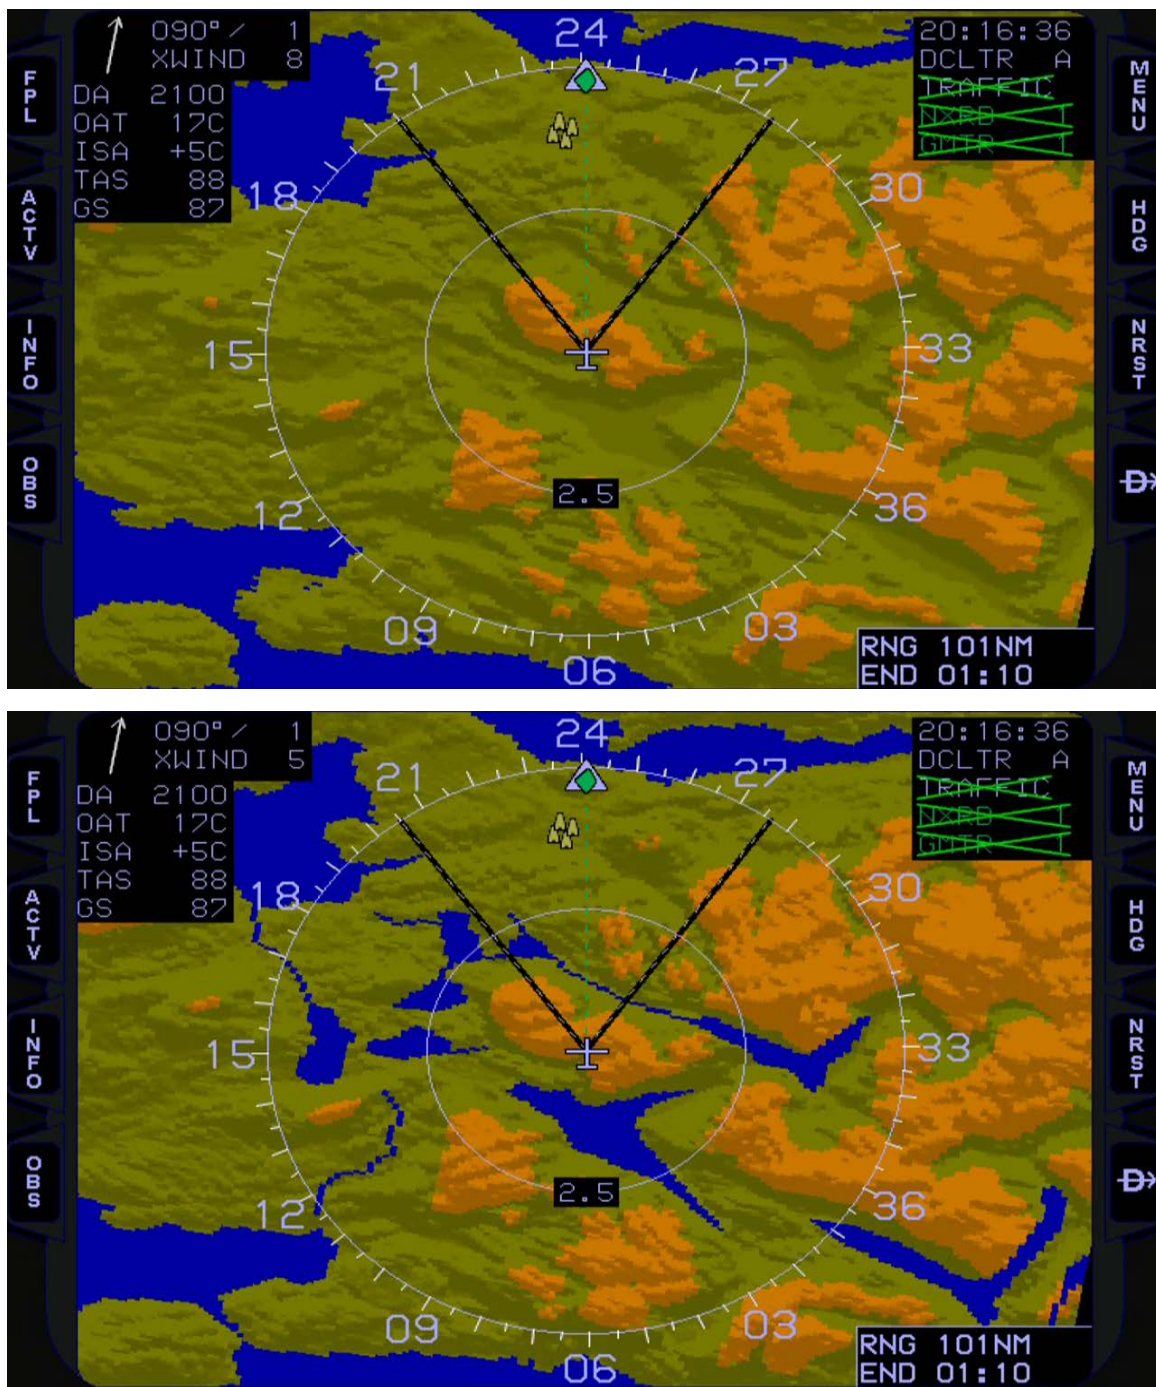
database did not show bodies of water on the display, whereas another does. The original 2003 database does not distinguish inland bodies of water, but the 2007 database update displays them in blue. (See figure 7.)

**Figure 7.** The top image shows how the Chelton EFIS's original 2003 database depicts the Ella Lake area, and the bottom image shows how the 2007 database update depicts the same area. Note that, in the most current database, the inland bodies of water are shown in blue.

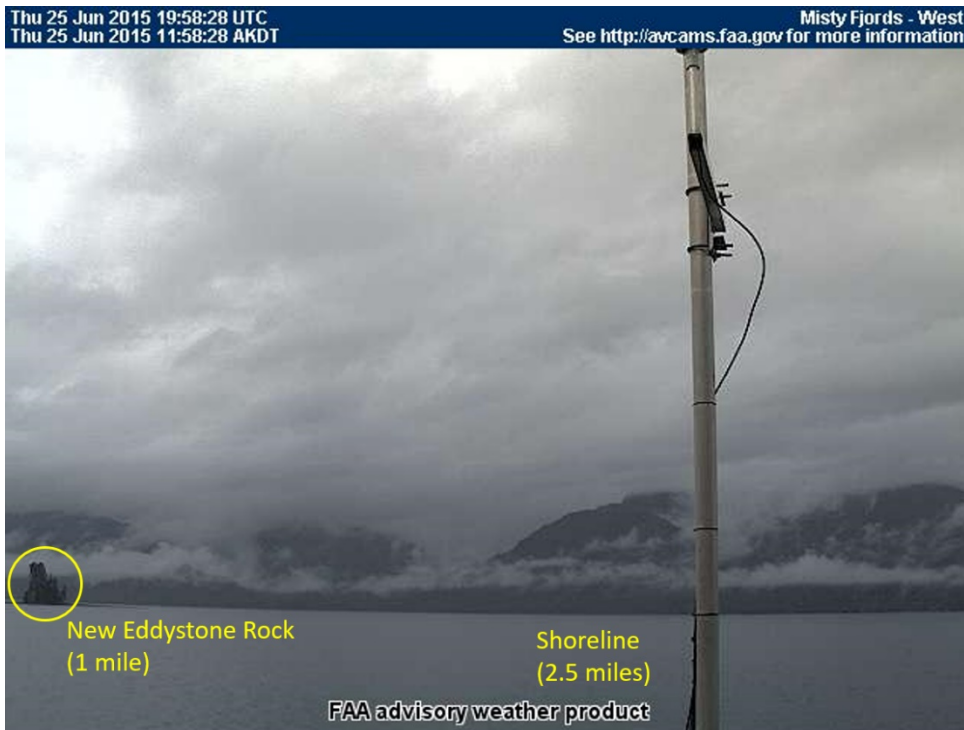
**Figure 10.** Image from west-facing (259°) Misty Fjords camera at 1158, a few minutes before the airplane’s departure from Rudyerd Bay.

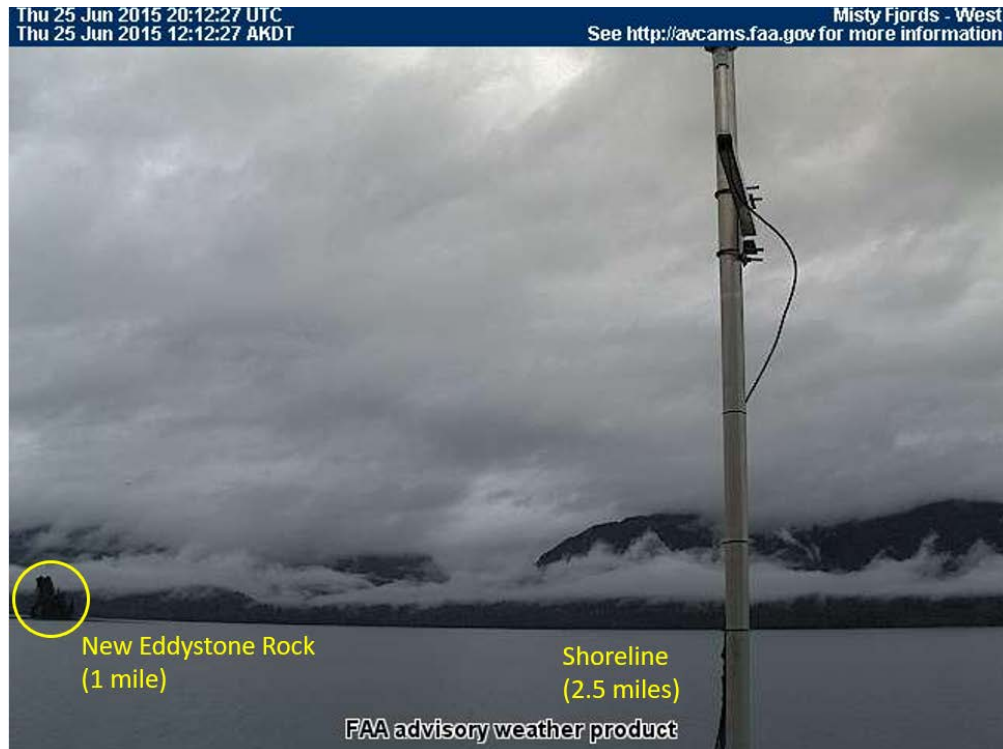
**Figure 11.** Image from west-facing (196°) Misty Fjords camera at 1212, about 3 minutes before the accident.

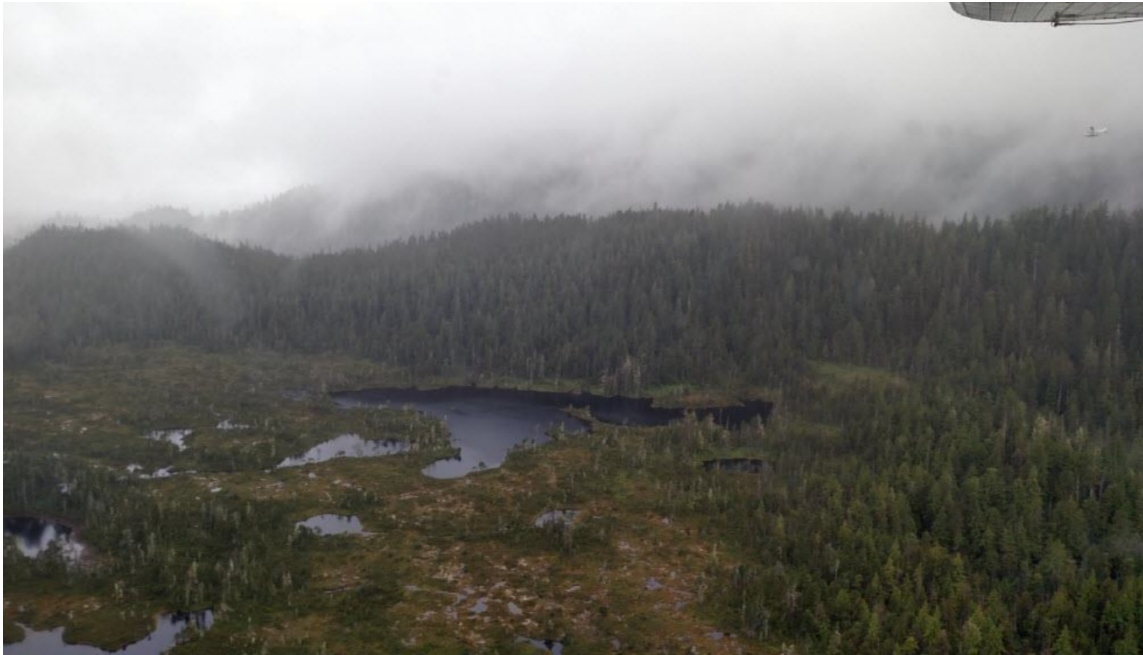
Digital photographs taken by a passenger on board this first Promech flight provided information about the weather conditions encountered when the airplane was about 0.5 nm south of Ella Lake. The most distant landmarks visible in the photographs are estimated to be about 1.5 nm away. Landmarks in the photographs provide a basis to estimate that the first Promech airplane transited this area about 300 to 400 ft agl. The southeast face of a large mountain is visible in the photographs and is completely obscured by clouds above about 1,000 ft msl, with some scattered clouds hanging down the mountainsides to lower elevations. This is the same mountain that the accident airplane subsequently struck about 1 nm to the north. A DHC-2 airplane operated by another tour company is visible in the upper right corner of the photograph. (See figure 14.)

**Figure 14.** Southwest-looking photograph taken about 0.3 nm south of Ella Lake and 1.3 nm south of the accident location by a passenger on board the first Promech airplane.

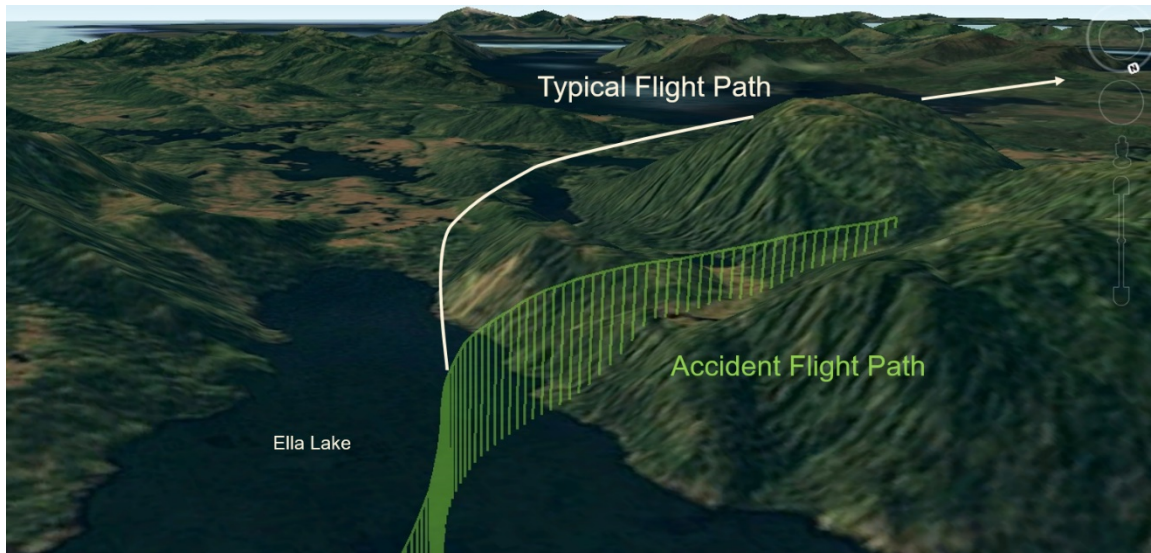
Despite the deteriorating weather conditions in the Ella Lake area, the two other Promech pilots on the short route (one who departed before the accident flight and one who departed after) successfully completed their trips. In reduced visibility weather conditions, Promech pilots typically fly southwest over Ella Lake and proceed beyond the south end of the lake before turning west. This route allows the flights to avoid the high terrain located west of the lake, which includes two similarly shaped mountains. (See figure 16.)

**Figure 16.** The typical flight route (white) passes two similarly shaped mountains before turning west. For comparison, the path flown by the accident pilot is shown in green.

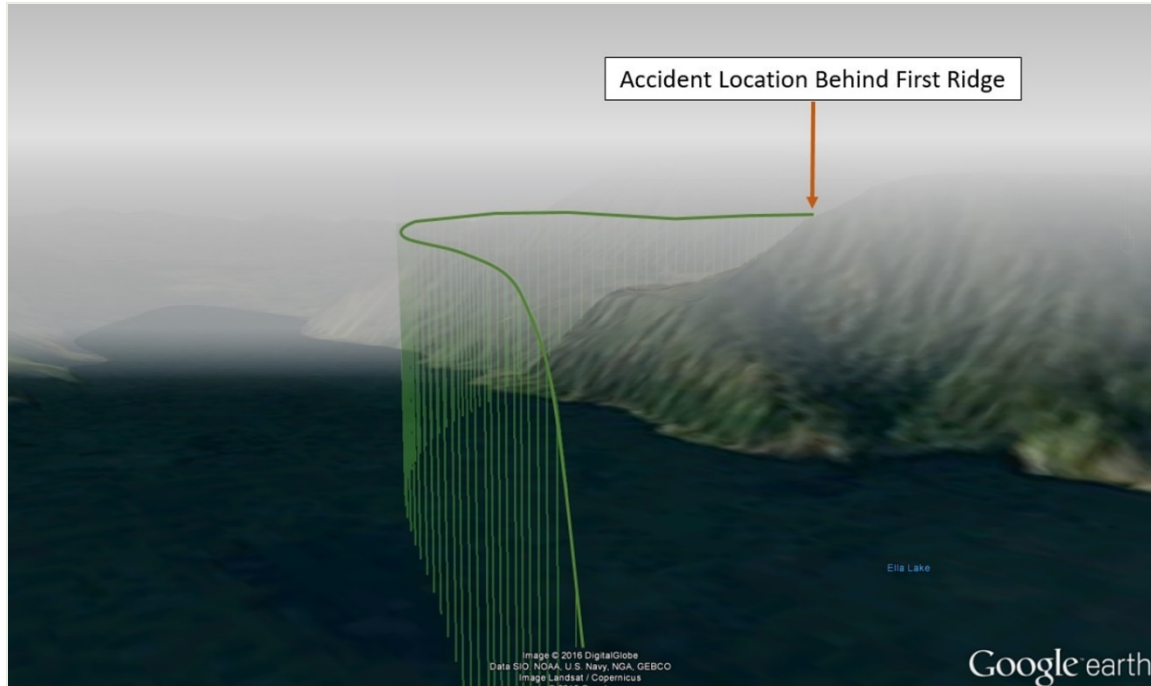
Although the accident pilot climbed the airplane to an altitude that would have provided safe terrain clearance along the typical route, he deviated from that route and turned the airplane west after it passed only the first of the two mountains. The pilot's route deviation placed the airplane on a collision course with the 1,900-ft second mountain, which it struck at an elevation of about 1,600 ft msl. (See figure 17.)

**Figure 17.** The path flown by the accident pilot (green), viewed from the approximate altitude of the accident airplane, is shown turning to the west (right) after passing the first mountain.
