**Docket No. SA-540**

**NATIONAL TRANSPORTATION SAFETY BOARD**

University of Alaska Simulator Evaluation

**ANC17MA001**

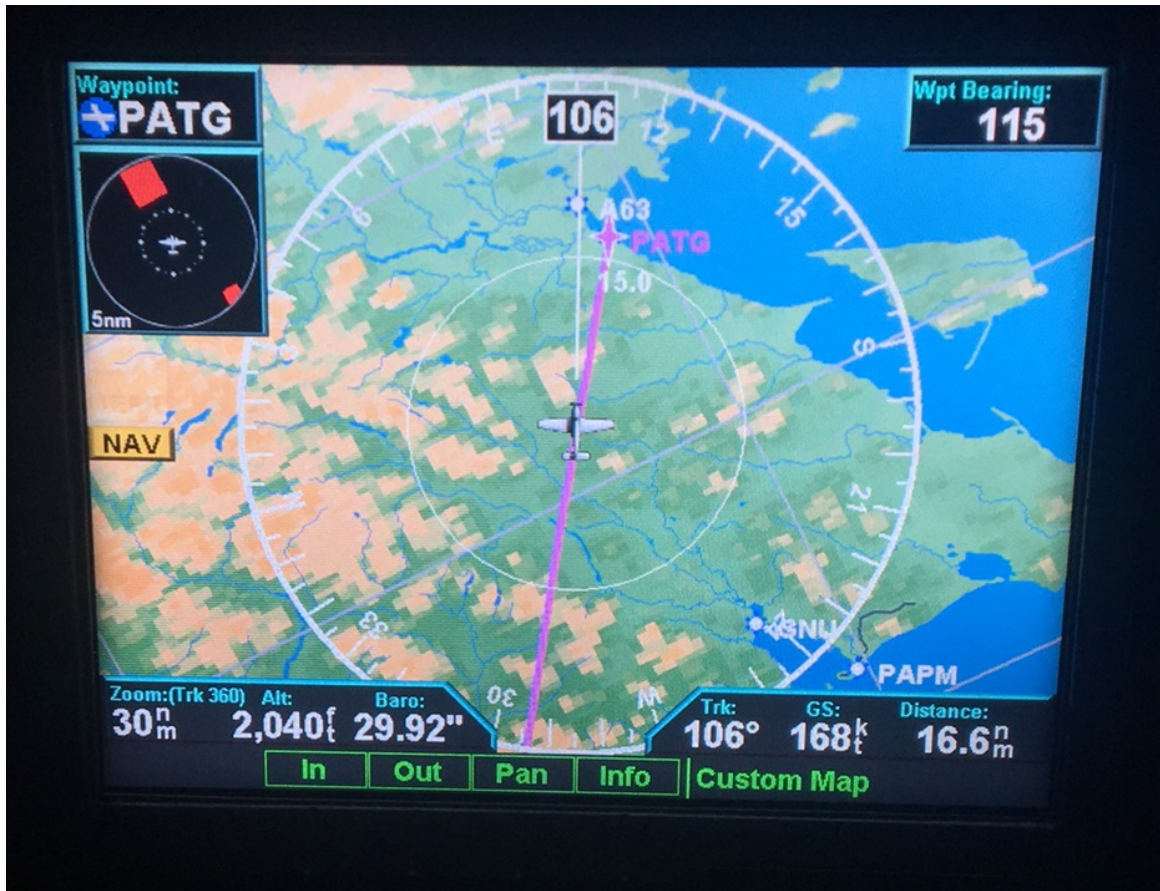
At 12.9 nm from Togiak, the airplane approached yellow caution terrain. The simulator was frozen at approximately 12 nm to observe different MFD modes (see Photos 4-6) – Map, Terrain and Split. Terrain and split modes show terrain depicted as yellow and red based on risk of collision. A flashing terrain warning on left side upper corner of the MFD pops up where red terrain is located close to the airplane. Per a phone conversation with the Hageland director of operations, Hageland pilots typically operate the display in Map mode so that other aircraft (TCAS) will display; they might also use Terrain mode but traffic will not be displayed. They do not operate in Split mode.

Photo 4. Garmin MX20 display – Map mode.

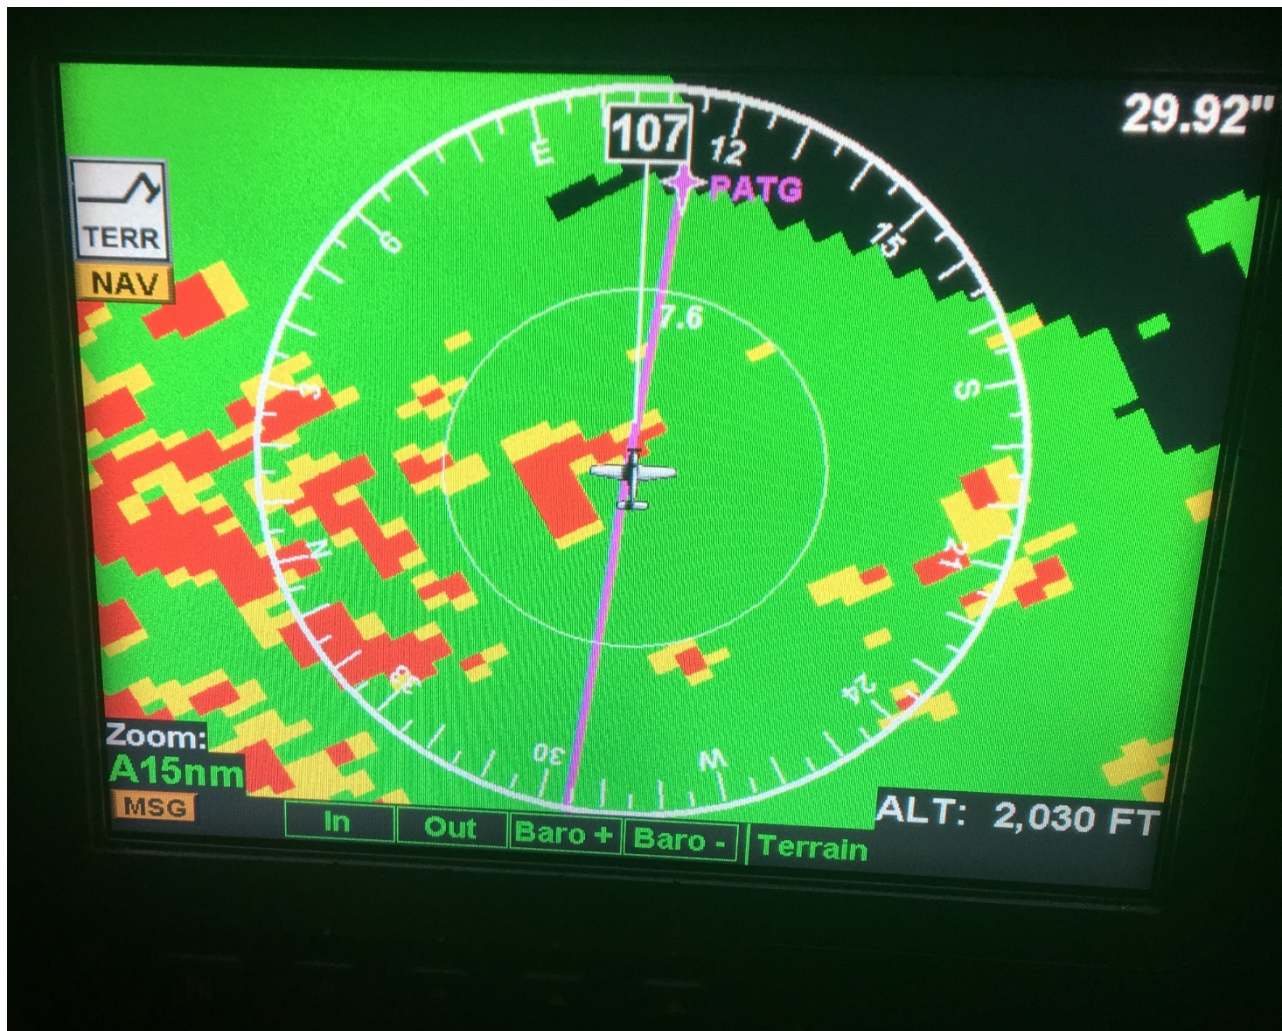
Photo 5. Garmin MX20 display – Terrain mode.

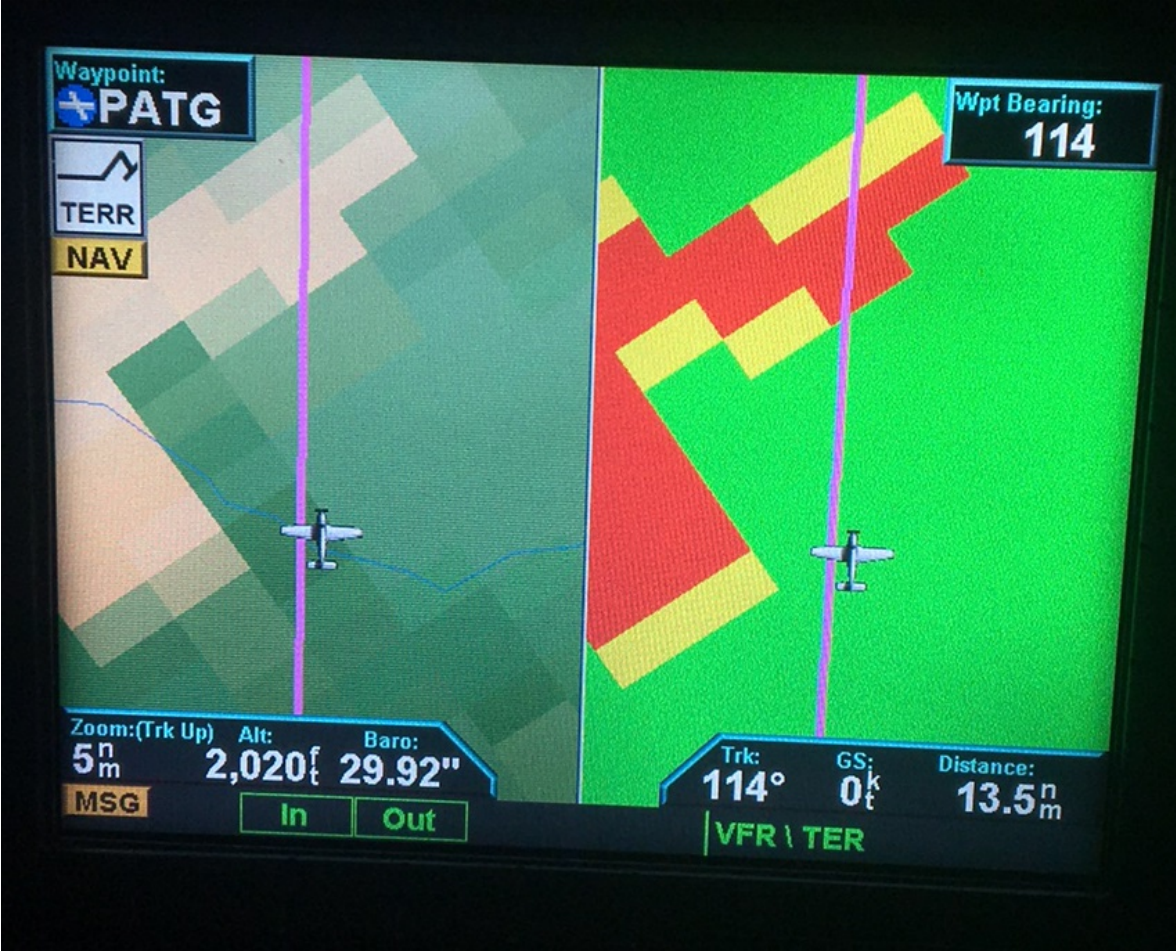
In Split screen mode, the airplane reached red terrain as displayed on right split screen (“terrain” mode) at 10.9 nm from Togiak

Photo 6. Garmin MX20 display – Split mode.

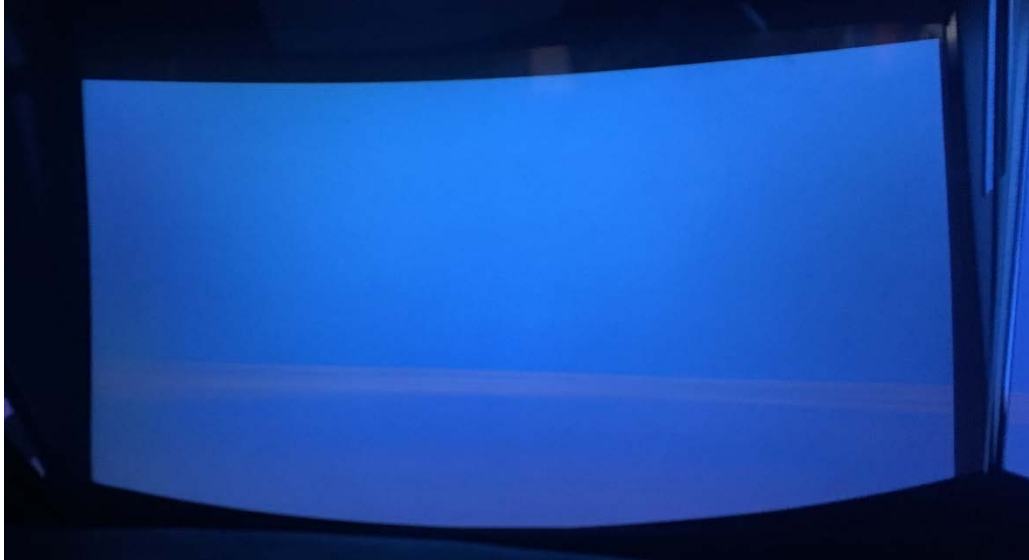
CFIT scenarios: Using the guidance provided in the CFIT-A manual, the simulator operator began adjusting visibilities, first to 5 miles, then 4, 3, and 2 miles. The simulator was not able to display multiple cloud layers, or replicate flat light or whiteout conditions. For the flat light condition, the simulator operator stated he could not input multiple cloud layers.. The closest replication to a whiteout scenario was to create a layer of clouds below the altitude of the airplane; snow covered terrain could not be simulated (see Photo 7).

Photo 7. Simulated whiteout condition.

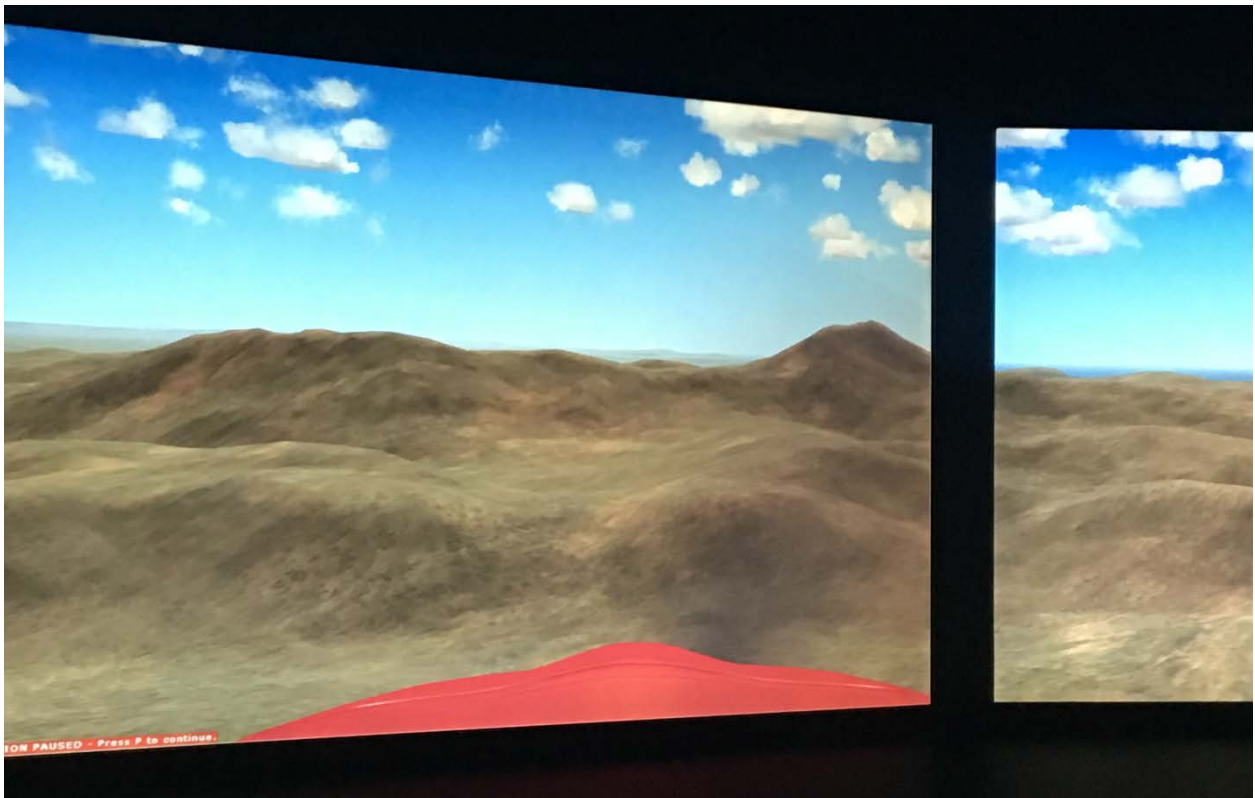
Following completion of activities in the CE208B simulator, the participants flew the accident route in a RedBird simulator, which had much more fidelity in the terrain presentation. The accident route was flown at an altitude of 2,240 feet to observe the terrain where the accident occurred (see Photos 8 and 9).

Photo 8. Distant view of accident site terrain as replicated in the RedBird simulator.

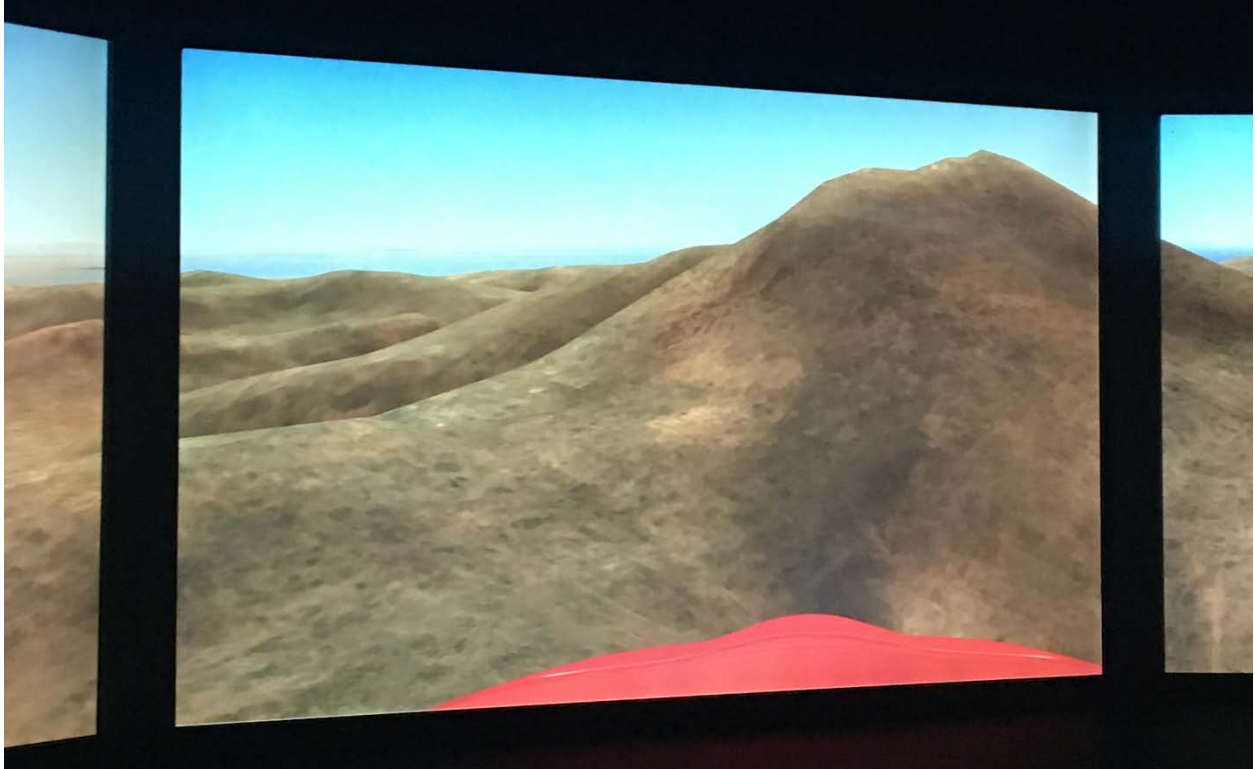
Photo 9. Close up view of accident site terrain as replicated in the RedBird simulator.
