A. Accident Information

Accident Number	DCA16FP003
Type of System	Natural Gas Distribution Pipeline
Accident Type	Building Explosion and Fire at 8701 Arliss Street, Silver Spring, MD (Flower Branch Apartment Building)
GPS Coordinates of Accident	Long. 38.59.54.36 N and Lat. 77.00.03.98 W
Date	August 10, 2016
Time	About 11:53 p.m. ¹
Pipeline Owner / Operator	Washington Gas
Material Released	Natural Gas
Pipeline pressure at time of release	About 20 Psig on main and 7-inches of water column downstream of service regulators and outlet of the building meter sets.
MAOP	25 Psig
Pipeline Material	Steel
Pipeline Outer Diameter	2-inch main, 2-, 1-, 3/4-inch services and 1-inch house piping. ²
Pipeline Year of Installation	1955
Buried Main and Service Pipeline Coating Type	Black Wrapped Coated Steel.

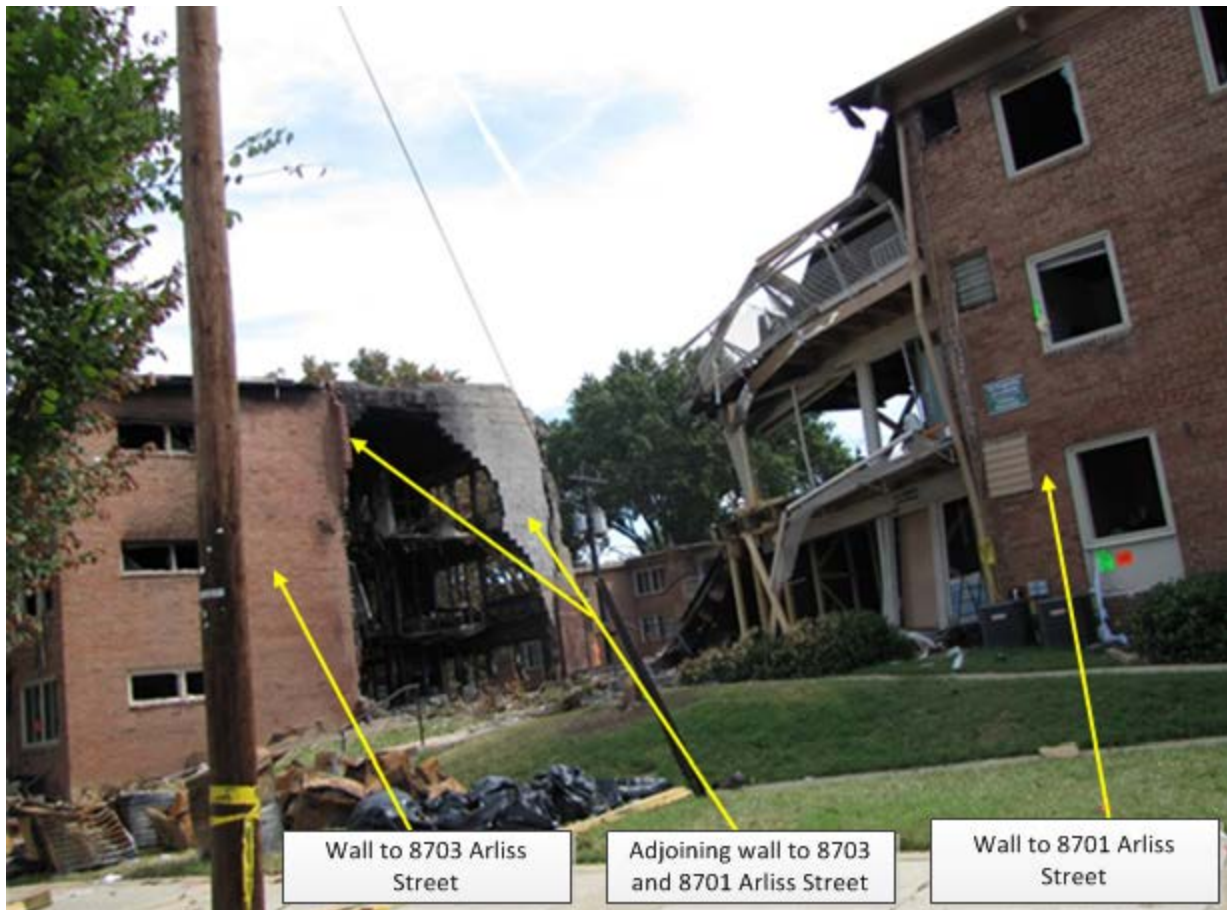
Figure 1: shows the standing remnants of 8701 Arliss Street (to the right) and the adjoining 8703 Arliss Street on the left.

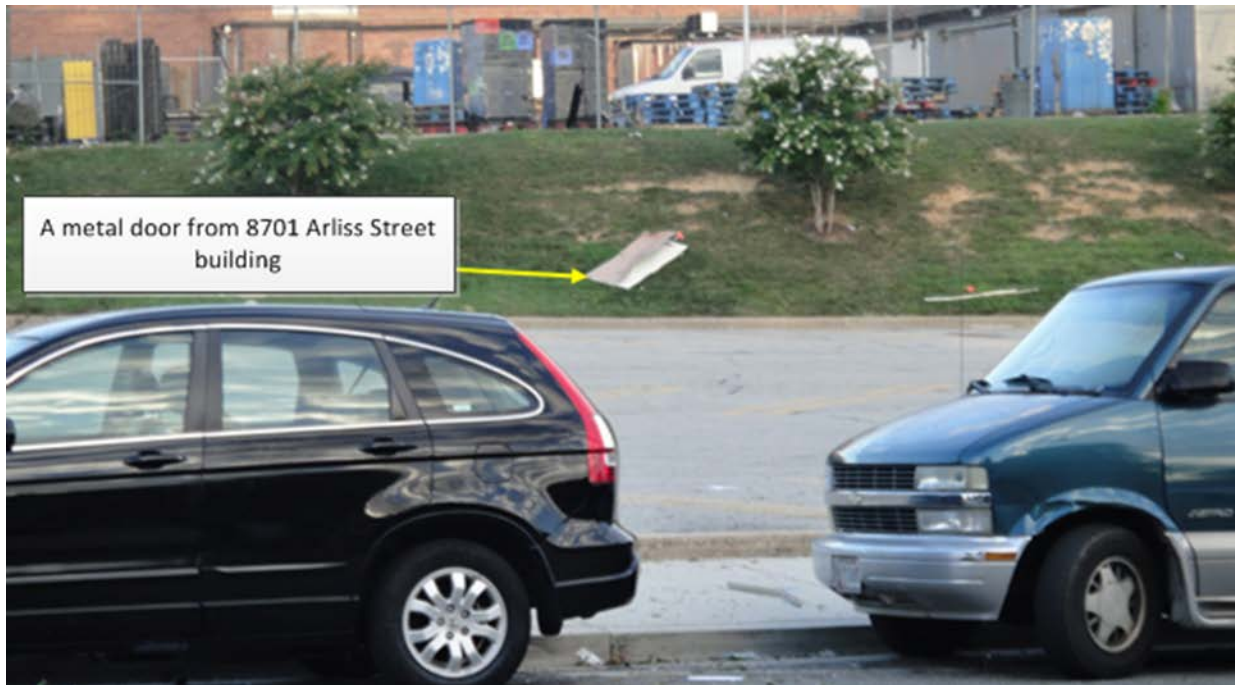
open areas on Arliss Street. Attachment A shows some of the debris.⁴ A metal door from one of the unit at 8701 Arliss Street was blown across Arliss Street, and the parking lot to an open field as shown in figure 2.

Figure 2: metal door from 8701 Arliss Street building blown to an open field across the street and a parking lot.

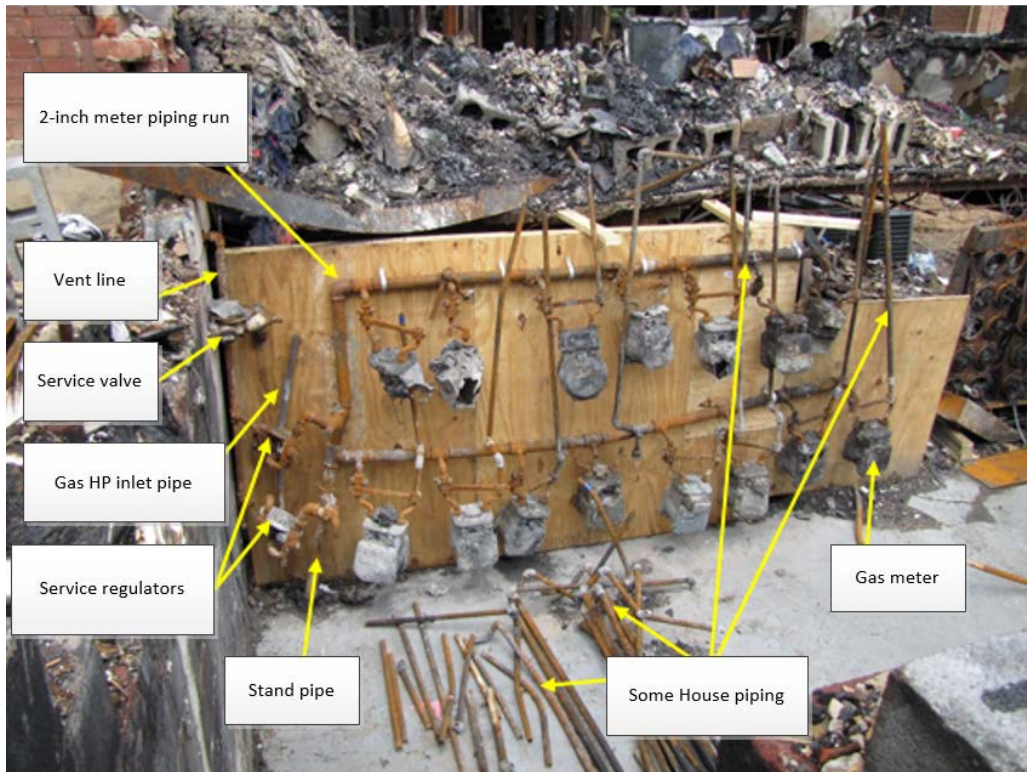
Figure 3: ATF reconstructed 15 meters of piping of gas services in the basement of 8701 Arliss Street, Silver Spring.

The Bureau of Alcohol Tobacco, Fire-Arms and Explosives (ATF) reconstructed the damaged natural gas meter sets, piping and appurtenances, including the water heater, that were damaged at 8701 Arliss Street as shown in figure 3. This comprised the vent pipe entrant, the gas service pipe entrant, positions of the service regulators, meters and service inlets and outlets piping. It also contained some of the 1-inch house piping which was gathered together on the basement floor after the accident. The operations group observed this process. See attachment A for pictures showing accident location before the debris were cleared.

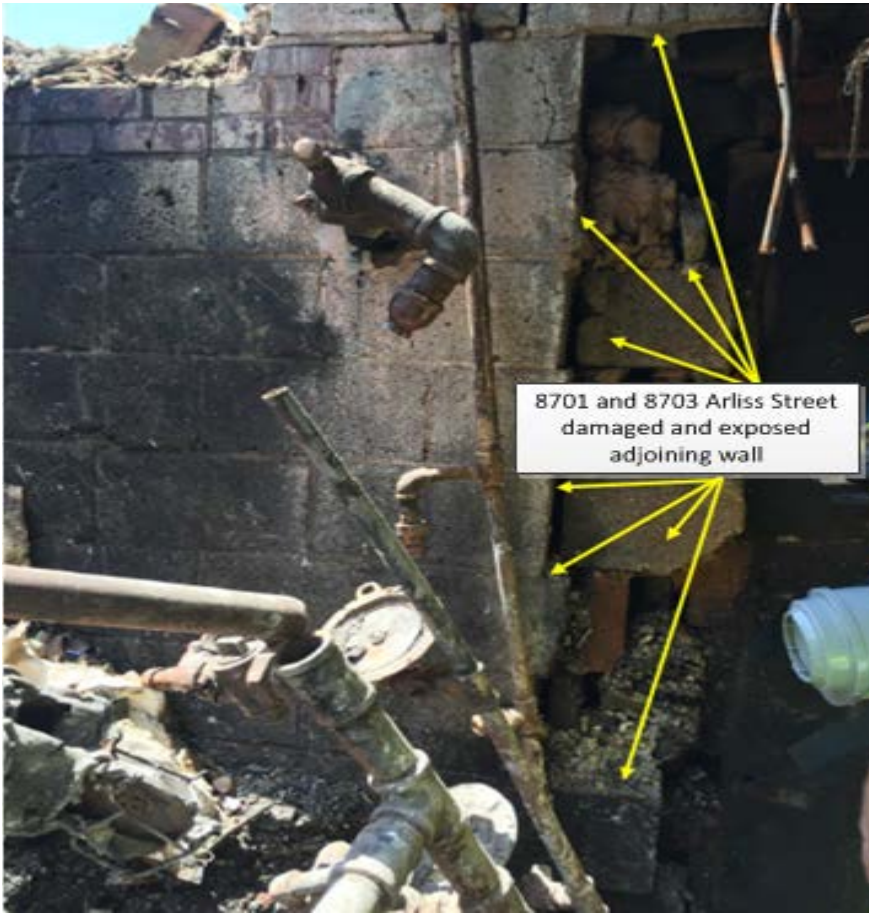
Figure 4: Gas meter piping, appurtenance and damaged adjoining wall to 8701 and 8703 Arliss Street following the explosion. Sources: WG

Figure 4 is the damaged wall separating 8701 and 8703 Arliss Street buildings in the basement. The damaged wall held the gas service meters and piping in the meter, utility, and storage room that served 8701 address. For more photographic documentation in this area, see attachment A.

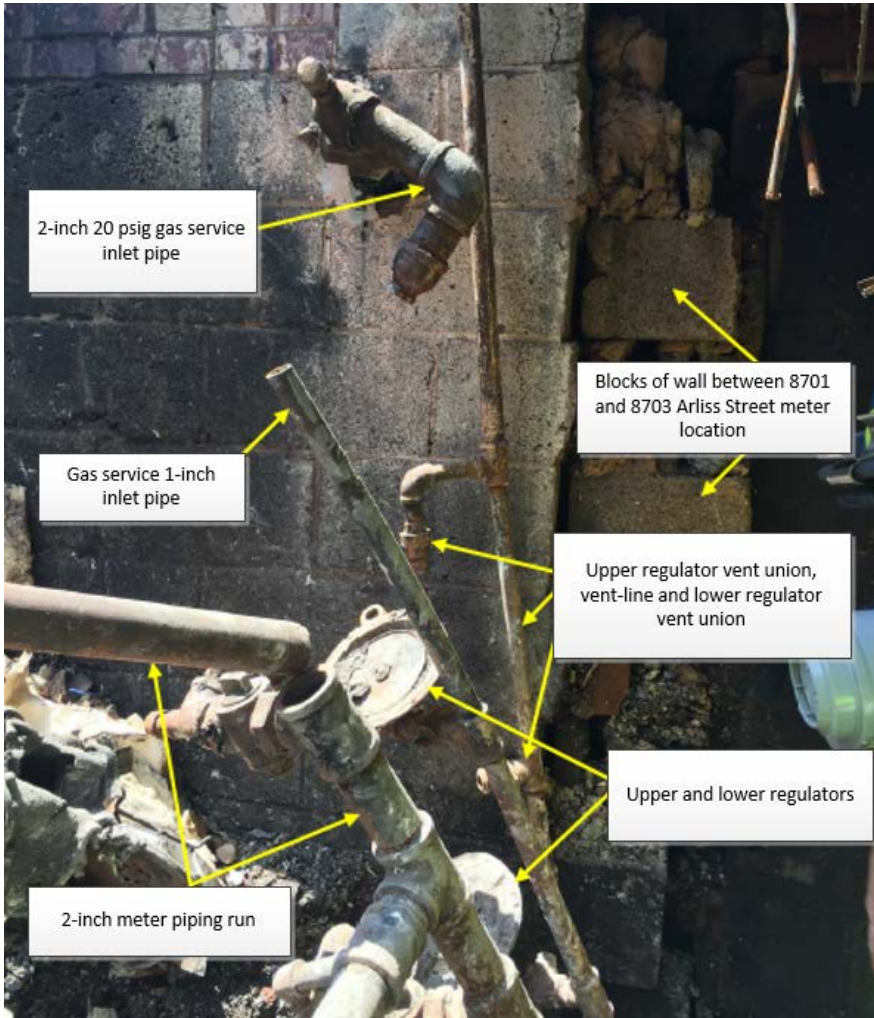
Figure 5: The meter and piping orientation before reconstruction by ATF. Source: WG

Figure 5 shows the gas meter piping orientations after the explosion and after partial debris removal by investigators, but before the reconstruction conducted by the ATF. It shows breakings in the service pipelines, the service entrant pipe and appurtenance exposed at the time of the photograph.

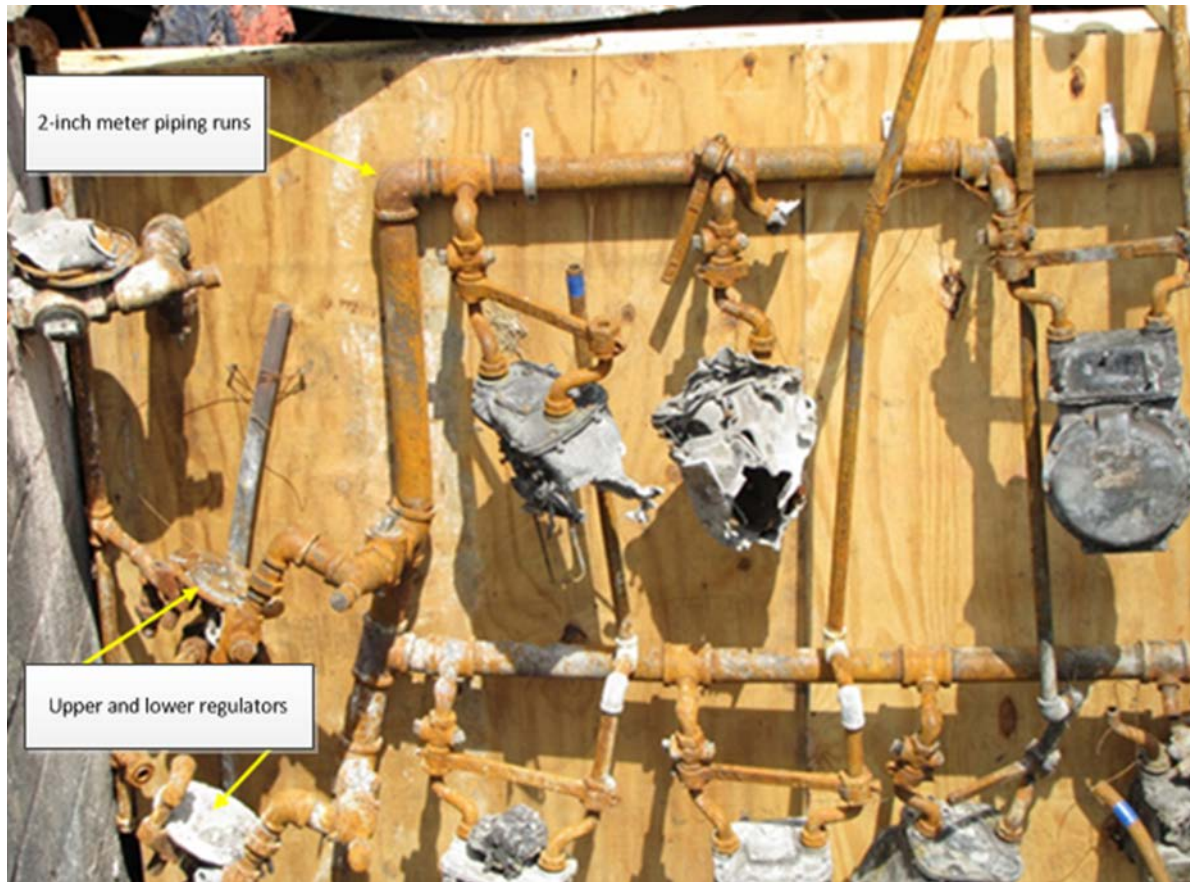
Figure 6: Close up view of two service regulators and the two 2-inch piping runs connected to customer meters.

Figure 6 shows a closer view of the first two connected gas service meters, the two regulators, and service pipe entrant as reconstructed. Figures 7, 8, 9, 10 and 11 show a close view of other reconstructed gas service components and piping. Additionally, conditions and positions of other utilities within this basement location (water heater, electric meters and electric switch box, and 1-inch house piping) were observed by the team. The pictures show the items the team observed from these inspections.

The operations group members observed the meter set assembly and saw that the left two customer meters connected to the upper piping run meter arrangement had a greater degree of fire damage compared to the remaining meter sets. The 1-inch gas service inlet pipe connected to the service regulators was found broken from the 2-inch gas service pipe reducer. After the accident, the reducer end of the service pipe was plugged for pressure testing. The group observed heavy fire damage to the right of the meter rack, which included, 4 gas meters, the electric meters and the water heater. The group also observed numerous breaks in the piping and appurtenances on the meter rack and customer house piping.

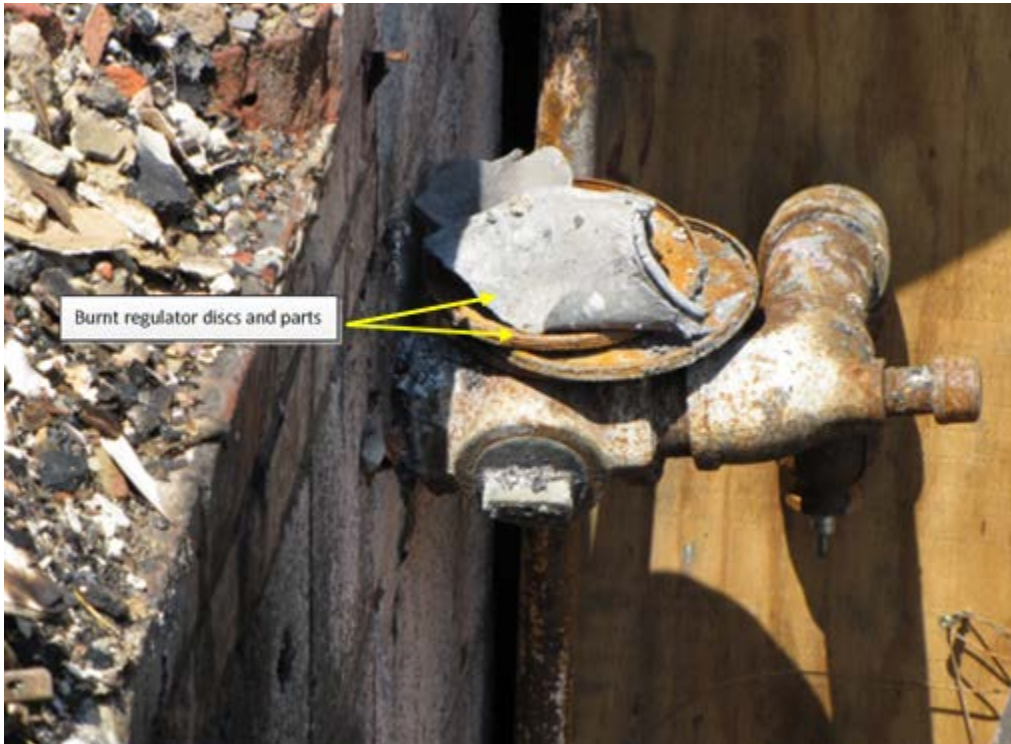
Figure 7: The 2-inch gas service entrant pipe, service valve, 2-inch reducing tee with capped 3/4-inch elbow, 2-inch downward facing elbow with plugged 1-inch service pipe connection.

Figure 7 shows the 2-inch gas service entrance pipe through the 12-inch external wall, first in place was the service valve before the regulators, and followed by the 2-inch 90-degree ell with capped 3/4-inch elbow⁸, then the 2-inch 90-degree ell, then by 2-inch by 1-inch reducer (plugged). Discs and parts damaged by the fire were placed on top of the service valve and piping after the accident as indicated with the yellow arrow.

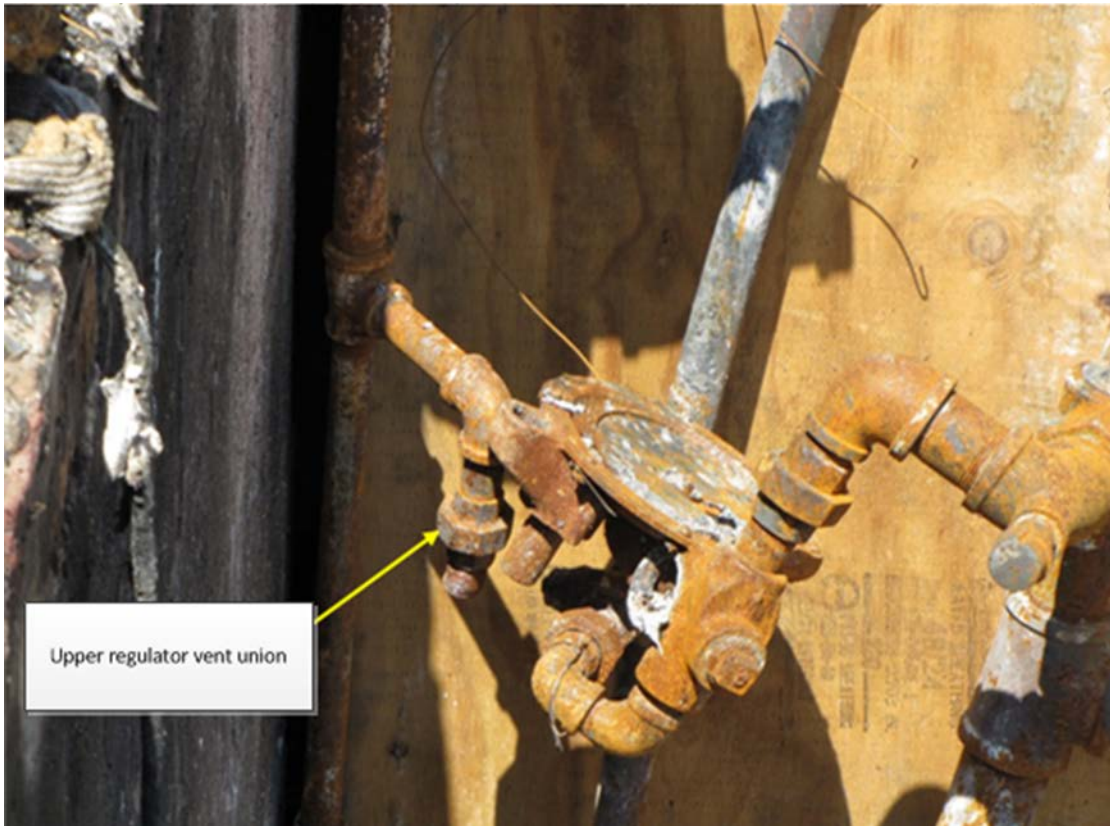
Figure 8: Damaged upper service regulator found broken from the vent pipe, and connected to the gas inlet service pipe and outlet service pipe.

Figure 8 shows the upper service regulator that was found broken and separated from the gas service vent pipe below the union connection. The regulator was connected to the 1-inch gas service inlet pipe by a 3/4-inch pipe segment and to the 1-inch gas service outlet pipe connected to the gas meter set piping.

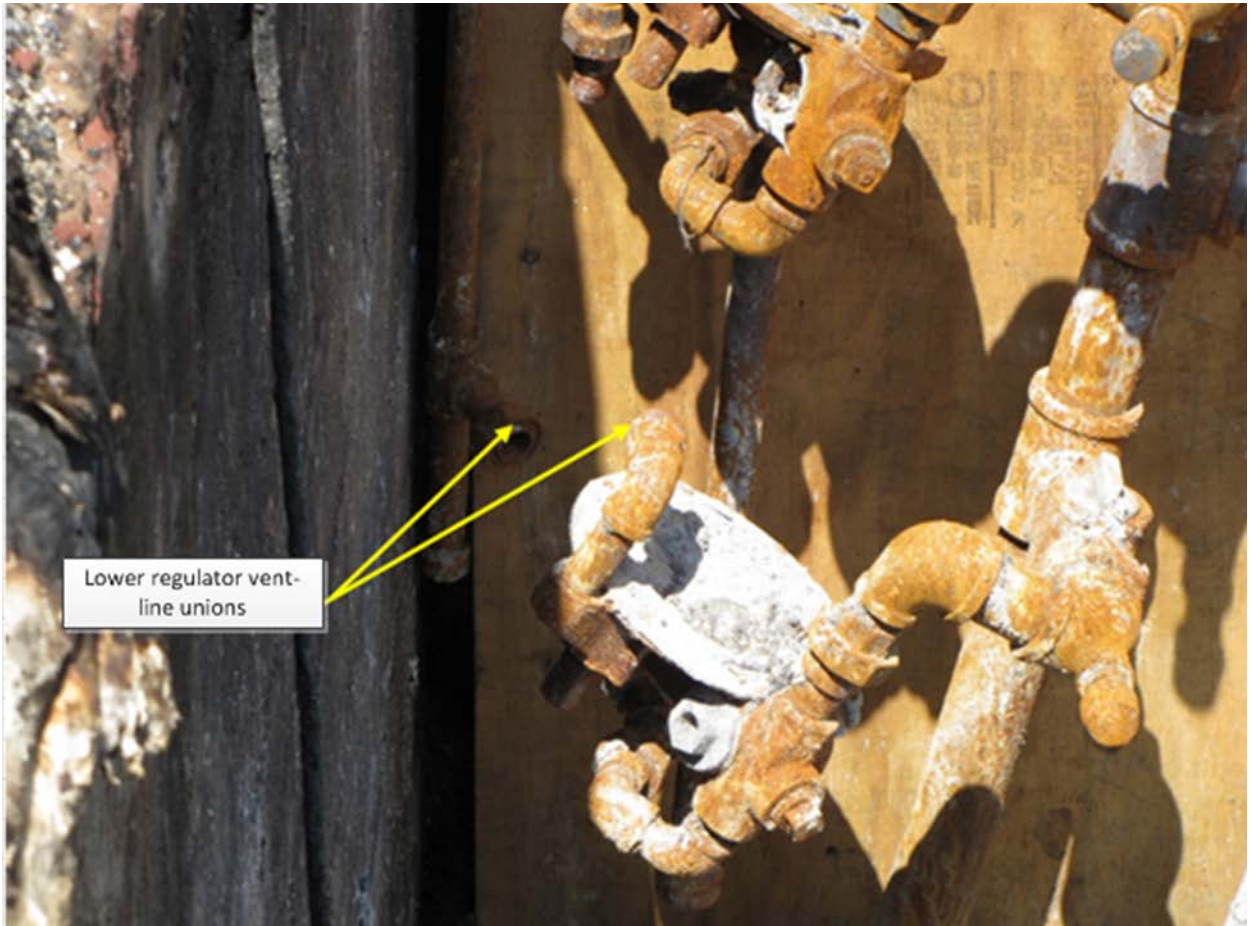
Figure 9: Damaged lower service regulator disconnected from the vent pipe at the union, and connected to the inlet service pipe and outlet service pipe.

Figure 9 shows the lower service regulator that was found disconnected from the regulator vent pipe at the union as indicated with the yellow arrows. This union was installed in a different configuration than that of the upper regulator shown in figure 8. The regulator was connected to the 1-inch gas service inlet pipe by a 3/4-inch pipe segment and to the 1-inch gas service outlet pipe connected to the gas meters piping.

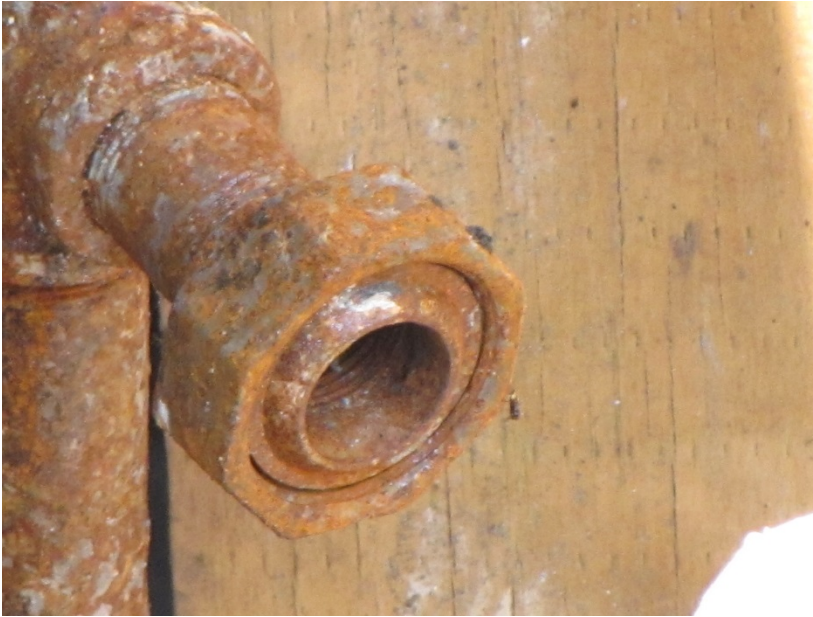
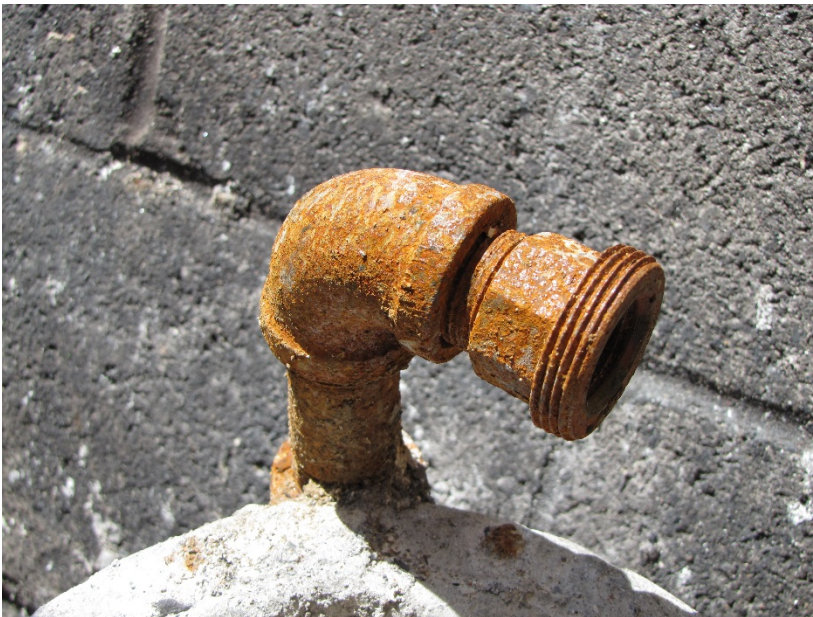
Figure 10: Female connection to the 1-inch vent pipe and the second damaged lower service regulator at 8701 Arliss Street.

Figure 11: Male union connection to the 1-inch vent pipe and the second damaged lower service regulator at 8701 Arliss Street.

Figures 10 and 11 show a close-up view of the female and male union threads respectively of the lower connected gas service regulator vent pipe. The operations group members visually inspected the disconnected vent pipe at the union and observed the threads were covered with rust, likely the result of the firewater and high temperature exposure, but otherwise appeared undamaged. Laboratory testing of the threads observed by operations group showed some minor deformation of threads on both the male and female sides of the unit nut, including the follower nut (female side). (See the Materials Laboratory Factual Report in docket for additional information.)

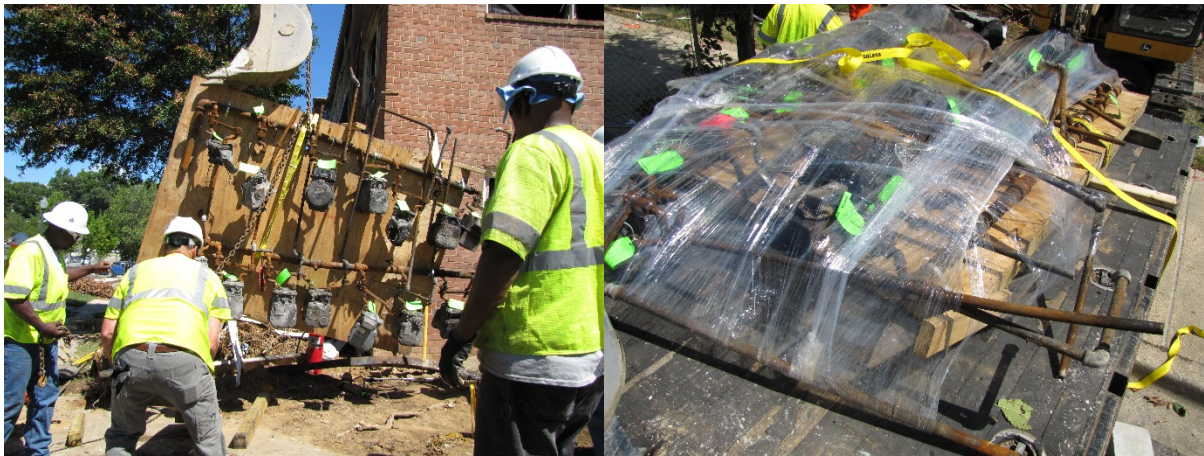
Figure 16: Reassembled meter rack containing 15 damaged customer meters and piping from 8701 Arliss Street, Silver Spring, MD.

Figure 16 is the 8701 Arliss Street customers meter sets, including some parts of the customers' gas piping retrieved from the incident building and loaded on truck bed. Figure 17 below shows the house piping retrieved from the incident building meters, utility and storage room located in the basement and loaded on a trailer bed for transportation to WG, Springfield, VA.

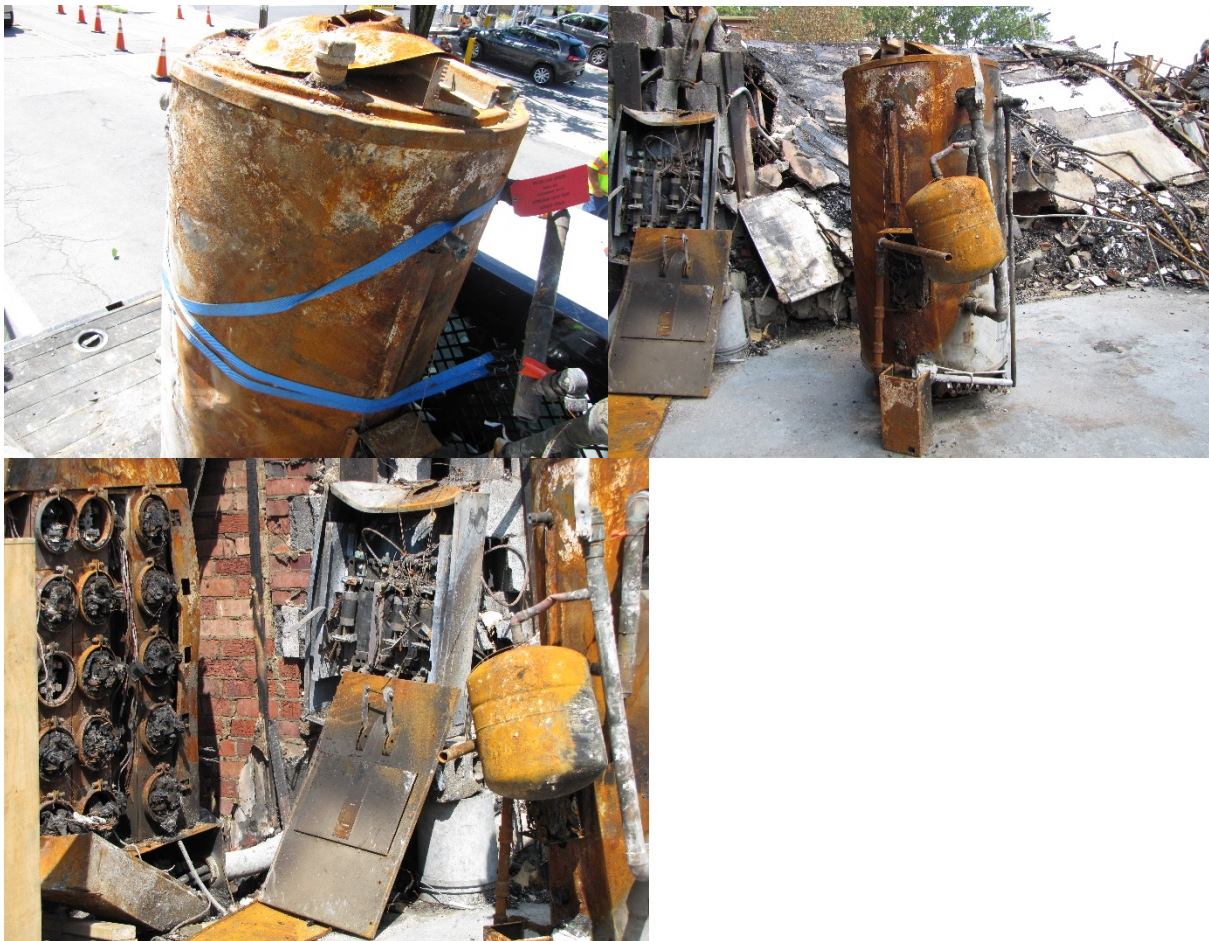
Figure 18: 8701 Arliss Street Silver Spring Apartment Building Water Heater, Electric Meters and Switch Box.

Figure 18 shows the 8701 Arliss Street damaged water heater shown loaded on a WG contractor pick-up truck for transportation to Springfield, VA (top left) and in the basement of the meters, utility and storage room where it once was located about 6 feet from the customers' meter sets (top right). It was also about 3.5 feet from the electric meters and switch box at the bottom left of the pictures. See NTSB Fire and Forensic Report for more information on the water heater.
