Appendix B: Photo coverage of the basement perimeter and accident area at 8701 Arliss Street by Kay Management representative.

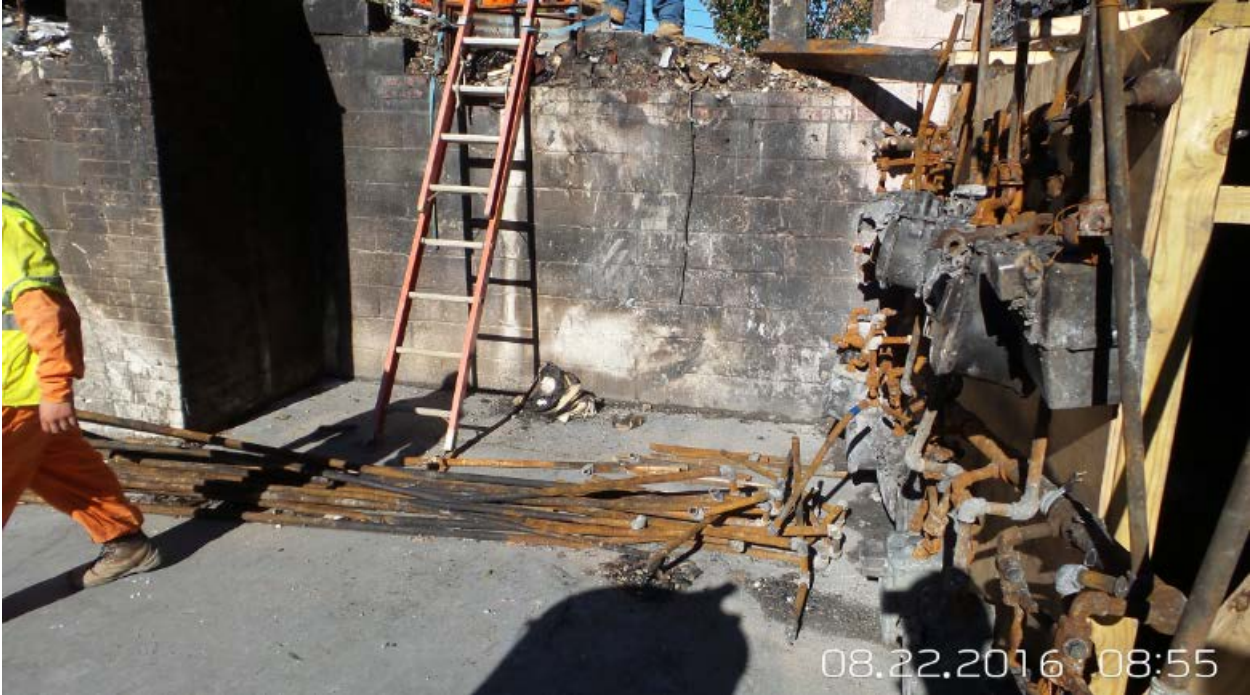
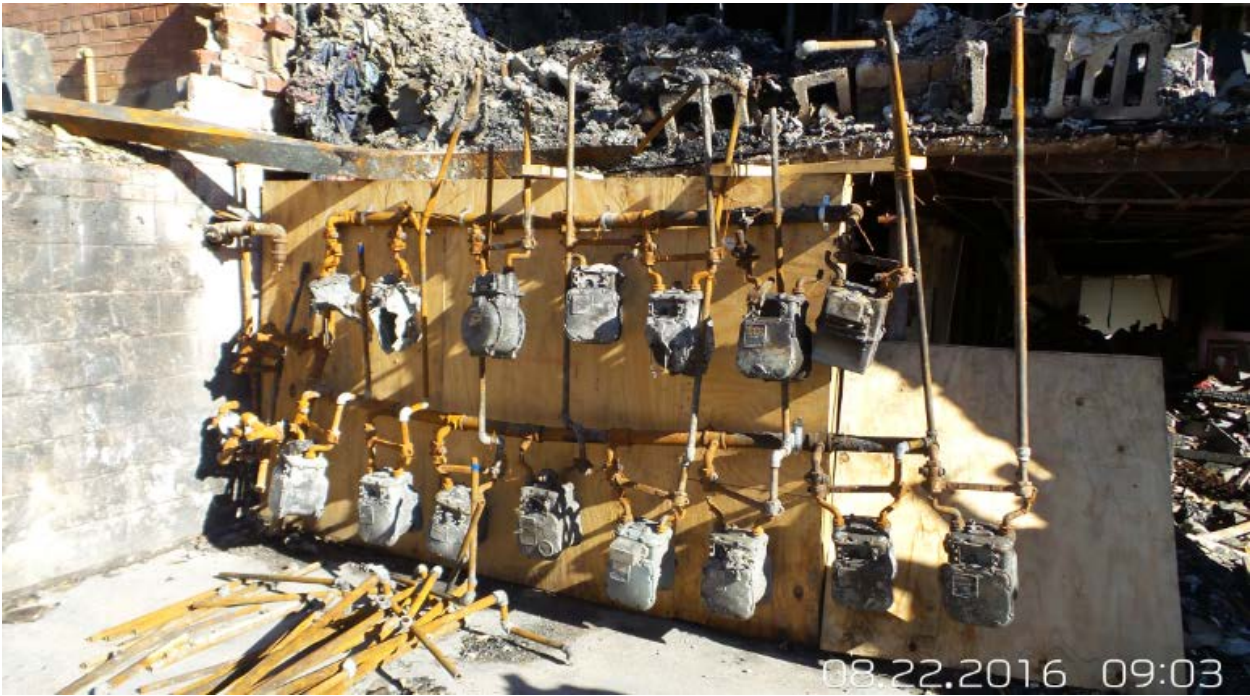
Incident building basement floor showing the damaged gas meters, and the water heater facing 8703 Arliss Street.
