From: Staebler, Douglas A <[REDACTED]>
Sent: Friday, October 28, 2016 2:54 PM
To: Chhatre Ravindra
Cc: Emeaba Kalu Kelly; Price, Stephen J.; Zakar Frank; [REDACTED]
Subject: RE: DCA16FP003; Silver Spring; Materials Laboratory Lab Examination - Exemplar Regulators- November 1, 2016
Attachments: NTSB piping 2.JPG

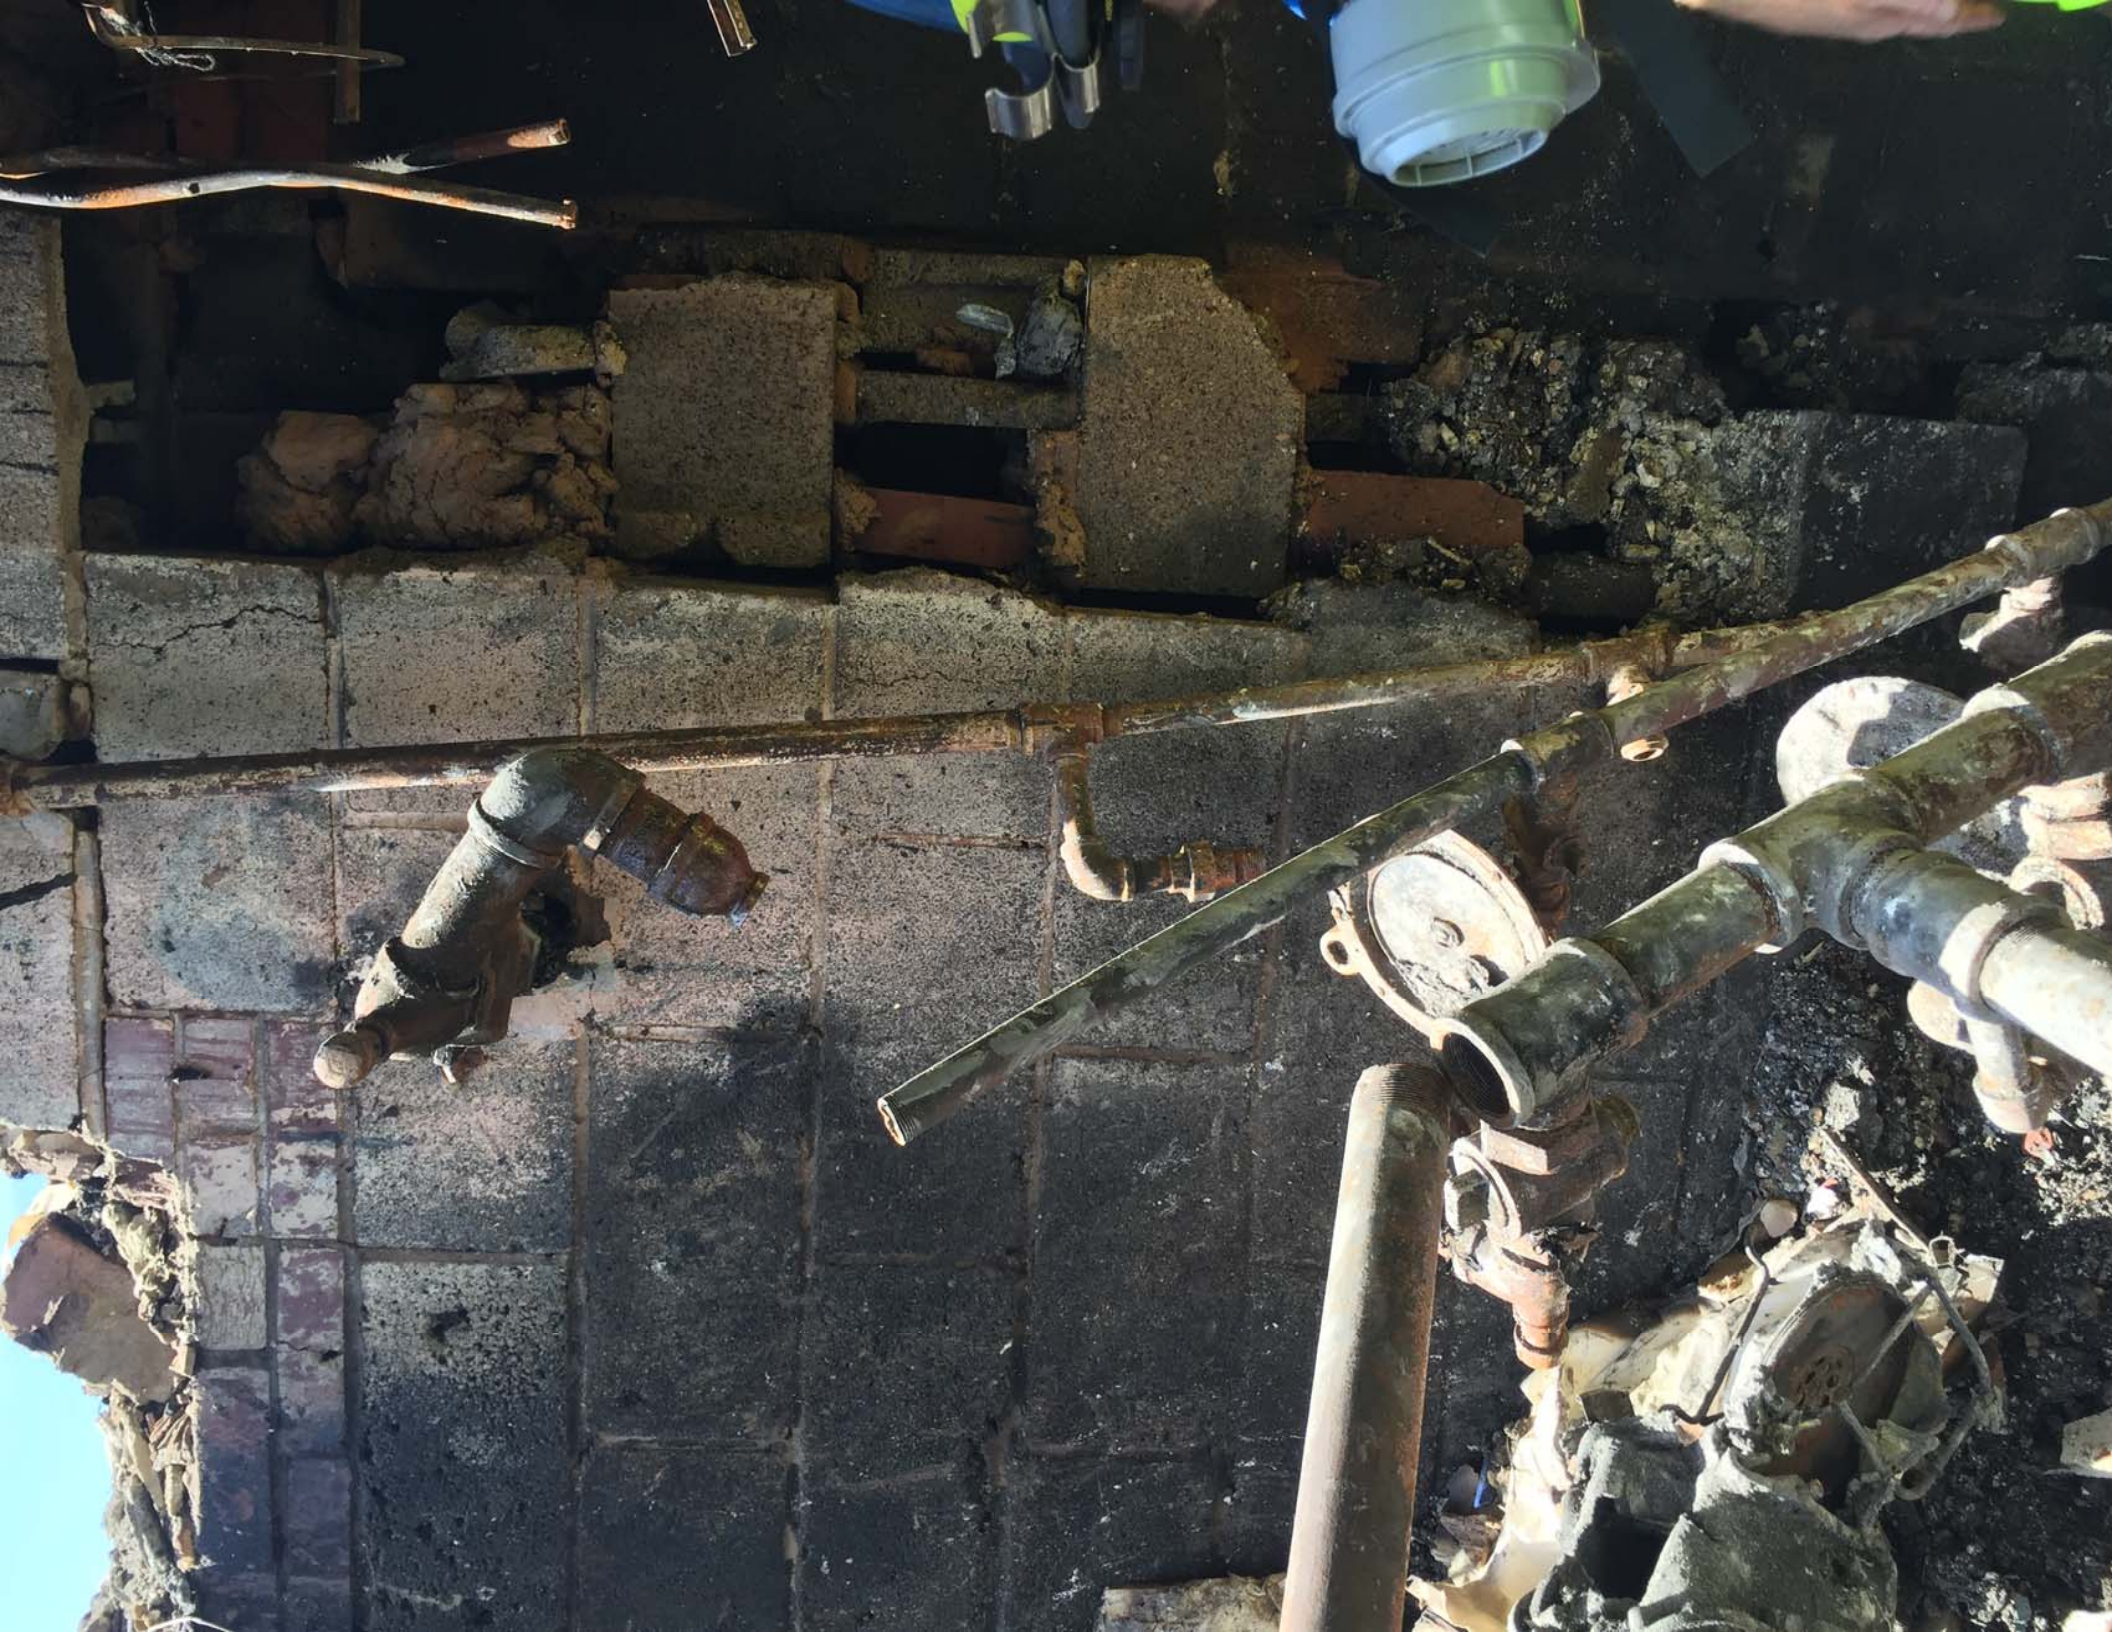
Per our discussion this morning, on Monday October 24th, during the testing of the two regulators and inspection of the associated piping from the basement of building 8701, we noted how the section of ¾" piping from the relief vent of the lower regulator to the male side of the union, the one that was found disconnected, had been rotated clockwise as it no longer aligned with female side of the union that was still connected to the vent stack. I mentioned to Frank and the group present that this would not be the typical direction a person would turn a fitting; into the threads further tightening the fitting. The resistance to turning pipe fittings in this direction, particularly fittings that have been set for many years, is usually very high and a lot of force would have been needed to accomplish this. To do this, a pipe wrench would have been used on the nipple that was connected to the regulator, and the force required would have left very noticeable wrench marks on this fitting. I did not observe any noticeable wrench marks on this fitting. This made me question how this small section of piping was rotated into the threads in the clockwise direction.

I went back to pictures from the scene and looked over the photo of the regulator and vent piping as found (attached). This photo shows the regulators and meter rack collapsed in a south-eastern direction (back wall running east-west), a direction that I believe would have created this rotation if the union was still connected at the time of the incident and collapse of the meter assembly. We also had noted that the 1" pipe on the lower half of the regulator's vent stack was slightly bent, and the force to create this would have required the lower regulator to still be connected during the collapse. Considering these observations, I feel we must investigate the piping and alignment more thoroughly to determine if the union being intact at the time of the collapse is in fact a possible scenario. We should also closely examine the nipple that pulled out of the upper regulator, as it appears to have been deformed when it pulled out. The direction of how it was deformed may also indicate what direction the regulators and piping were being pulled.

The question would then be how the union separated in the course of the event, and what forensic investigation could be performed to determine that? We should try and identify the potential pull out forces that would be generated upon the relevant union joints in the event of the forced collapse of an intact meter assembly. We should also test to determine the expansion effect upon the union fittings and threads as a result of being engulfed in temperatures at least high enough to melt the aluminum components of the two regulators; could this cause the union to loosen and separate with little affect on the threads?
