National Transportation Safety Board

Highway Accident Brief

Fatal Pedestrian Collision with Sport Utility Vehicle Alexandria, Virginia, August 30, 2016

Accident Number:	HWY16SH025
Accident Type:	Fatal pedestrian collision with sport utility vehicle
Location:	Richmond Highway (US Route 1) at Gregory Drive, near Alexandria, Virginia
Date and Time:	August 30, 2016, about 6:17 a.m. eastern daylight time
Vehicle:	2008 GMC Yukon
Driver:	69-year-old female
Pedestrian:	56-year-old male
Fatalities:	1

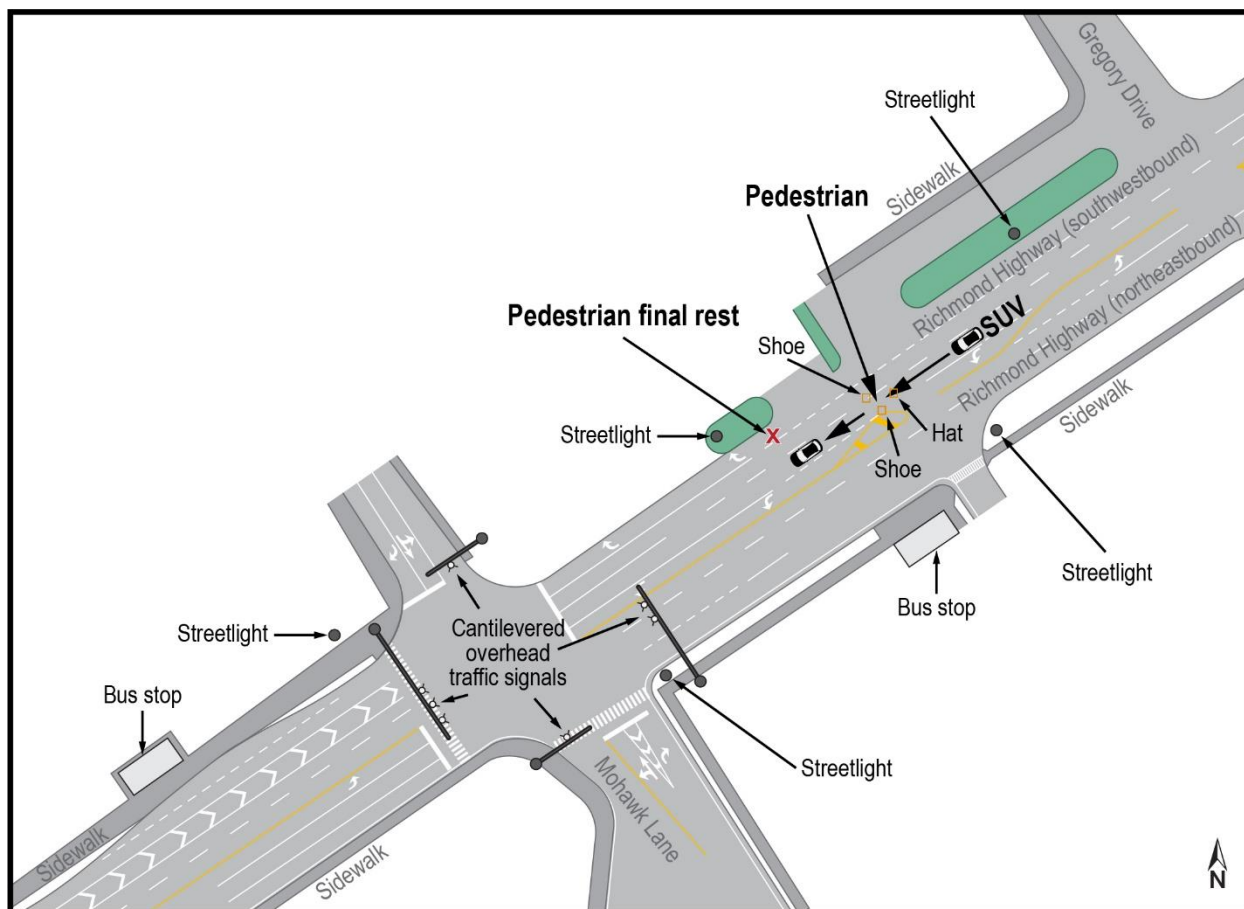
About 6:17 a.m. on Tuesday, August 30, 2016, a 2008 GMC Yukon sport utility vehicle (SUV), driven by a 69-year-old female, was traveling south in the left southwestbound lane of Richmond Highway (US Route 1) about 9 miles southwest of Alexandria, Virginia.¹ A 56-year-old male pedestrian had walked into the southwestbound lanes from the northwest side of the highway. The pedestrian continued to walk south in the left lane for a short distance until the right front of the SUV struck him, causing fatal injuries. The driver told responding police officers that she did not see the pedestrian until it was too late. Investigators found no evidence of preimpact braking and no postimpact skid marks. The area of impact was 100 feet southwest of the intersection of Richmond Highway and Gregory Drive (figure 1).

After the collision, the SUV driver stopped in the left southwestbound lane of travel, about 11 feet from the pedestrian. The driver stayed on the scene until the police arrived. The pedestrian came to rest on the roadway in the right-turn lane of southwestbound Richmond Highway near the curb, about 112 feet from the point of impact. The Fairfax County Police Department documented a debris field near the impact point between the pedestrian and the SUV.

Figure 1. Diagram showing path of SUV on Richmond Highway, point of impact, pedestrian final rest, roadway debris, and surrounding features such as streetlights and bus stops.

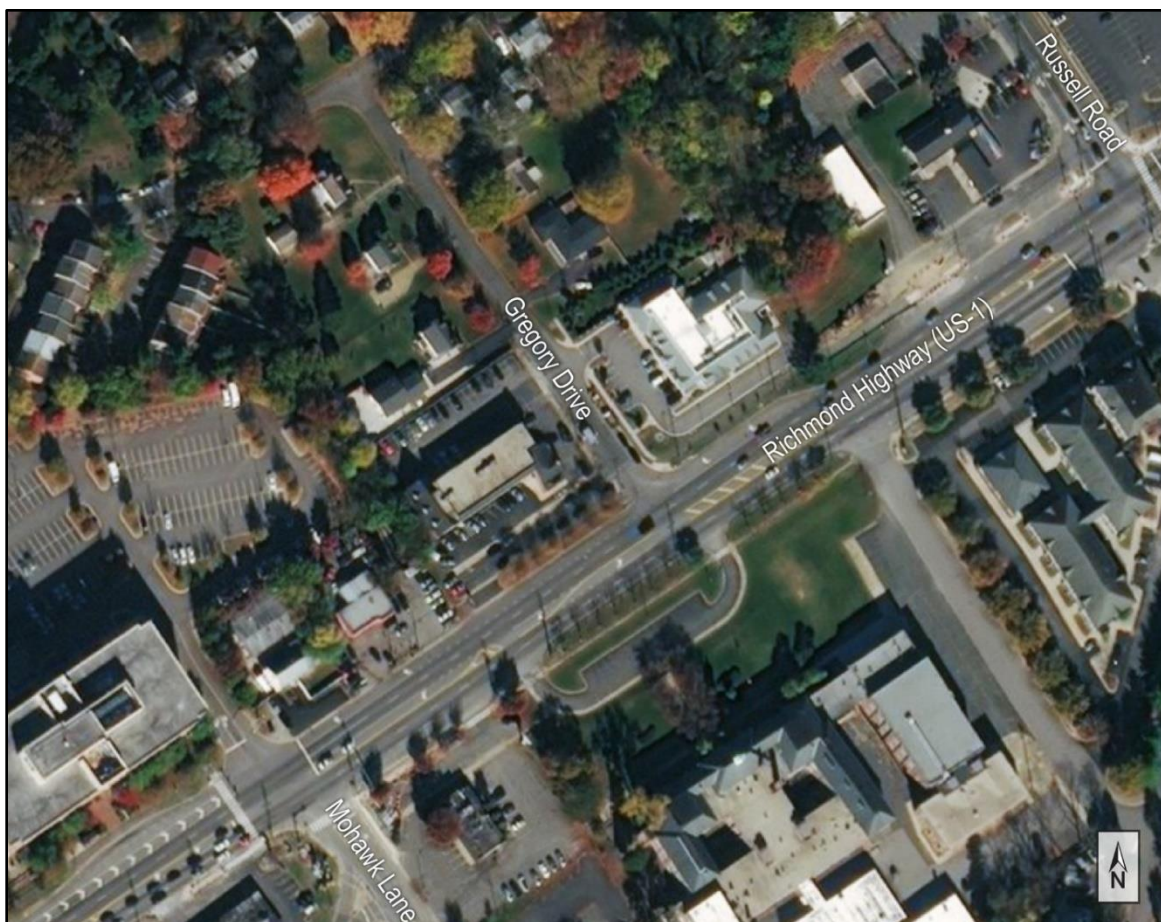
right-turn-only lane is about 15 feet wide. The speed limit in this area of Richmond Highway is 45 mph. Figure 2 is an aerial view of the area near the crash site.

Figure 2. Aerial view of crash location showing nearest intersection to crash site (Gregory Drive), nearest pedestrian crosswalks (at Russell Road and Mohawk Lane), surrounding buildings and parking lots, and nearby residential neighborhood. (Base photo by DigitalGlobe)

The closest crosswalk on Richmond Highway is 350 feet southwest of the area of impact, at the intersection of Richmond Highway and Mohawk Lane. The closest crosswalk to the northeast, at the intersection of Richmond Highway and Russell Road, is 850 feet from the crash site. Pedestrian walk phases are incorporated into the timing sequence of the traffic lights at both intersections.

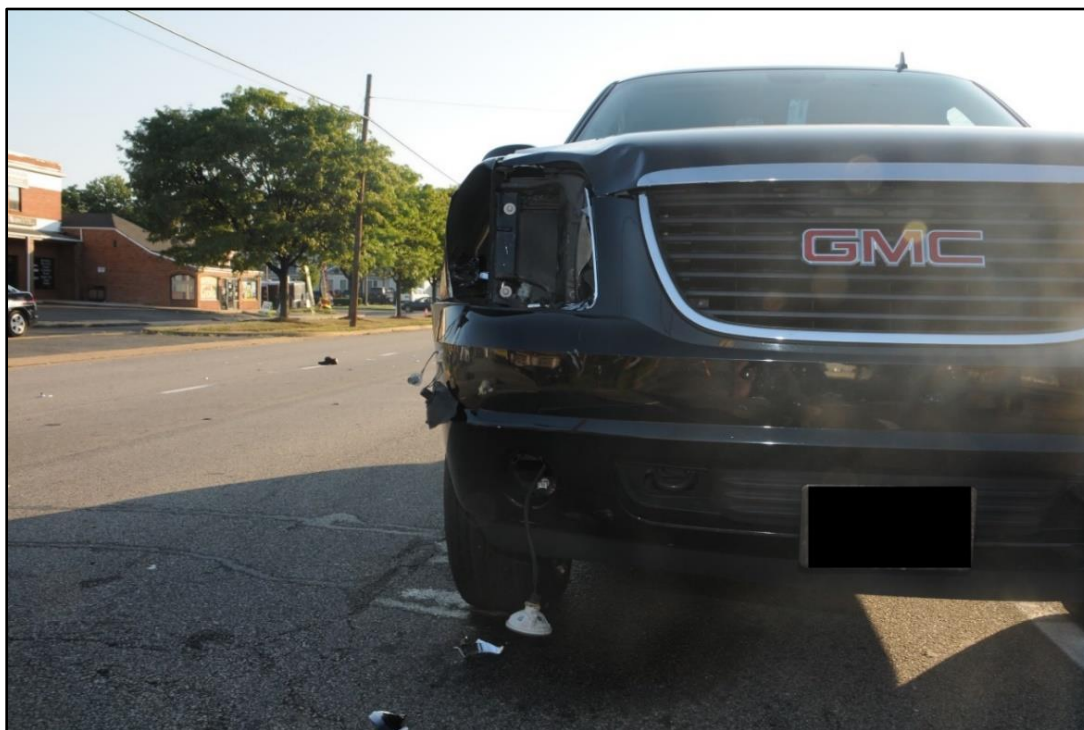
front of the vehicle (figure 3). The headlight lens and most of the assembly on that side were missing. The headlight bulb was still attached to part of the reflector and was hanging from the connector wire. The right side of the hood showed contact damage from the top of the headlight cavity to the base of the windshield. The right front fender also showed contact damage near the headlight. The right front headlight bulb, in the area of impact, displayed hot shock on the filament, indicating that the headlight was illuminated at the time of impact. The vehicle's headlight controls were in the automatic position. The SUV's front air bags did not deploy in the crash.

Figure 3. Photograph of crash SUV showing damage on right side to headlight, hood, and fender.
