## **SURVIVAL FACTORS**

### Group Chairman's Factual Report

Operator : Southwest Airlines  
Airplane : Boeing 737-7H4 (N772SW)  
Location : Philadelphia, PA  
Date : April 17, 2018  
Time : 1103 eastern daylight time (EDT)<sup>1</sup>  
NTSB # : DCA18MA142

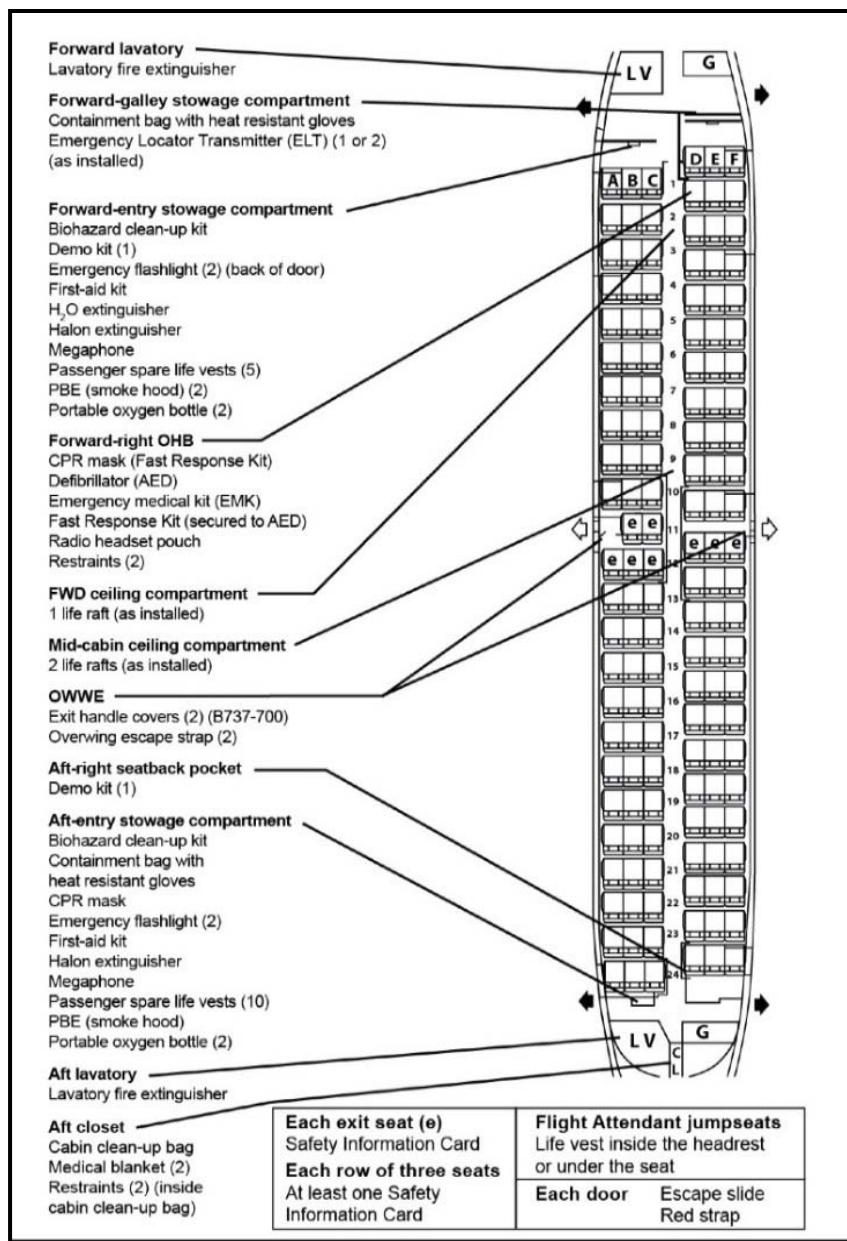
**Figure 1 – Emergency equipment stowage locations (from Southwest Airlines Flight Attendant Manual Revision #17-04 effective at the time of the accident).**

After the decompression, flight attendants retrieved 2 portable oxygen bottles for use from the forward-entry stowage compartment, and 2 portable oxygen bottles for use from the aft-entry stowage compartment. To attend to the injured passenger in row 14 flight attendants retrieved and used the automated external defibrillator (AED) and attached Fast Response Kit (containing tools and supplies needed to use the AED along with personal protective equipment and a CPR mask) from the forward-right overhead bin.<sup>3</sup>

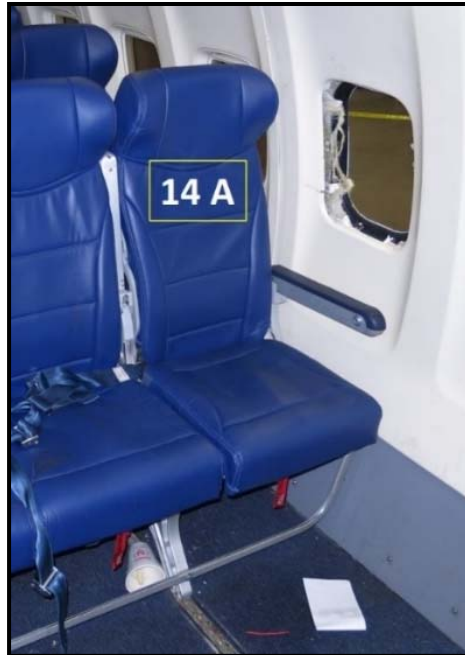
Row 14 consisted of 6 passenger seats in two triple seat sets (ABC and DEF). Seat 14A was located next to the cabin sidewall with a window on the left side of the airplane (photograph 1). The 14 ABC triple seat was manufactured by B/E Aerospace, P/N 87517501 MFG date 11/98. The seat cushion was manufactured by Franklin Product Inc. P/N 44BM1490 MFG date 14MAR2016.

**Photograph 1 – Row 14 ABC triple seat set showing seat 14A adjacent to broken window.**

F/A C also walked aft and when she reached row 14, noticed that passenger 14A was still restrained in her seat by her lapbelt, however the passenger's upper torso, arms and head had been pulled outside the airplane through the window. F/A C grabbed onto the passenger and tried to bring them back into the airplane with assistance from F/A A. Two male passengers (8D and 13D) helped and were eventually able to get the passenger back into the airplane. One of the men and a nurse (passenger 11C) started CPR while F/A A went to retrieve the AED and F/A C went to the back of the airplane and called the pilots to alert them to the passenger's condition and request additional medical assistance from qualified passengers.

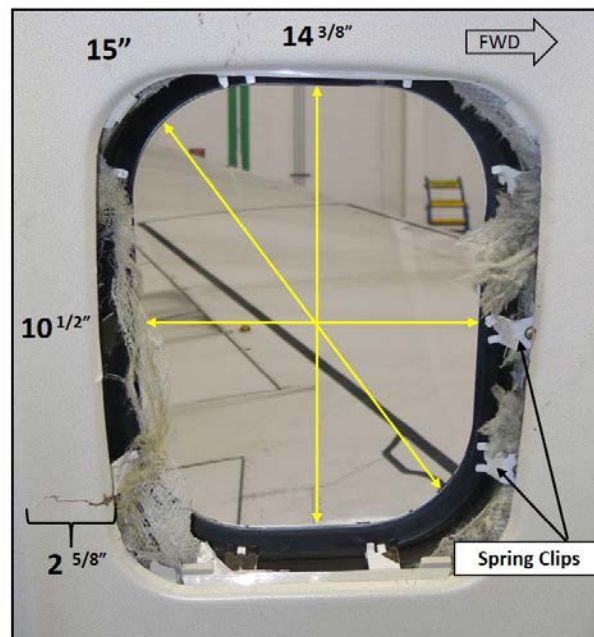
The exterior cabin window measured 10 1/2 inches horizontally, and 14 3/8 inches vertically, and 15 inches diagonally (photograph 2). The interior sidewall had a fracture in the lower left aft corner measuring 2 5/8 inches. Ten spring clips surrounded the window frame. Figure 2 shows the components of the window assembly including the outer pane, middle pane, rubber seal, and spring clip.

**Photograph 2 – Row 14 window measurements.**

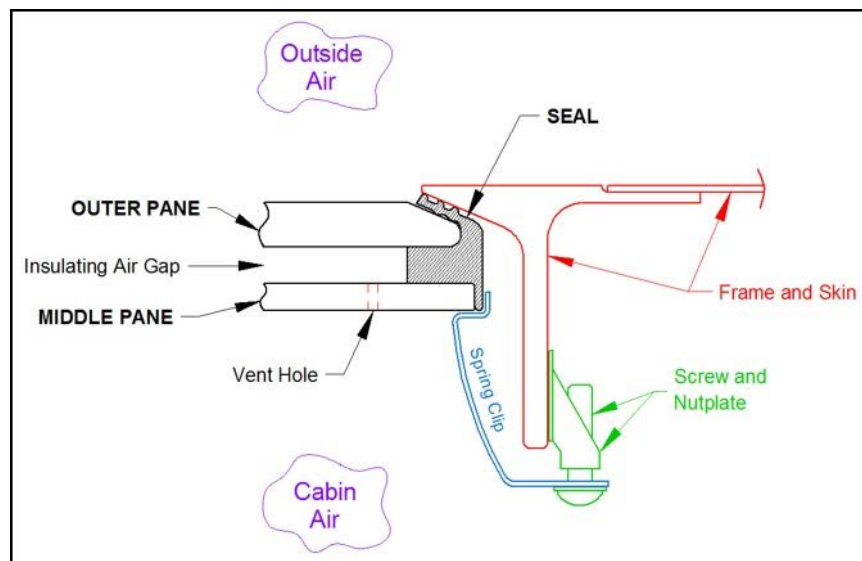
**Figure 2 – Window diagram.**
