# NATIONAL TRANSPORTATION SAFETY BOARD

MATERIALS LABORATORY FACTUAL REPORT

Report No. 18-008

Place : Silver Spring, Maryland  
Date : August 10, 2016  
Vehicle : Washington Gas service pipe and gas regulators  
NTSB No. : DCA16FP003  
Investigator : Ravi Chhatre

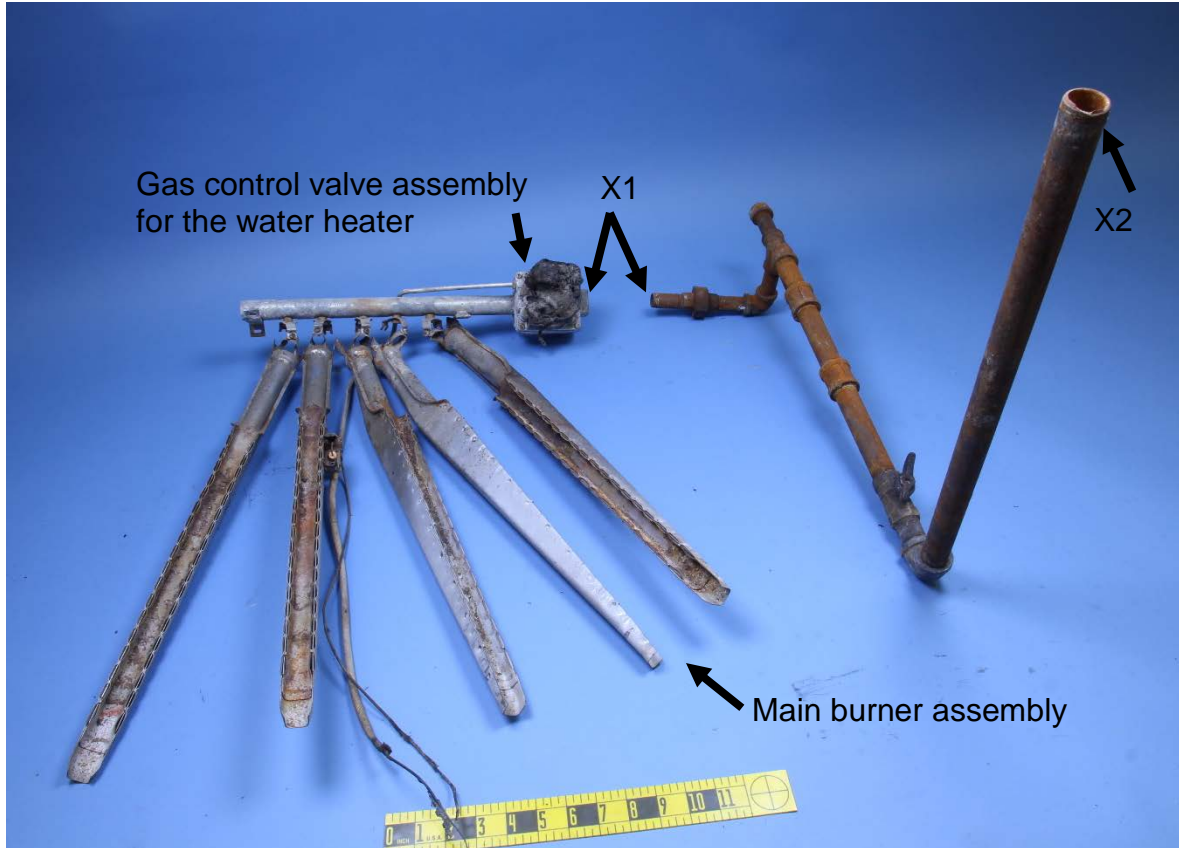
Figure 1 shows a photograph of the main burner assembly and a pipe segment that separated from the gas control valve assembly. Examination of the pipe segment revealed one end separated from the gas control valve assembly, in the area indicated by arrows "X1" in figure 1. The fracture indicated by arrows "X1" in figure 1 intersected the threaded end of a pipe nipple. The outside diameter of the nipple measured approximately 0.85 inch. The mating threaded-remnant of the fractured nipple, approximately a 0.7-inch length portion, remained attached and inside of the gas control valve assembly. The other end of the pipe segment also fractured at the threaded portion, in the area indicated by arrow "X2" in figure 1. Saw cuts were made through the pipe near the fractured ends to facilitate examination and cleaning.

Figure 1. As-received main burner assembly and pipe segment that separated from the gas control valve assembly, in the area indicated by arrows "X1". This photograph shows the location of the mating fracture faces and does not show the alignment of pieces relative to each other prior to the accident.

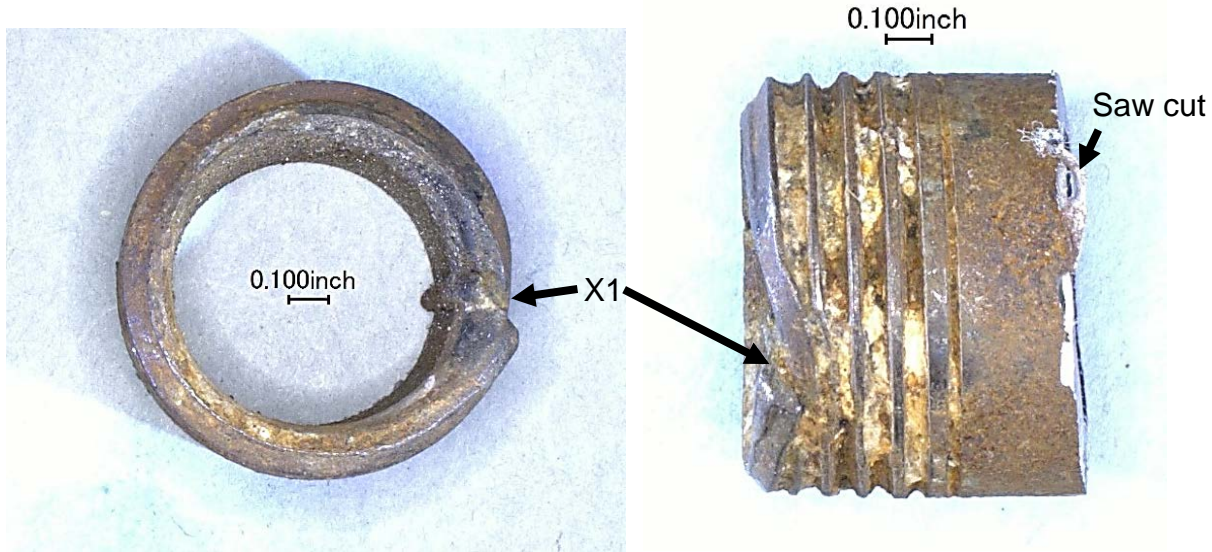
A saw cut was made through the pipe in areas located approximately one inch from each fractured end. Figures 2 and 4 show photographs of the fractured ends prior to cleaning. Bench binocular microscope examination of the pipe segments revealed the fracture faces were covered with brown iron oxide. The fracture faces were ultrasonic cleaned in Alconox, a commercial detergent. Figures 3 and 5 show photographs of the fracture faces after cleaning. Post cleaning examination of the fracture faces revealed they contained a rough fracture texture on slant planes consistent with overstress separation.

Figure 2. Side profile of pipe segment (right side of page) that fractured at the threaded end indicated by arrows "X1" in figure 1 and the fracture face (left side of page), prior to cleaning. The portion indicated by arrows "X1" contained evidence of bending deformation.

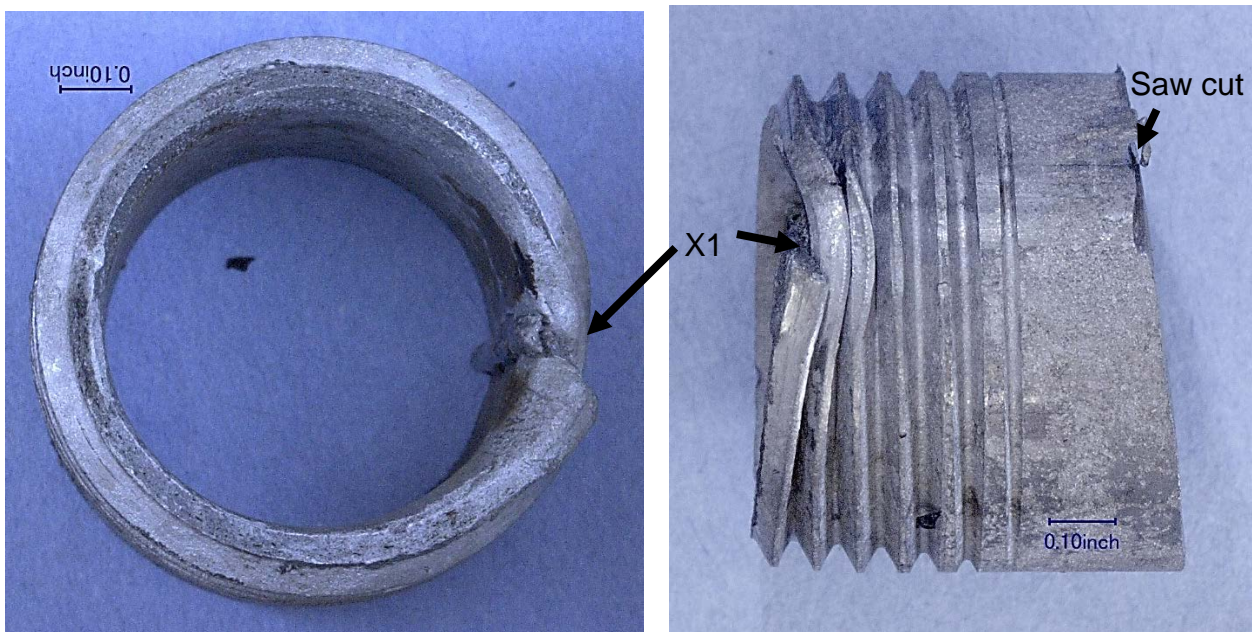
Figure 3. Same pipe segment as shown in figure 2 after cleaning.

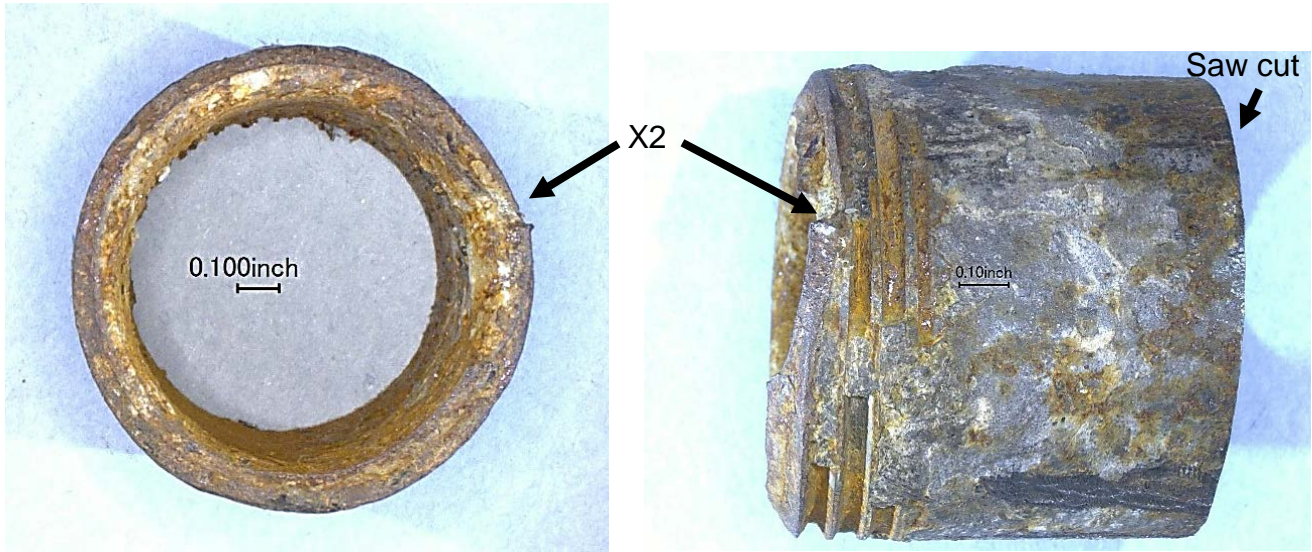
Figure 4. Side profile of the pipe segment (right side of page) that fractured at the threaded end in the area indicated by arrow "X2" in figure 1, and the fracture face (left side of page), prior to cleaning. The portion indicated by arrows "X2" contain evidence of bending deformation.

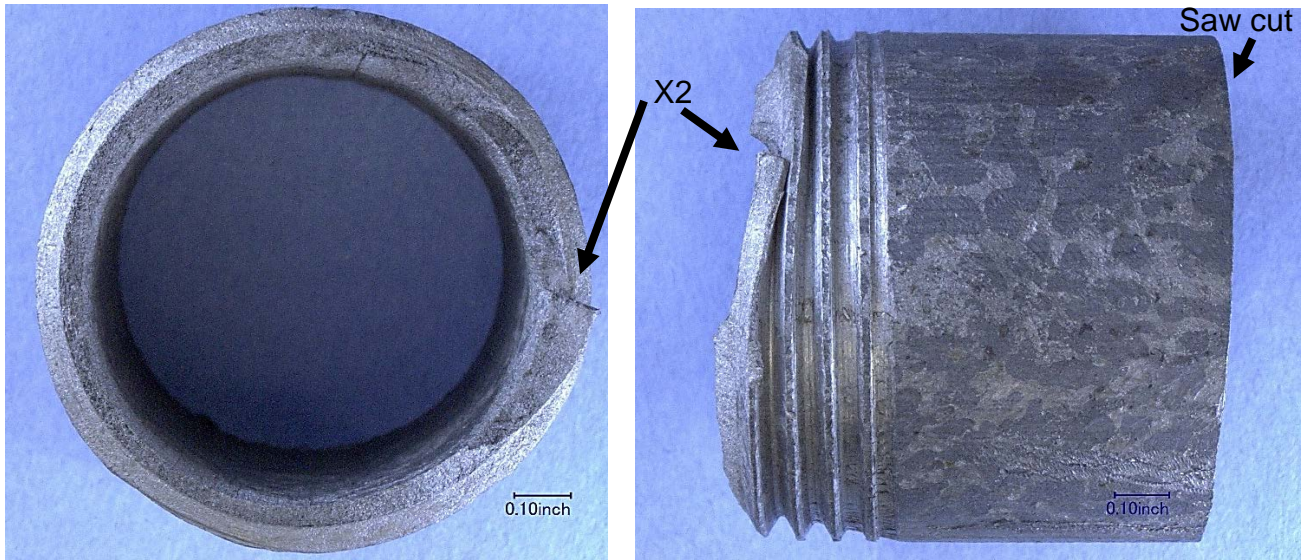
Figure 5. Same pipe segment as shown in figure 4 after cleaning.
