**NATIONAL TRANSPORTATION SAFETY BOARD  
OFFICE OF HIGHWAY SAFETY  
WASHINGTON, D.C.**

**SURVIVAL FACTORS GROUP CHAIRMAN'S  
FACTUAL REPORT**

Location: 17000 Block 480<sup>th</sup> Street, Oakland, Pottawattamie County, Iowa  
Vehicle #1: 2004 IC, Model 3S530, 65 passenger school bus  
Operator #1: Riverside Community School District  
Date: December 12, 2017  
Time: Approximately 06:52 a.m. CST  
NTSB #: **HWY18MH003**

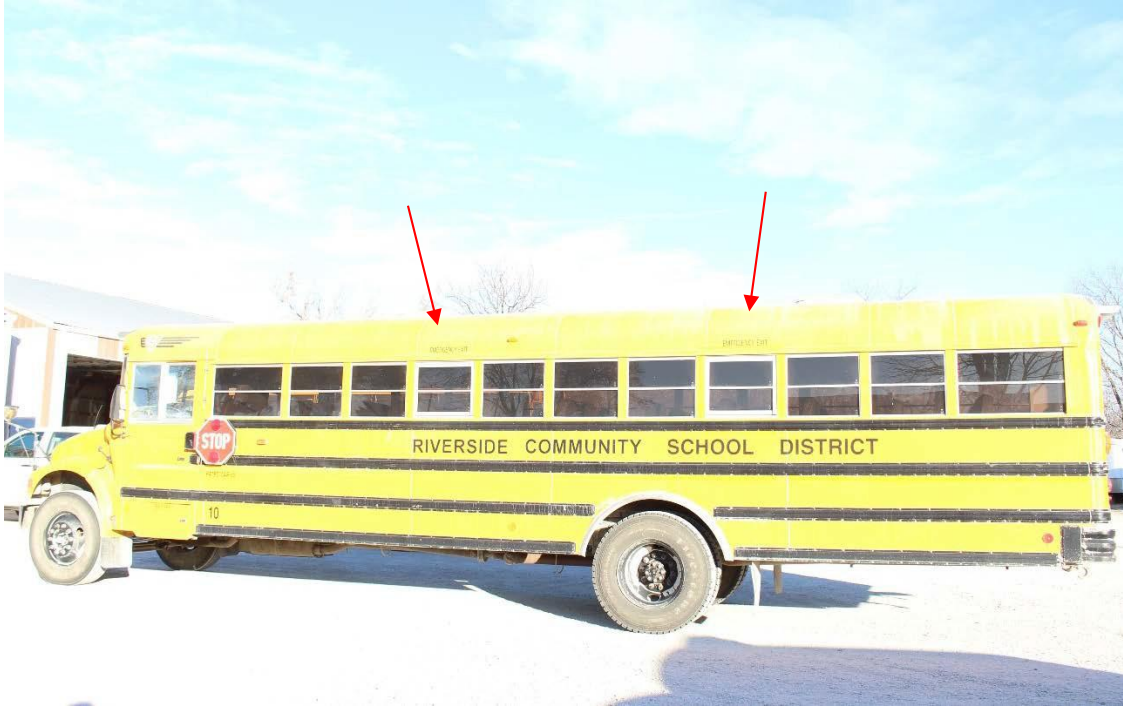
Photo #1: Exemplar school bus showing the location of the emergency exit windows.

There are twelve windows on the left side of the school bus to include the driver’s window. Window number #5 and number #9 on the left side and window number #4 and number #8 on the right side are designated emergency exit windows. These emergency exit windows are located adjacent to seat row #4 and between seat row #7 and #8 on the interior of the school bus and are marked on both the exterior and the interior surface. The measurements of the school bus windows are provided in **Table 1**.

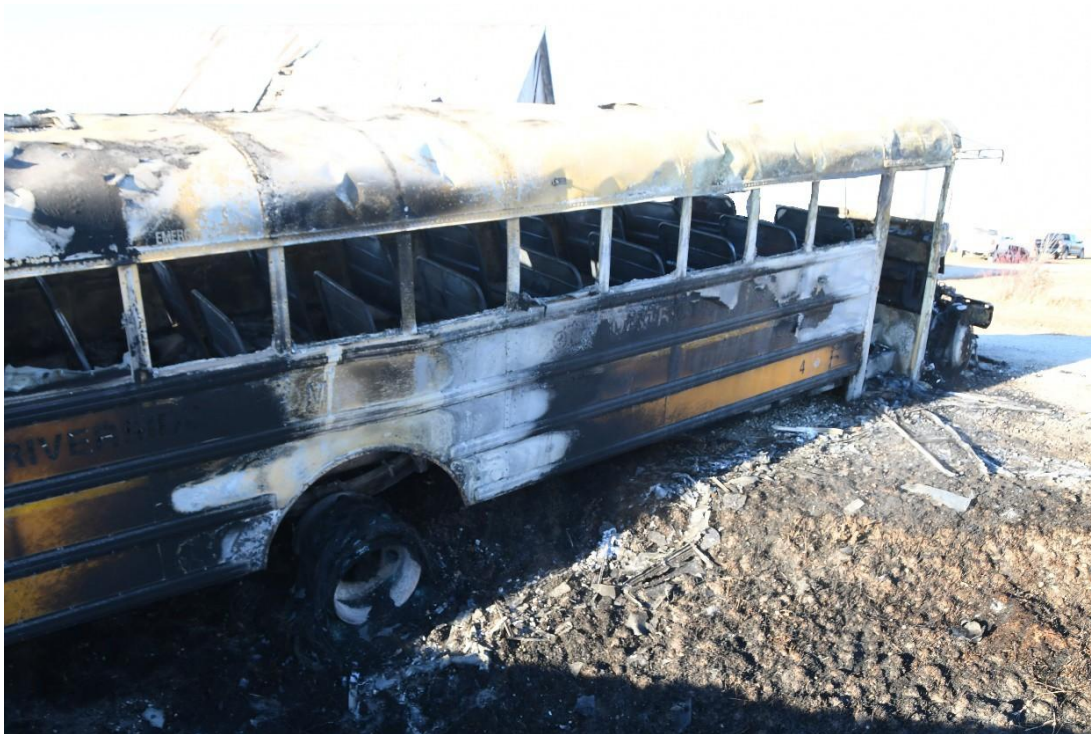
The school bus sustained minimal damage due to the collision with the ditch. However; it sustained extensive exterior damage resulting from the post-crash fire. The engine cowling and the hood were consumed in the fire. All the windows in the school bus broke out during the fire to include the window panes in the rear emergency exit door. The hard-plastic covers for the two roof hatches and the front-loading door were missing.

Photo #2: Exterior view of the crash school bus on scene.

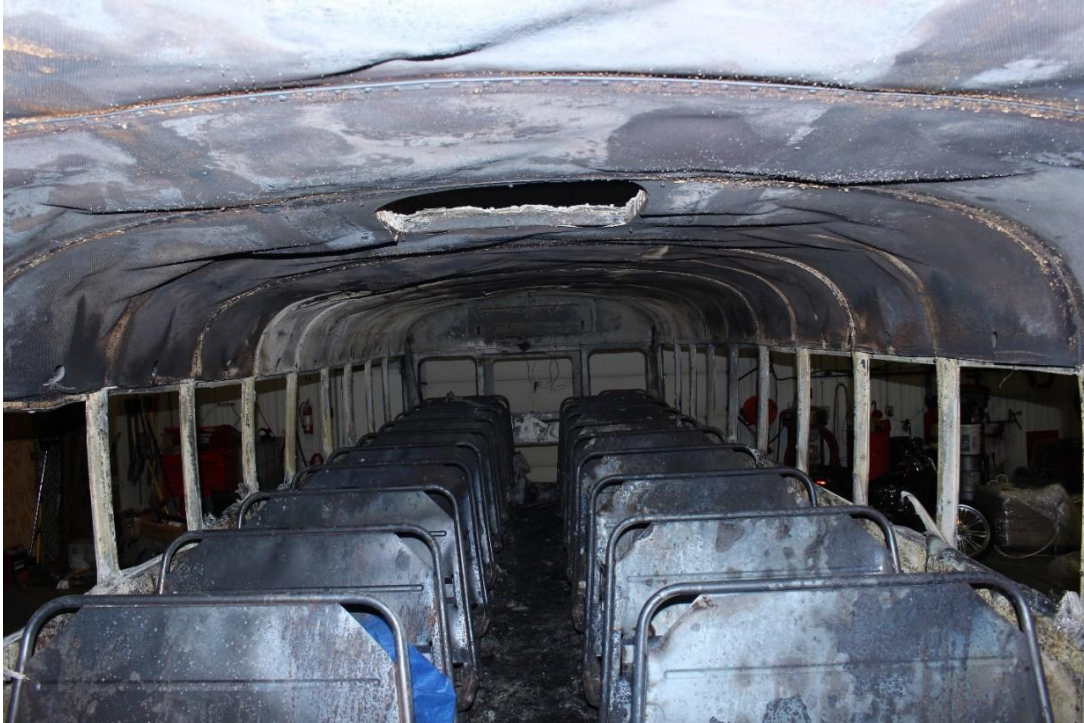
The school bus sustained extensive damage to the interior of the bus resulting from the post-crash fire. All non-metallic materials in the school bus were consumed in the fire. The interior of the school bus was exposed to intense heat and direct flame impingement. The fire spread quickly throughout the interior. The structural frame supports failed buckling and deforming the roof.

Photo #3: Interior view of damage to school bus caused by intense heat and fire.

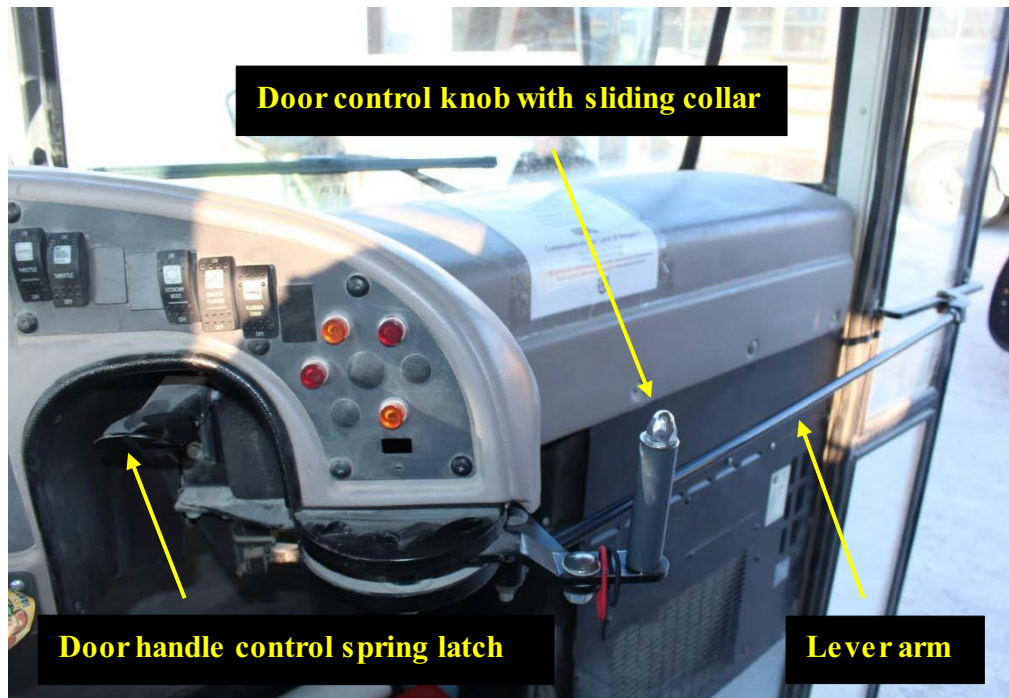
The door control arm handle acts on the lever arm which exerts force against the door to open. To close the door, the driver simply pulls up on the collar and pulls the door control arm handle towards him and then pushes it into the spring-loaded control latch which catches the handle and secures the door in the closed position. This manual door release has a locking feature that prevents the door from being inadvertently opened while the school bus is in motion.

Photo #4: Manual door release for the front-loading door.

An examination of several exemplar buses was performed. A load-cell was used to determine the pounds-force required to open the front-loading door. There was no standardization regarding the force required to open the doors. The determining factor was how well the vehicle was maintained. It was found that between 9-22 pounds of force was required to be exerted to open the manual door. An exemplar bus with very little preventative maintenance was found and the door was tested. It required a significantly higher amount of force to open the door. The examination of the door control assembly revealed a lack of lubrication and the formation of rust on the control parts.
