**NATIONAL TRANSPORTATION SAFETY BOARD
OFFICE OF HIGHWAY SAFETY
WASHINGTON, D.C.**

**VEHICLE FACTORS GROUP CHAIRMAN'S
FACTUAL REPORT**

Location: 17000 Block 480th St, Oakland, Pottawattamie County, Iowa
Vehicle 1: 2004 IC, Model 3S530, 65 passenger school bus
Operator 1: Riverside Community School District
Date: December 12, 2017
Time: Approximately 06:52 a.m. CST
NTSB #: **HWY18MH003**

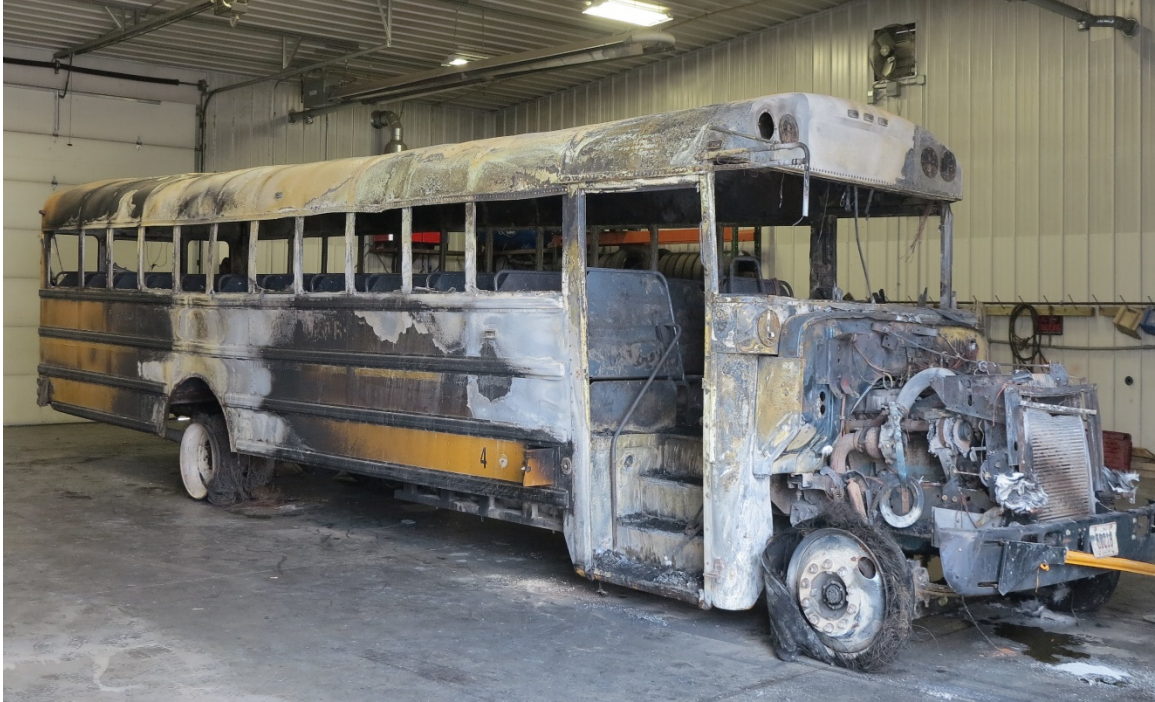
The IC school bus sustained severe fire damage affecting all major mechanical systems. Damage specific to many of the vehicle components will be described in greater detail later in the appropriate sections of this document.

For uniform description, “left” will refer to the driver’s side, and “right” will refer to the boarding door side of the school bus. **Figure 1** shows the damage to the right side of the school bus.

Figure 1: Damaged Right Side of School Bus

The hood was entirely missing, exposing the engine compartment. All rubber hoses and belts were missing and many aluminum parts had sustained fire damage as well. Plastic parts such as fluid reservoirs and the air cleaner were missing.

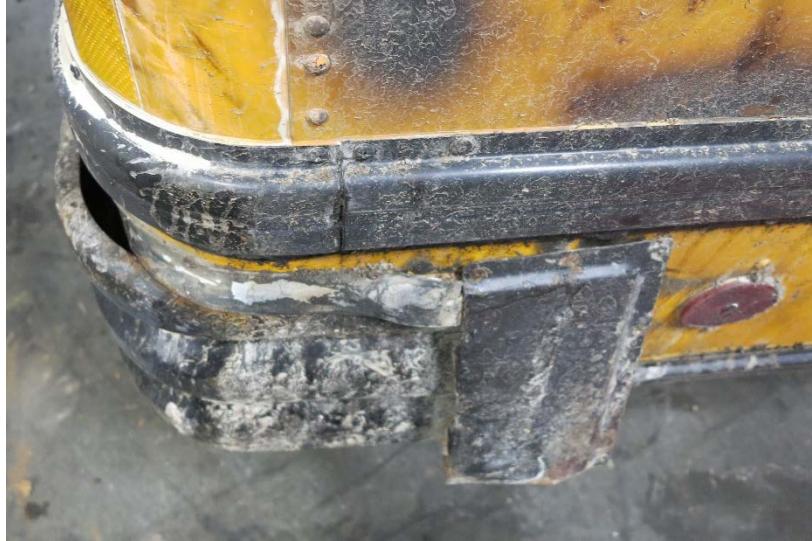
On the right rear corner of the bus was contact damage. The wrap around steel bumper was slightly deformed rearward and had pulled through several rivets holding it to the body of the bus. There was dirt, debris, and grass embedded in the surface and lodged behind the bumper on a small lip. **Figure 2** shows the damage to the right rear corner of the bus.

Figure 2: Damaged Right Rear Corner of Bus
