NATIONAL TRANSPORTATION SAFETY BOARD
Vehicle Recorder Division
Washington, DC 20594

Onboard Image Recorder

Specialist's Factual Report
By Jane Foster

Location: Oakland, Iowa
Date: December 12, 2017
Aircraft: 2004 IC, Model 3S530,
Operator: Riverside Community School District
NTSB Number: HWY18MH003

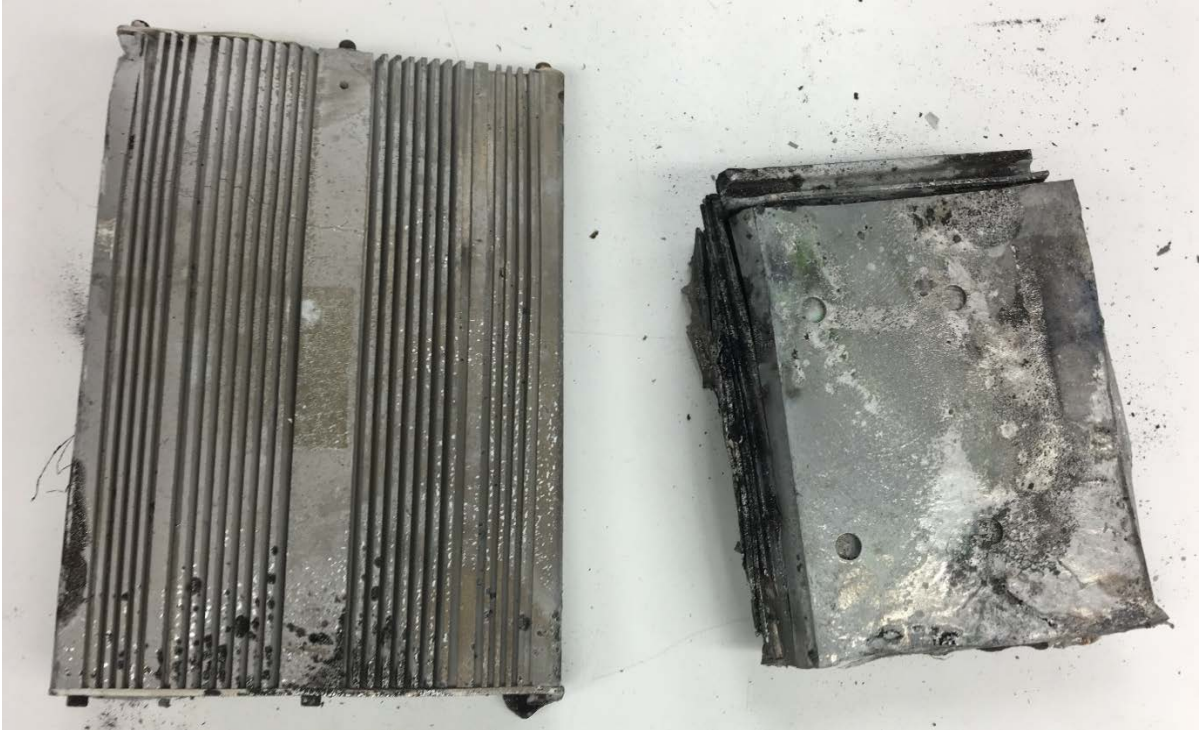
It was evident that the REI RV-4001 Version 2.0 had sustained significant heat and structural damage. The device was disassembled at the manufacturer's facility and

Figure 1. Image showing the top of the recording system and the hard drive casing after removal from the school bus.

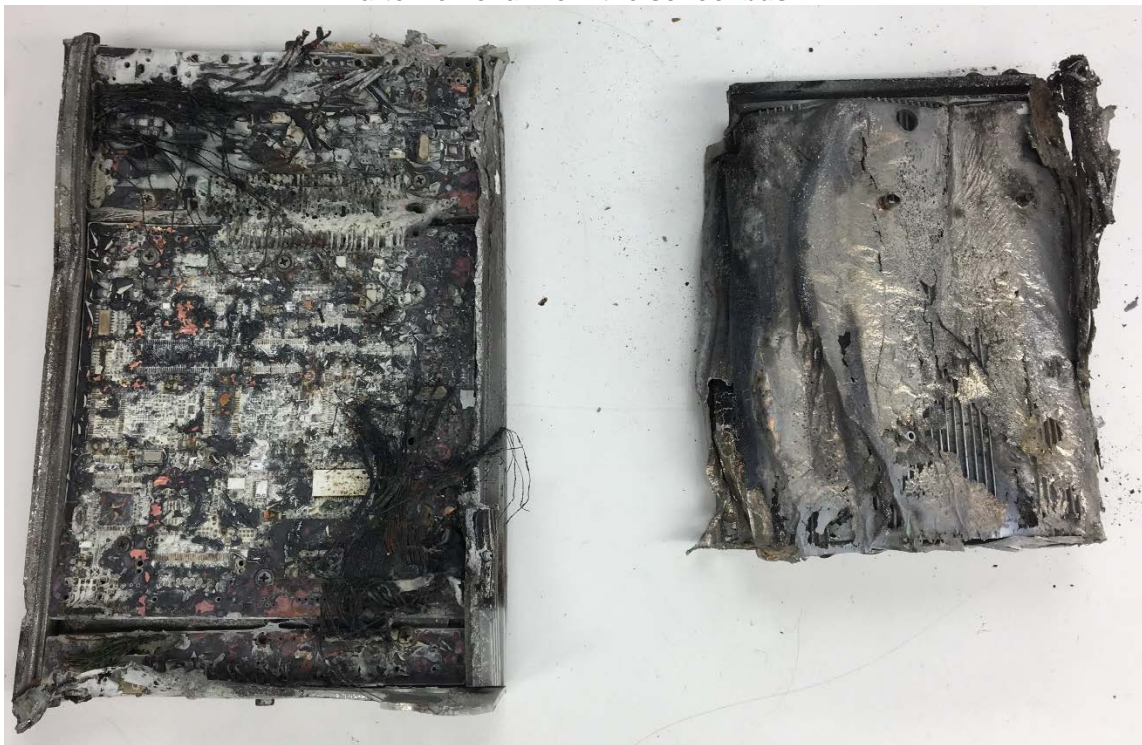
Figure 2. Image showing the bottom of the recording system and the hard drive casing after removal from the school bus.

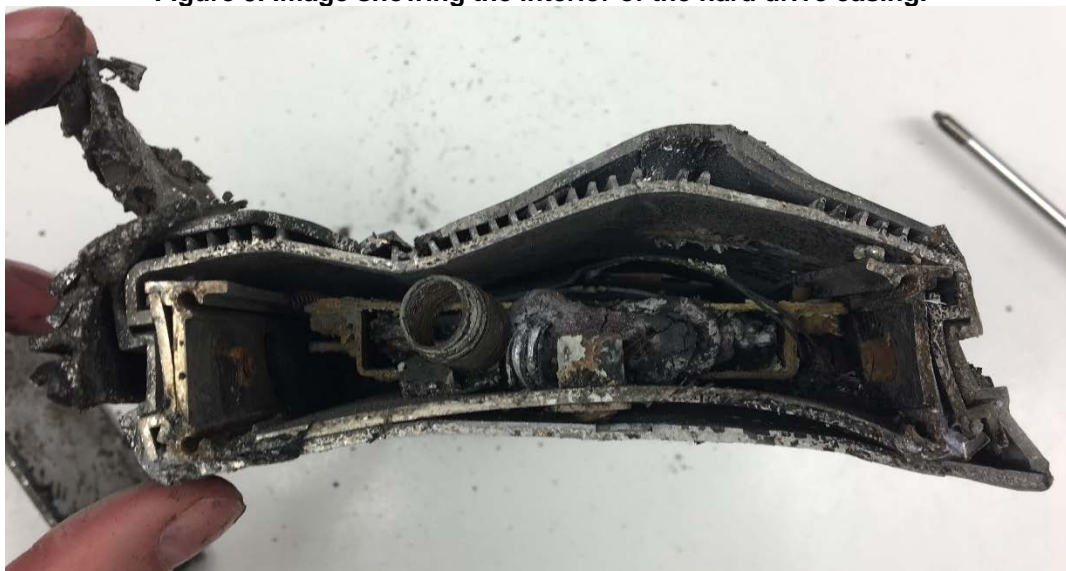
Figure 3. Image showing the interior of the hard drive casing.

Due to the extreme heat damage to the device, no video files could be recovered. Neither the NTSB or a third party hard drive recovery vendor were successful in recovering the data.

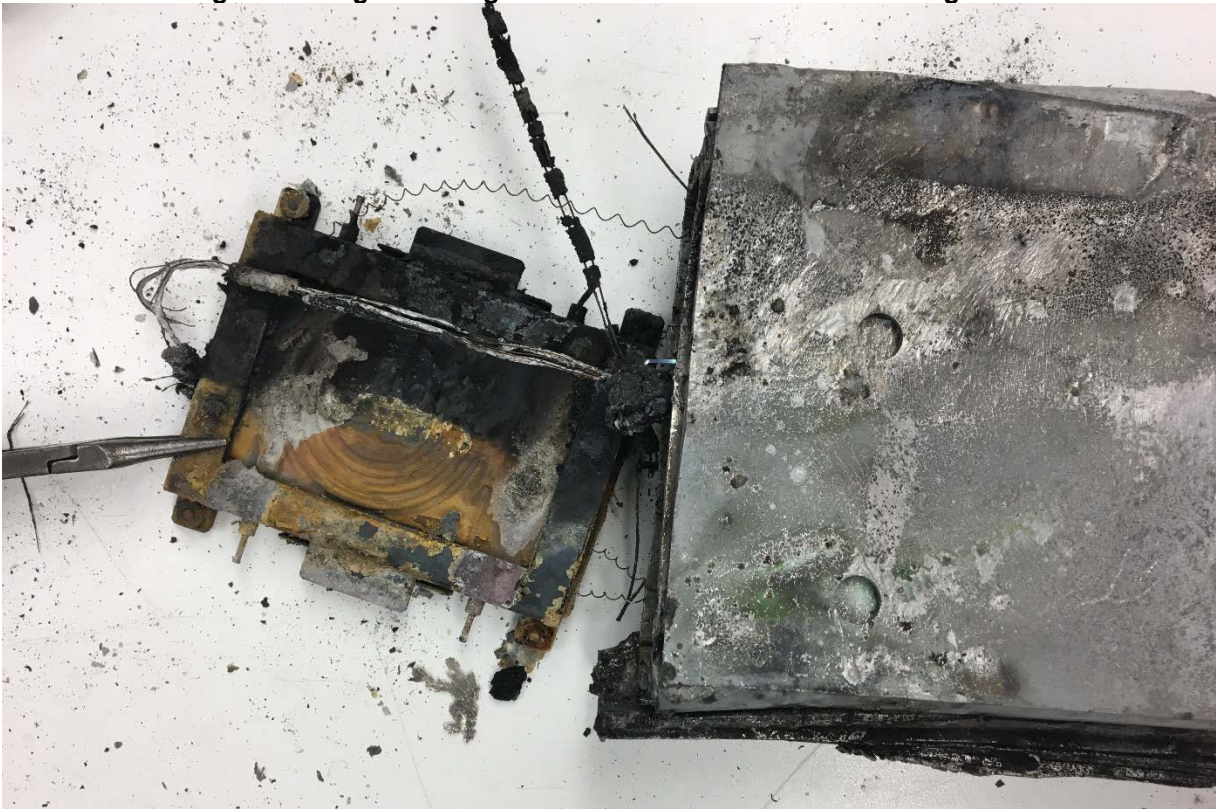
Figure 4. Image showing the removed hard drive from casing.
