**Washington
Gas**
A WGL Company

WASHINGTON GAS MEETINGS WITH NTSB MEMBERS

NTSB ACCIDENT ID
DCA16FP003

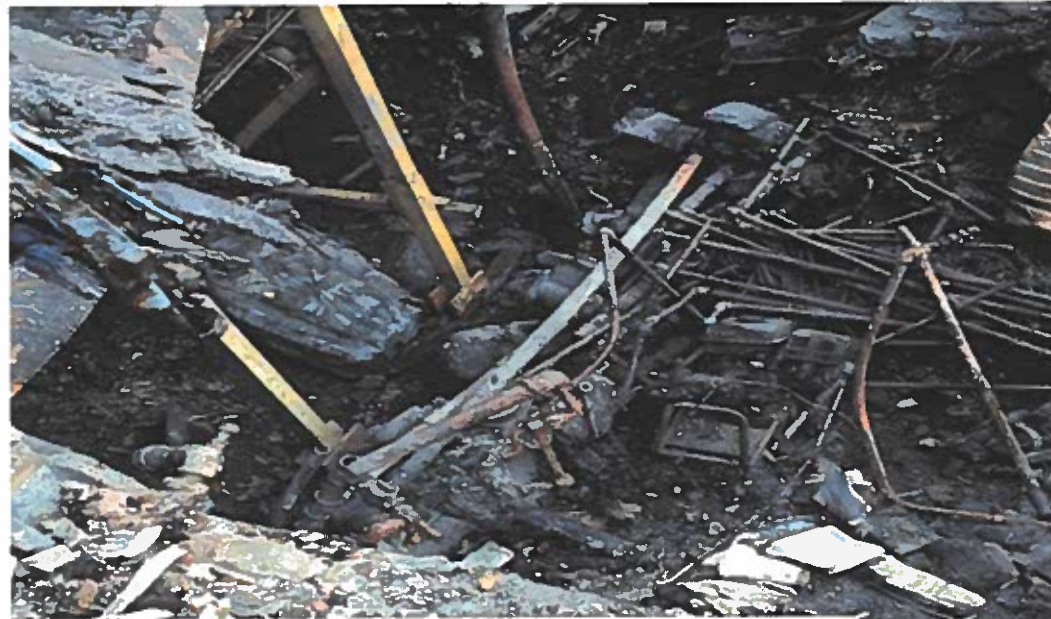
EXTENSIVE DESTRUCTION OF METER ROOM

“Given the damage to the natural gas regulators, natural gas meter bank and water heater, investigators were not able to immediately determine the failure that led to the release of fugitive natural gas in the 8701 Meter Room. “ -- ATF Report

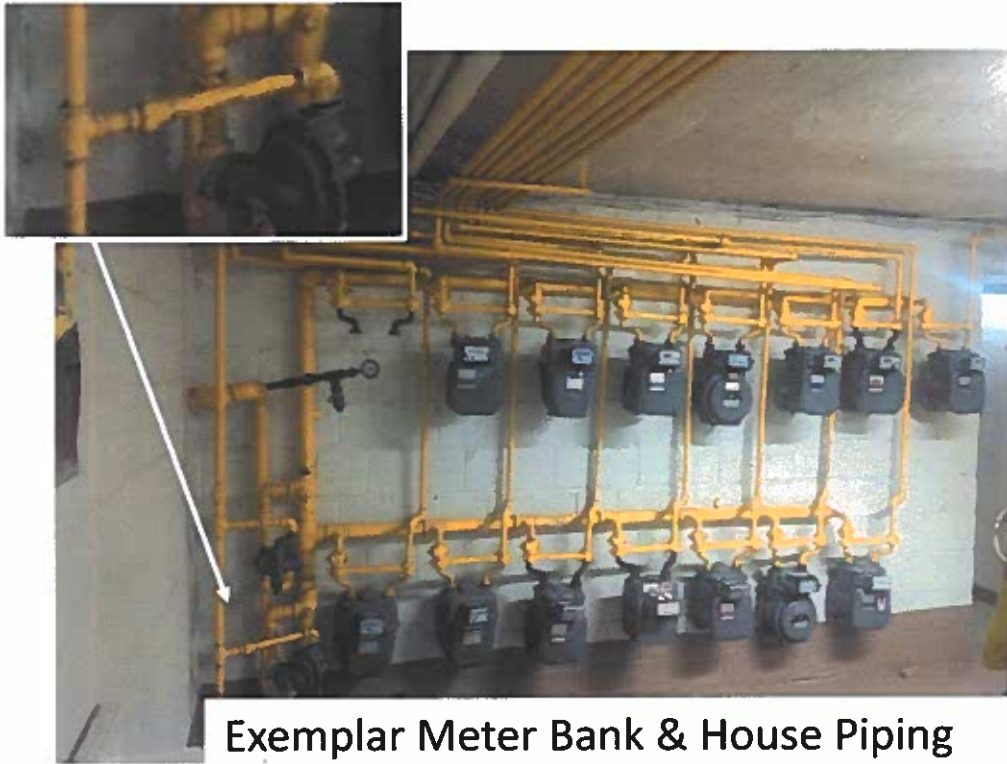
Exemplar Meter Bank & House Piping
(8709 Arliss St)

MANY POTENTIAL SOURCES AND CAUSES

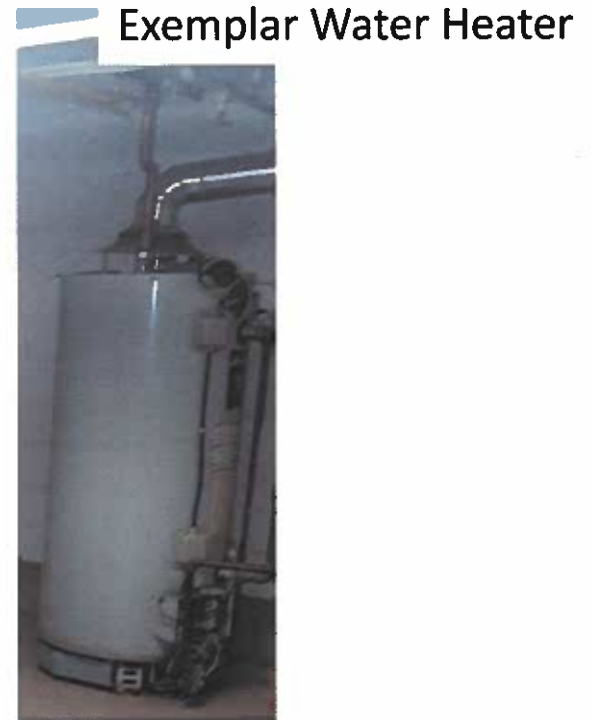
Exemplar Water Heater

“Sources of natural gas in the 8701 Meter Room involve the main natural gas feed, natural gas meter bank, an 81-gallon water heater and the associated piping.”

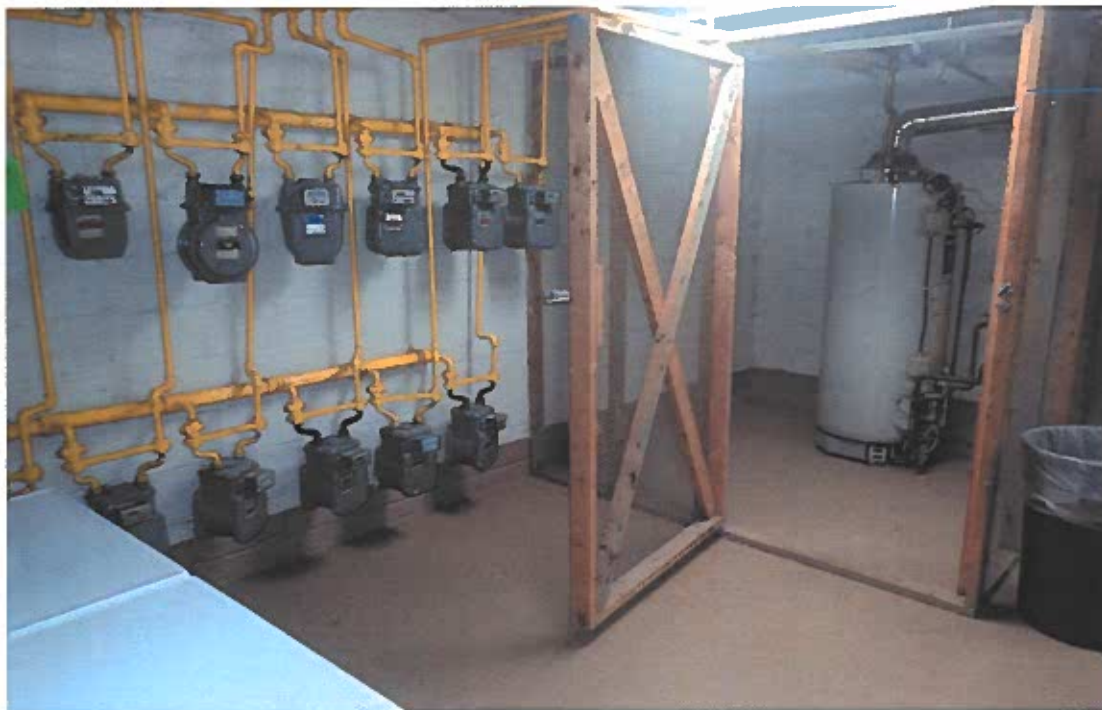
Protective Cage

20 OF 21 METER ROOMS ARE WELL-PROTECTED

20 of 21 Meter Rooms in complex:

- Have protective cages around water heater and piping
- No delivery or storage of heavy equipment or maintenance activities

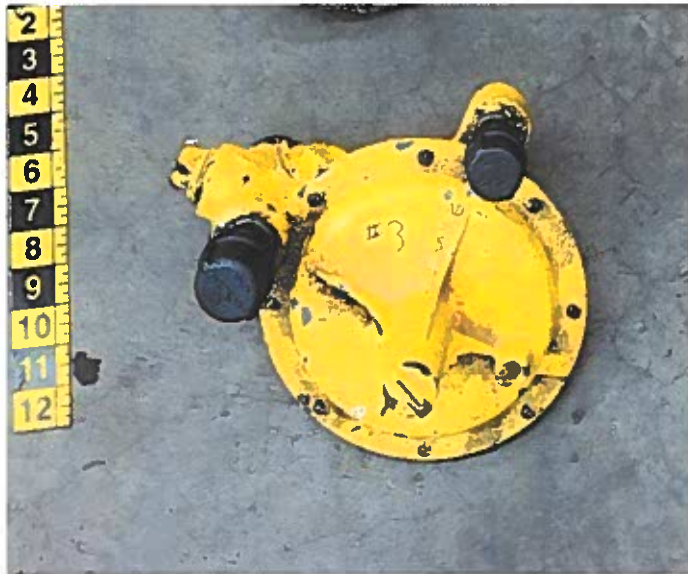
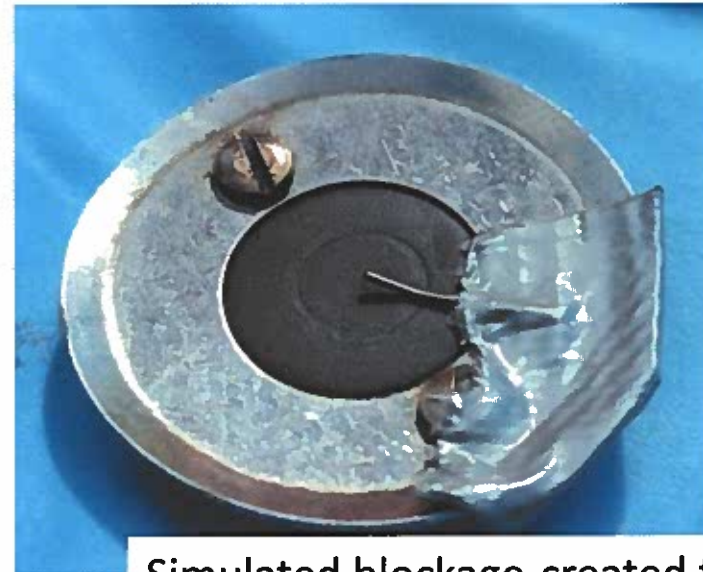
Simulated blockage-created for testing

- Less than 0.05% removed annually for leakage and venting
- 1950s exemplar regulators from Flower Branch complex in excellent working order—best evidence of condition of regulators at incident site
- Any regulator failure scenario would be low flow (\ll 165 CFH)

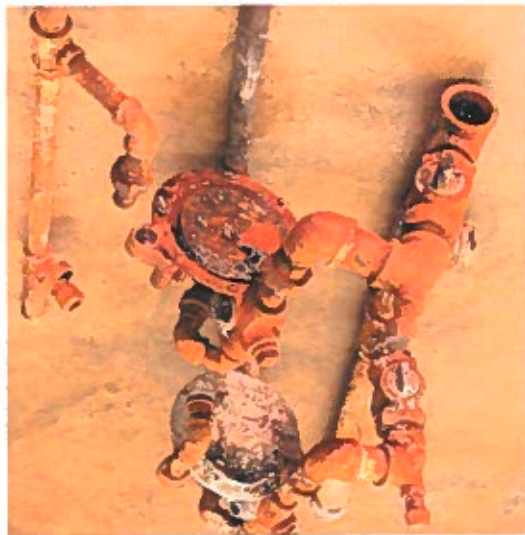
Deflection of Vent Piping

- Piping conditions consistent with union being intact
- Damage indicates forceful separation
- No observations of open/breached vent line
 - No procedure required fitting to be opened
 - No evidence it was left open by Washington Gas

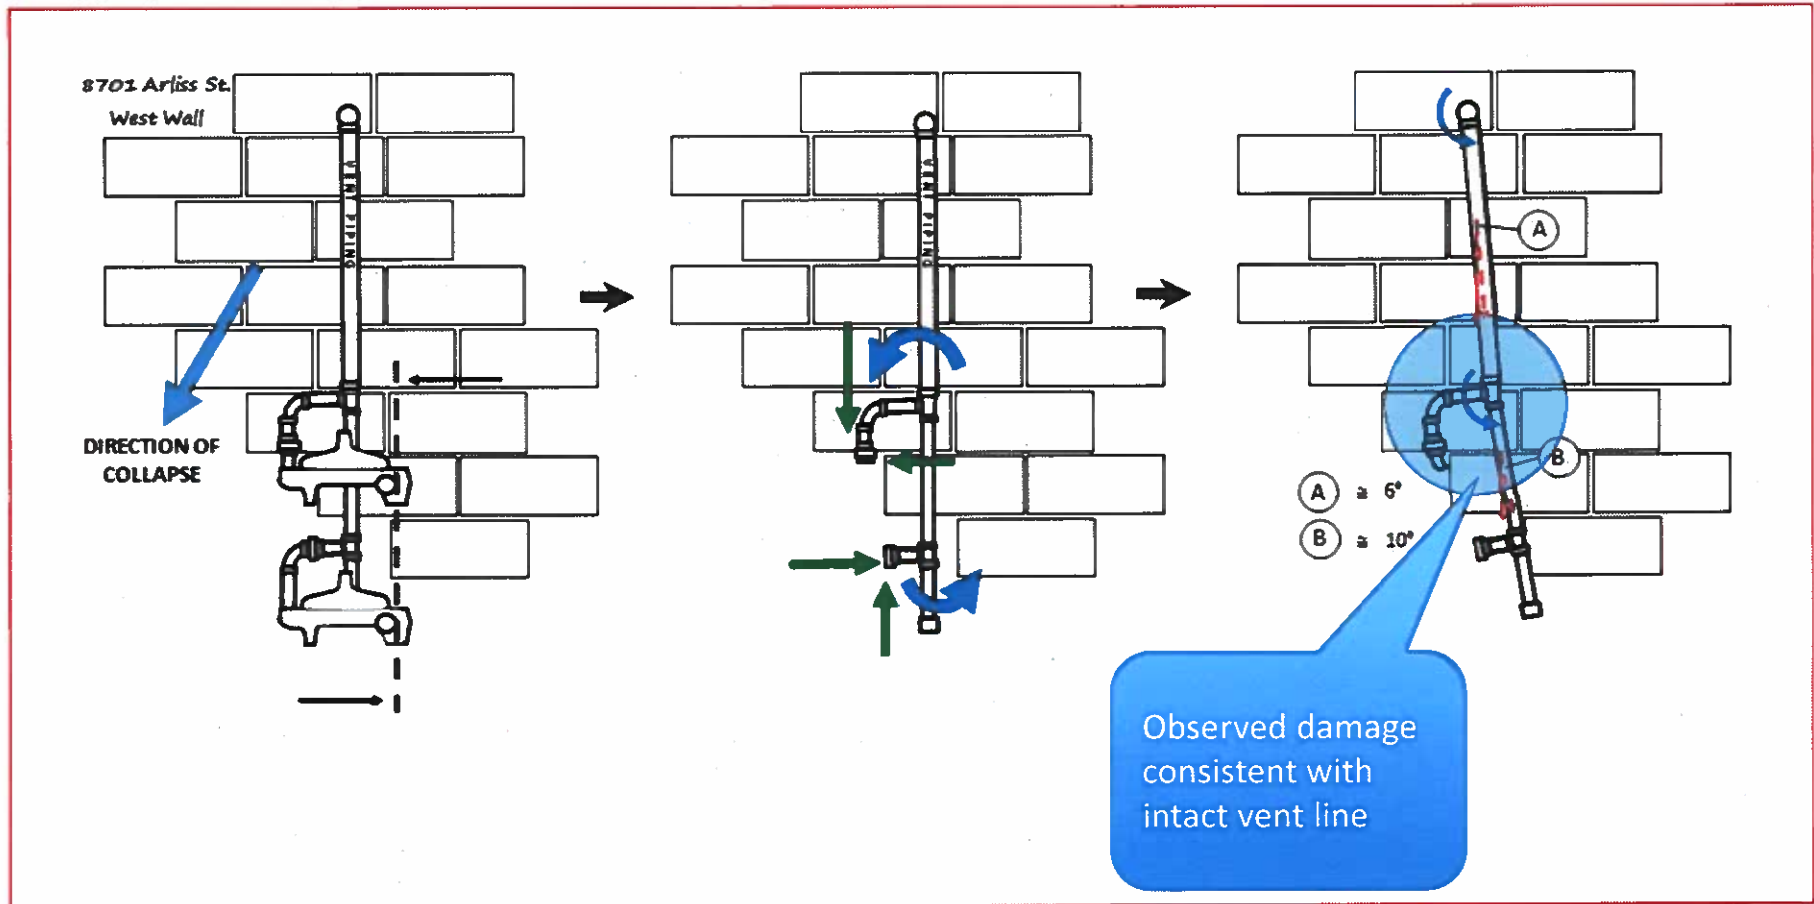
ONLY A CONNECTED VENT LINE EXPLAINS OBSERVED PIPING CONDITION

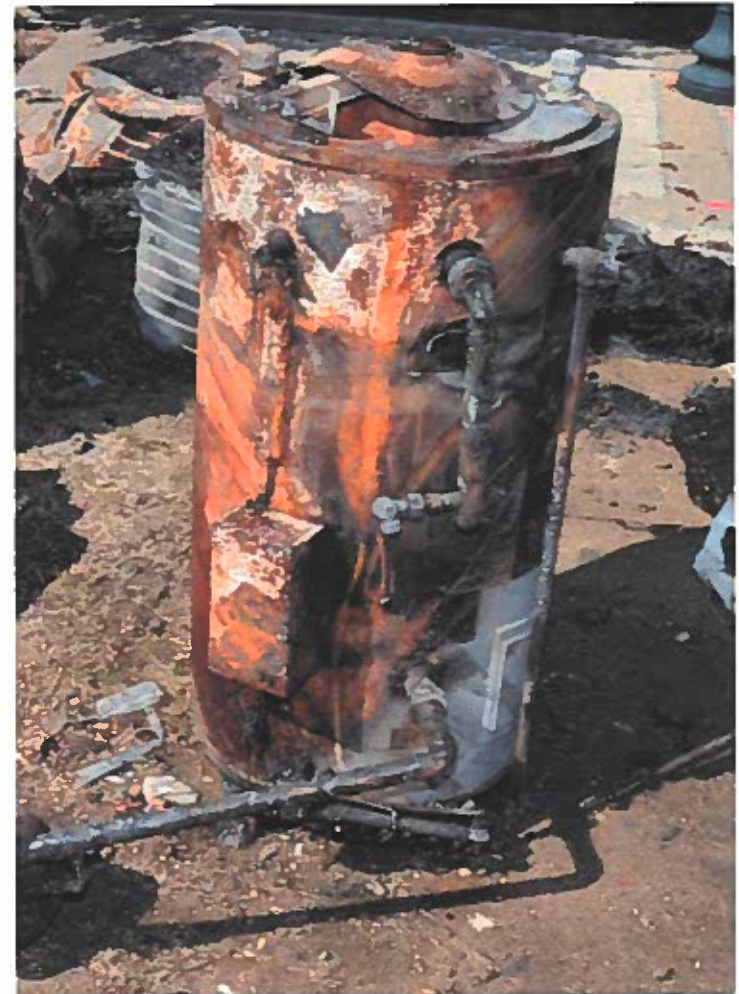
- Fuel line exposed and vulnerable
- Active storage of heavy, appliances, equipment and materials near water heater and exposed gas fuel line (human factors)
- Broken ½” threaded connection observed
- Broken ½” threaded connection produces a large flow of gas: 650 CFH (<20 minutes to LEL)

cleaned in Alconox, a commercial detergent. Figures 3 and 5 show photographs of the fracture faces after cleaning. Post cleaning examination of the fracture faces revealed they contained a rough fracture texture on slant planes consistent with overstress separation.

- Enhance code enforcement regarding storage activities in meter rooms
- Require flexible connections at rigidly mounted gas appliances
- Require methane detector installations in the gas meter rooms
- Enhance tenant information re gas safety and reporting of gas odors

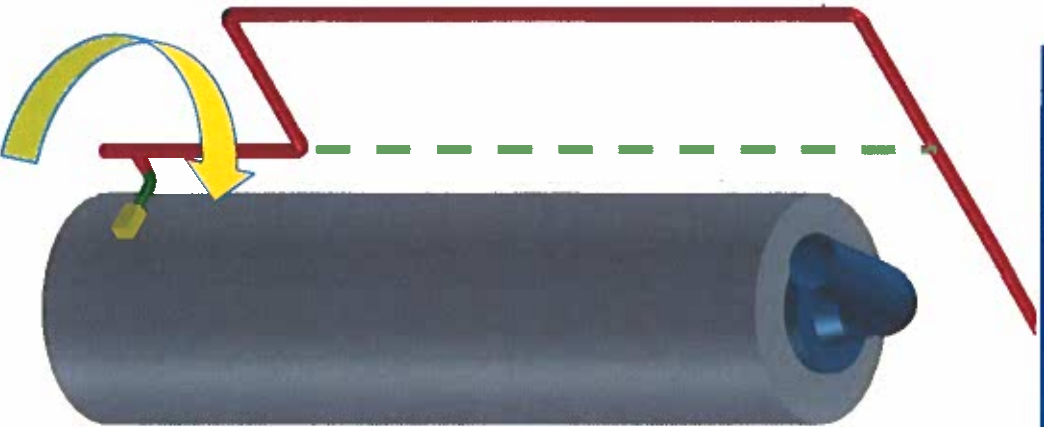
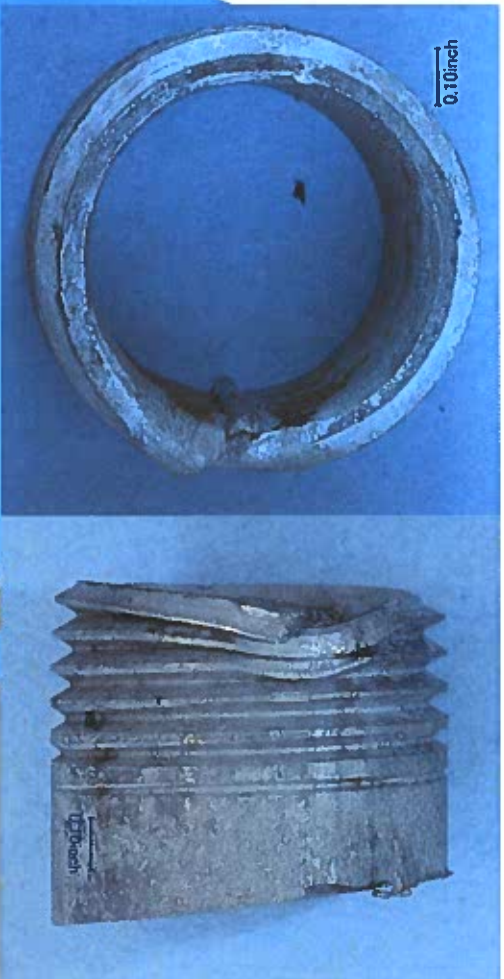
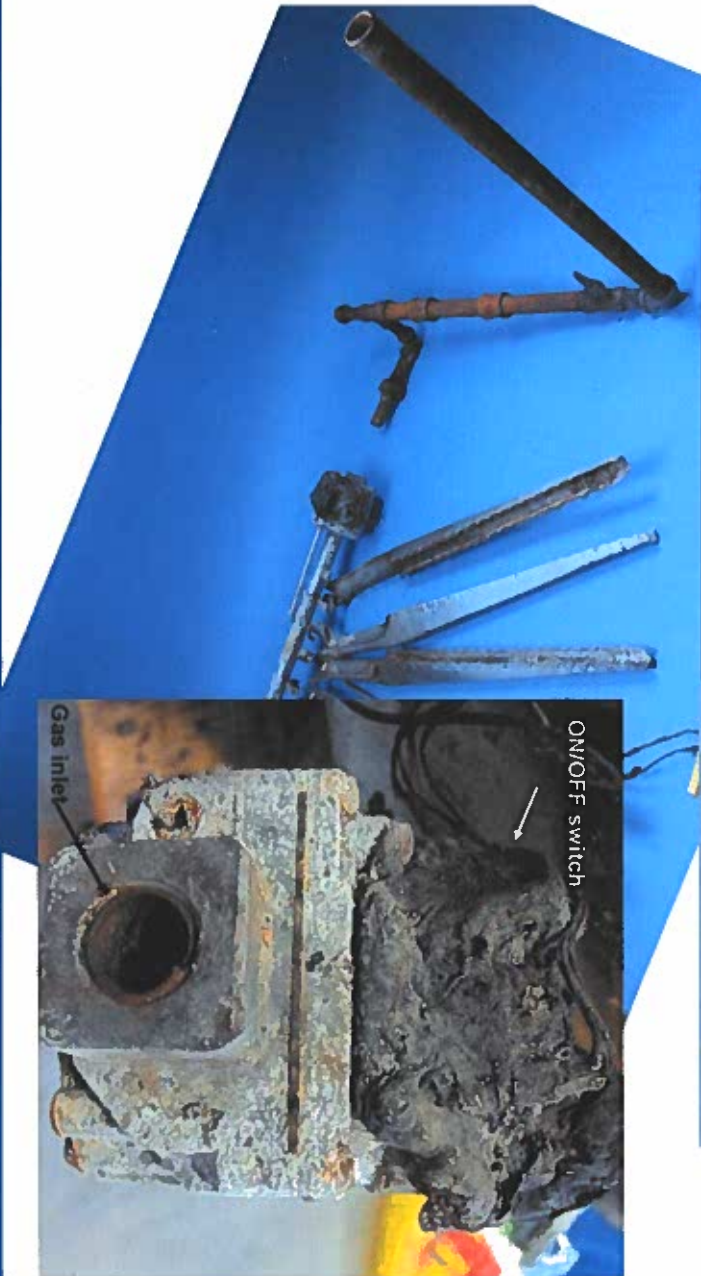
VULNERABILITY OF WATER HEATER FUEL LINE

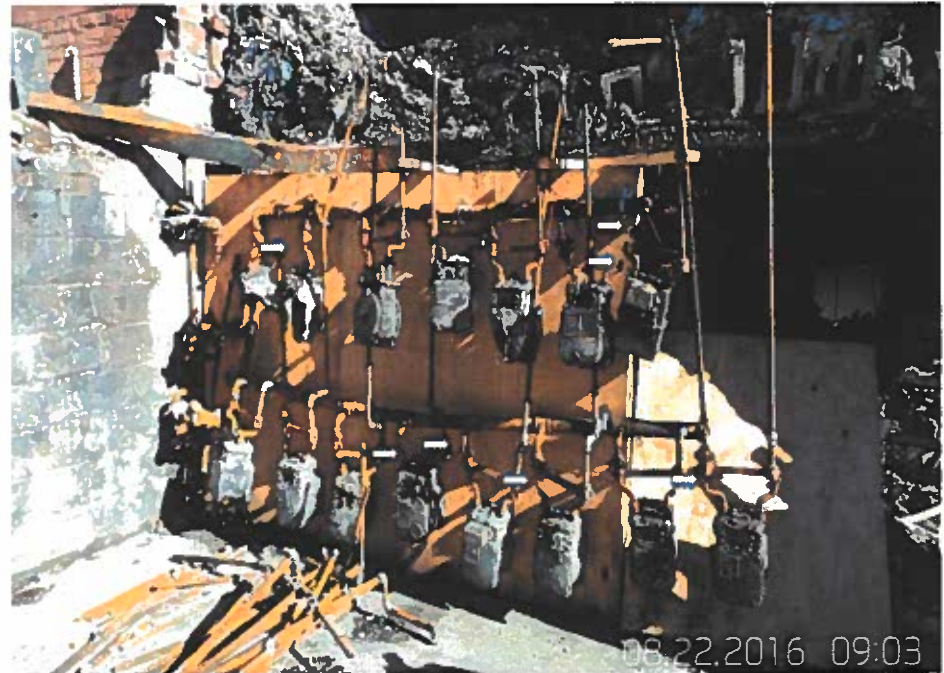
Exemplar Meter Bank & House Piping

- Meters exposed and vulnerable to damage from heavy objects
- Numerous swivels found broken
- Evidence of heavy materials / equipment stored near meter rack
- Severed swivel would produce a gas flow of 1,613 CFH (<10 minutes to LEL)

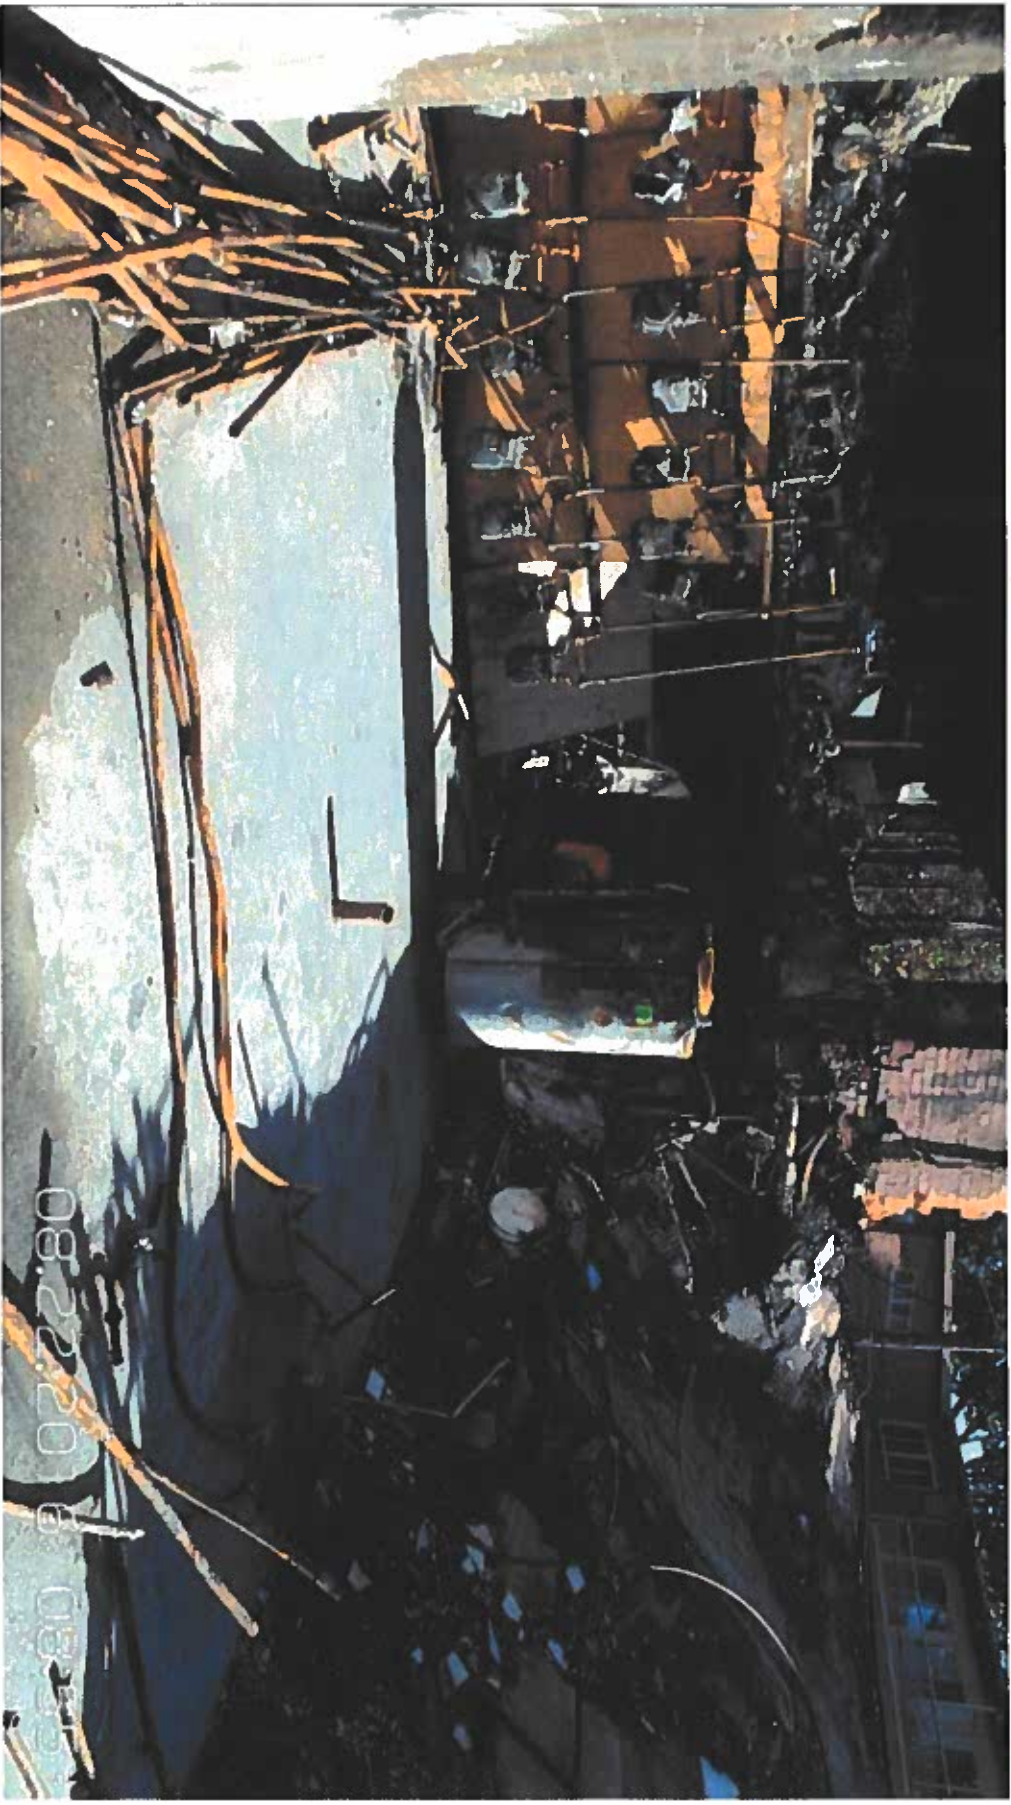
NUMEROUS BROKEN HOUSE PIPE CONNECTIONS

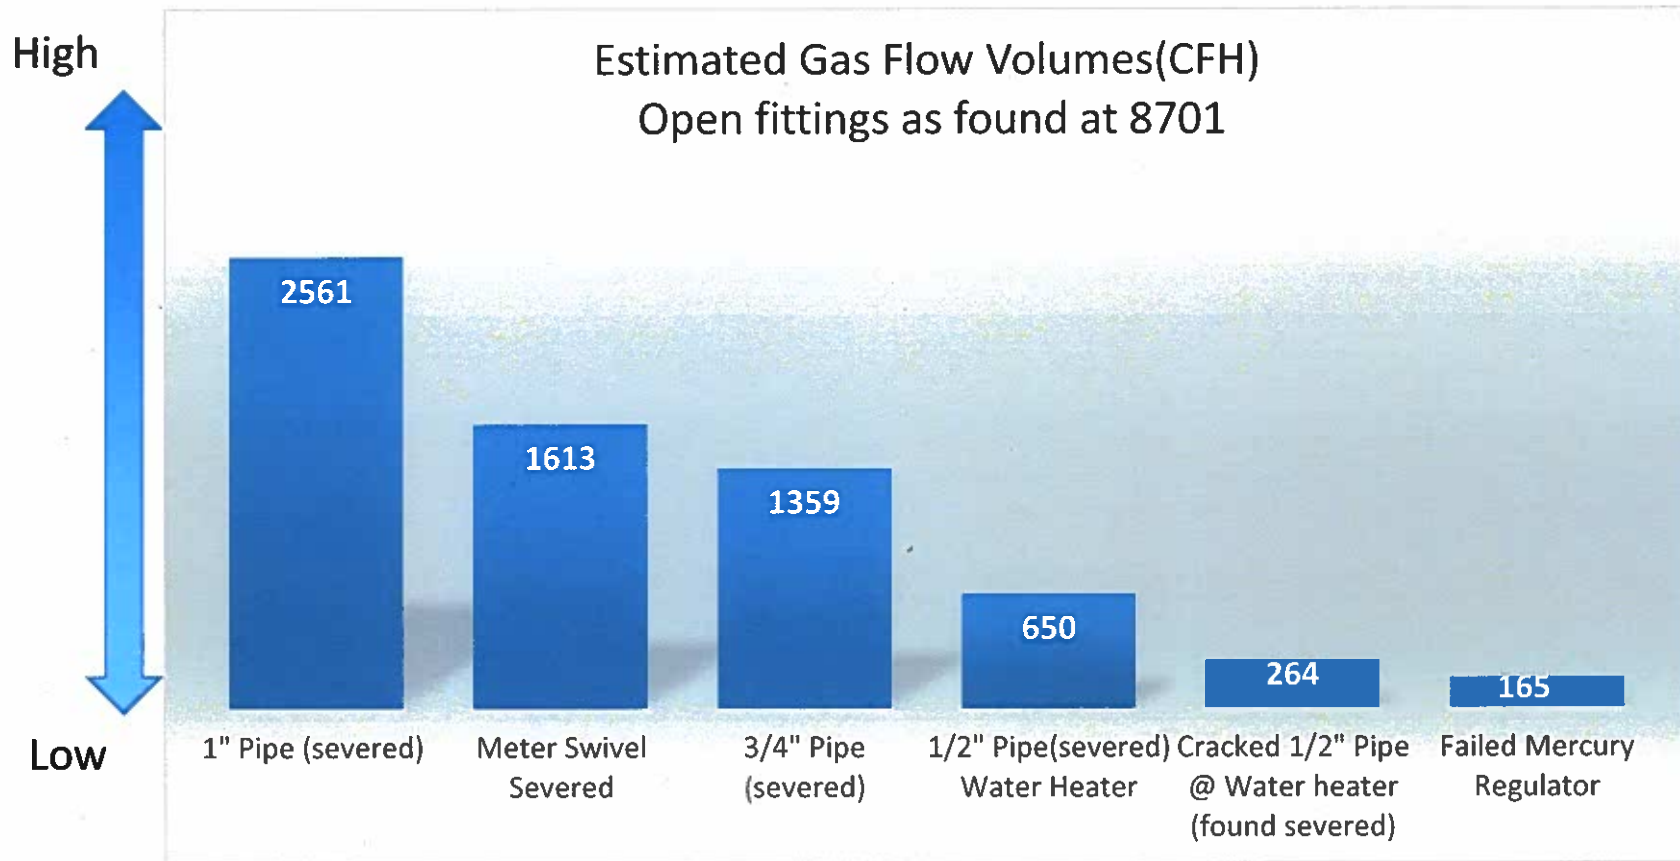
FLOW RATES OF POTENTIAL SOURCES

ATF made incorrect assumption about relative gas flow rates.
