NATIONAL TRANSPORTATION SAFETY BOARD
Office of Aviation Safety
Aviation Engineering Division
Washington, DC 20594
June 21, 2019

STRUCTURES GROUP CHAIRMAN'S FACTUAL REPORT
DCA18MA142

On April 17, 2018, at 1103 eastern daylight time, Southwest Airlines flight 1380, a Boeing 737-700, N772SW, experienced a left engine failure and loss of portions of the engine inlet and fan cowl during climb through flight level (FL) 320. Fragments from the engine inlet and fan cowl struck the wing and fuselage, followed by one cabin window departing the airplane and cabin depressurization. The flight crew conducted an emergency descent and diverted into Philadelphia International Airport (KPHL), Philadelphia, PA. Of the 144 passengers and five crewmembers onboard, one passenger received fatal injuries and eight passengers received minor injuries. The airplane sustained substantial damage. The regularly scheduled domestic passenger flight was operating under 14 Code of Federal Regulations Part 121 from LaGuardia Airport (KLGA), Queens, New York, to Dallas Love Field (KDAL), Dallas, Texas.

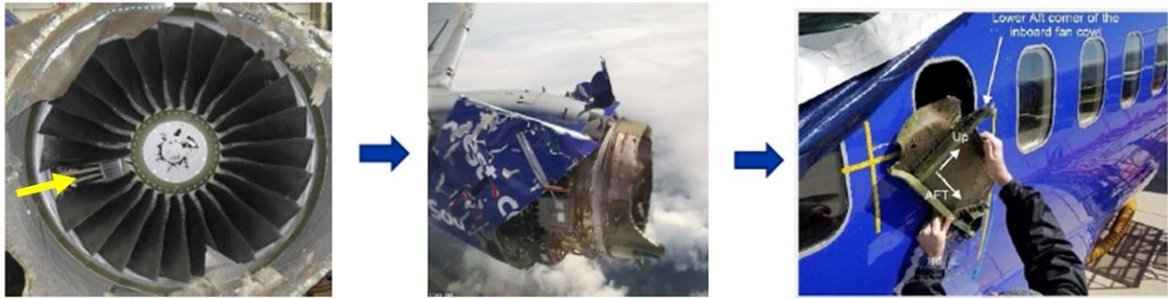
During climb through FL320, the left engine experienced a single fan blade separation at the blade root (**FIGURE 5 LEFT** – yellow arrow point to missing blade location). The separated fan blade impacted the engine fan case at about the 6:00 o'clock position and fractured into multiple fragments with some fragments traveling forward out of the engine and into the inlet with sufficient mass and energy to substantially damage the structural integrity of the inlet. The energy resulting from the impact of the separated fan blade with the fan case resulted in local deformation of the fan case, which started a high-energy displacement wave that propagated circumferentially around the fan case and inlet interface, causing additional damage to the inlet structure. The displacement wave also imparted significant load into the fan cowl through the fan case radial restraint pin located near the bottom of the fan cowl. The inlet damage created by the fan blade fragments and the displacement wave were substantial enough that the inlet could not sustain the flight loads; thus, the inlet lip, forward and aft bulkheads, outer barrel and portions of the inner barrel all departed the airplane (**FIGURE 5 MIDDLE**). The containment shield, portions of the inner barrel attached to it and the attach ring remained attached to the airplane.

The initial fan blade impact and subsequent displacement wave initiated cracks in the fan cowl which rapidly propagated and resulted in the separation of the fan cowl halves. The inboard aft latch assembly separated from the inboard cowl, and subsequently portions of both fan cowl halves liberated from the nacelle. Examination of the left side of the fuselage just forward and below where the cabin window was missing revealed evidence of impact including fan cowl grease transfer and witness marks consistent in size and shape with the recovered inboard aft latch assembly (**FIGURE 5 RIGHT**). The lack of any acrylic windowpane fragments and window frame material found inside the airplane was consistent with a rapid departure of the cabin window and subsequent depressurization of the cabin (See **ATTACHMENT 1** for description of the cabin pressurization system).

Figure 5 – Accident Sequence Overview

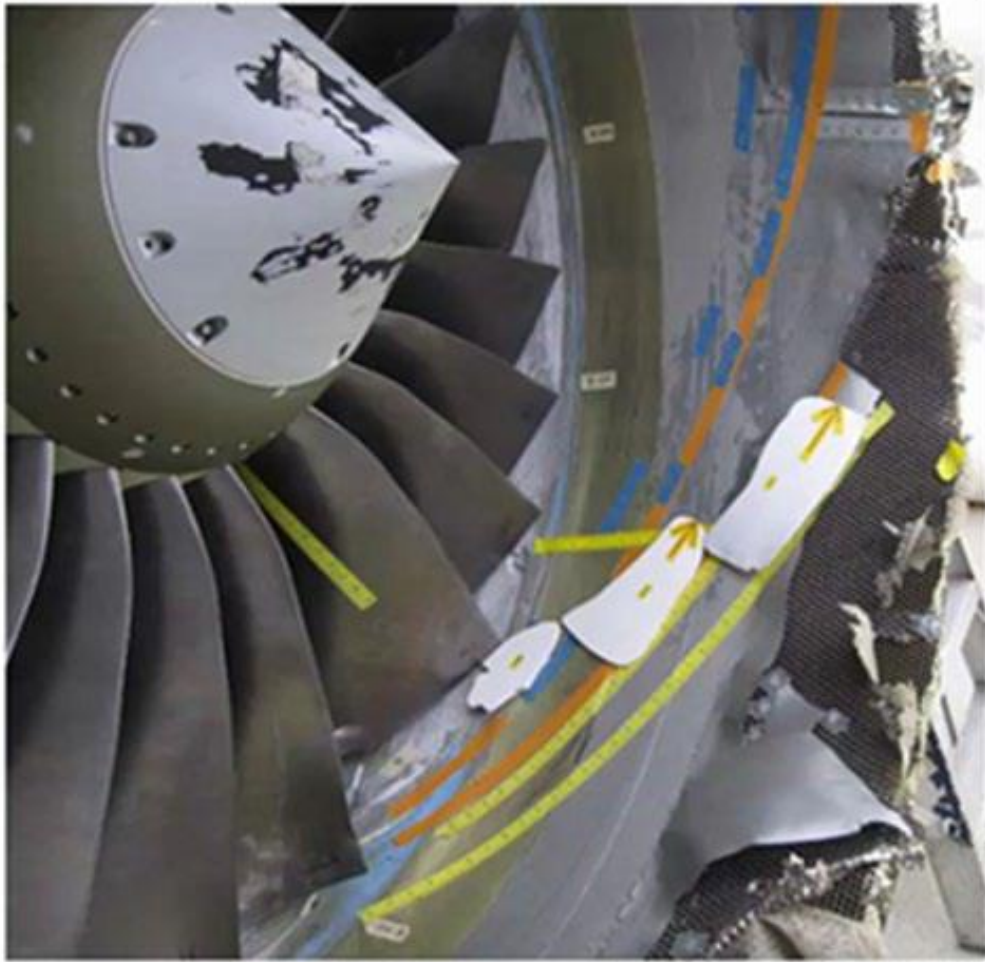
1) As the fan blade impacted the engine fan case, it fractured into several smaller fragments, some of which moved aft in the direction of the predominant air-stream motion, and some traveled forward into the inlet. Impact marks on the fan case and inlet along with the recovered fragments indicated that portions of the fan blade tip and mid panel exited the fan case and entered the inlet along a forward helical path (**FIGURE 6**). Although not recovered, the quantity and mass of the fan blade fragments that exited forward of the fan case in this accident are believed to be comparable to or greater than those observed during CFM56-7B engine fan blade out (FBO) rig tests and the engine FBO containment certification test (See the Powerplant Group Chairman's Factual Report in the docket for this accident for engine FBO testing and certification details). Due to the numerous impact and scuff marks in both the fan case and inlet and the unknown nature of the exact fragment orientation at the time the marks were created, there were various interpretations of how the marks were created. Therefore, the exact trajectory path of the departing blade tip and the mid span fragments could not be conclusively determined. The likely trajectory of the fragments in the accident event were considered to range from 15° to 30°. During the engine and nacelle development process, a fan blade tip exit trajectory of 15° was used. Midspan fragments were not defined during engine FBO certification.

Figure 6 – Possible Fan Blade Fragment Forward Helical Trajectory from Fan Case to Inlet

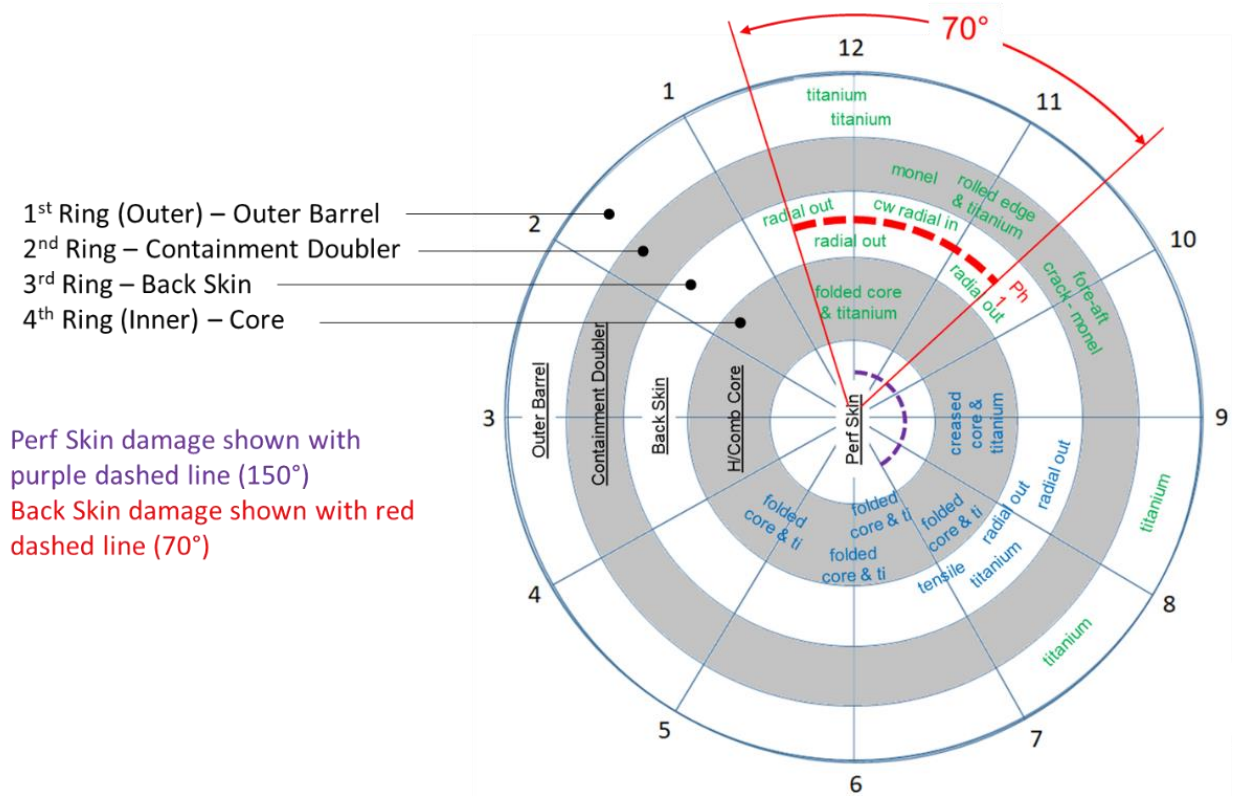
- 1) Gouges and indentations in the inner barrel flow side attach ring, perforate skin, and honeycomb core
- 2) Fractures and deformations in the inner barrel containment doubler
- 3) Punctures in the outer barrel
- 4) Traces of titanium on inlet components
- 5) Inner barrel back skin fracture surface topography.

FIGURE 8 summarizes those observations used in defining the plausible range of inlet damage due to fan blade fragments; details of the accident hardware observations are provided in the **REPORT FROM PARTIES – COLLINS, AND REPORT FROM PARTIES – CFM**. A plausible level of damage attributed to fan blade fragments used for the Boeing Progressive Failure Analysis included 150° of damage to the inner barrel perforate skin as well as 70° of damage through the inner barrel back skin forward of the containment doubler.

Figure 8 – Inlet Damage Due to Fan Blade Fragment Assessment

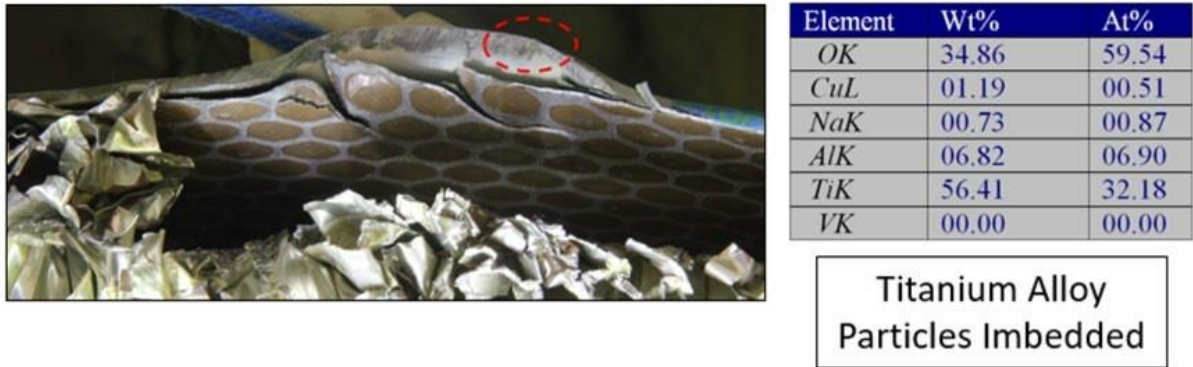
Two main findings supporting inlet damage due to the fan blade fragments are shown in **FIGURES 9 and 10**.

Figure 9 – Inlet Containment Doubler Forward Edge with Evidence of Titanium Transfer
FIGURE COURTESY OF COLLINS

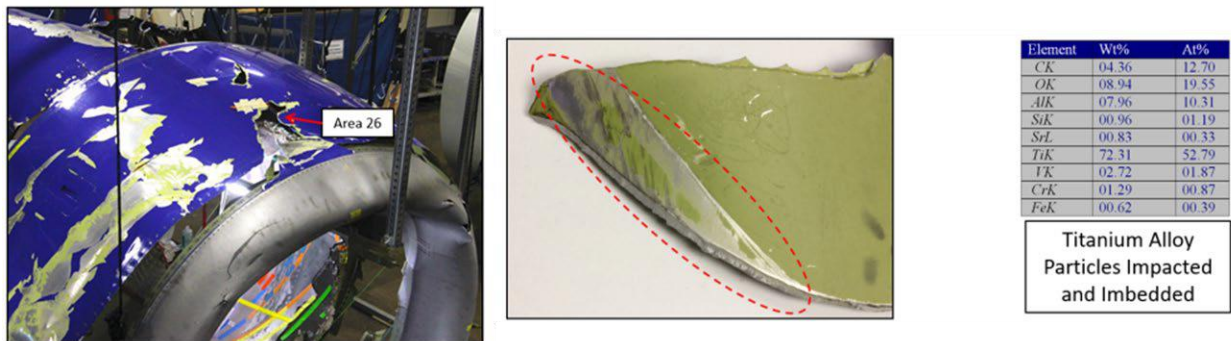
Figure 10 – Inlet Outer Barrel Penetration with Evidence of Titanium Transfer
FIGURE COURTESY OF COLLINS

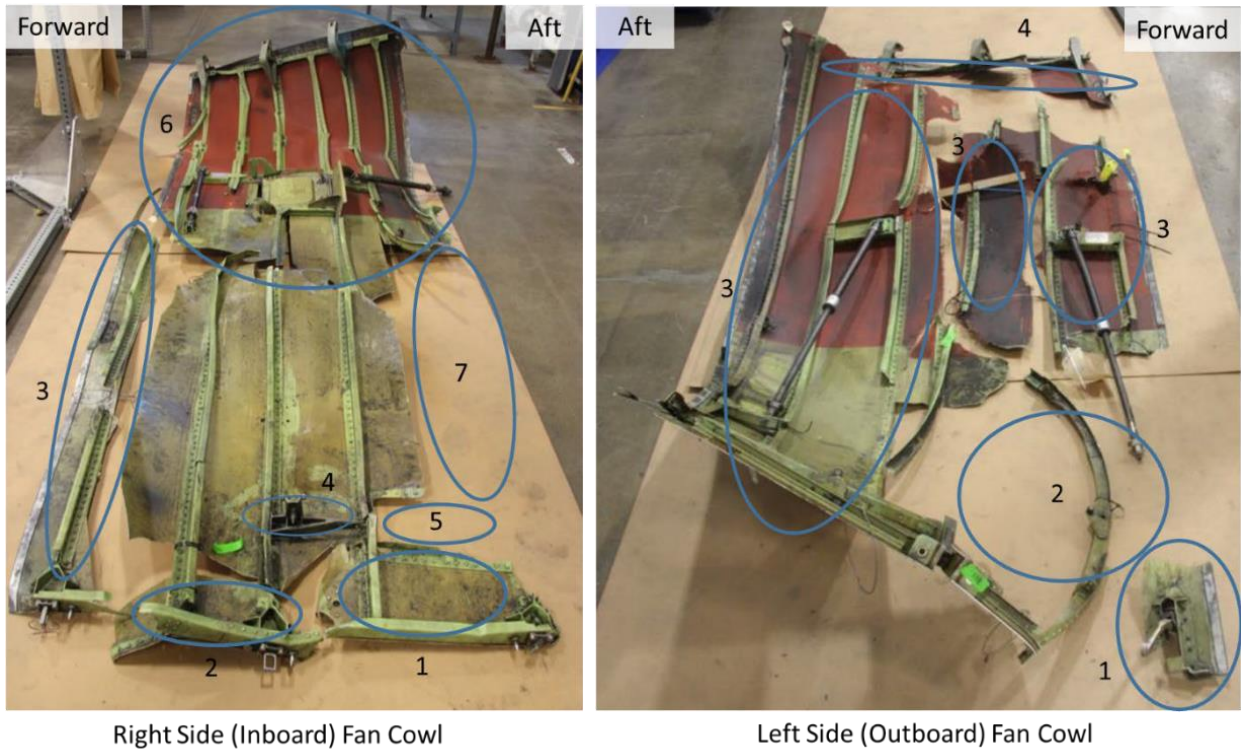
- 1) Small skin panel with latch 3/aft keeper fitting separated – appears to have hit fuselage
- 2) Small skin panel with latch 2/mid keeper fitting separated
- 3) Long narrow skin panel with latch 1/forward keeper fitting separated
- 4) Radial restraint bracket shows significant damage at attachments to cowl frames
- 5) Cast starter vent mostly missing, but remaining attach flanges show fast fracture failures
- 6) Upper cowl panel remained attached to airplane via three hinges
- 7) Aft lower cowl panel was not recovered

- 1) Small skin panel with latch 1 and fitting separated from cowl
- 2) Forward lower cowl panel was not recovered
- 3) Multiple cowl panel sections separated
- 4) Small remnants of fan cowl panel attached to hinges remained attached to airplane

Figure 11 – Accident Fan Cowl Damage Locations and Observations

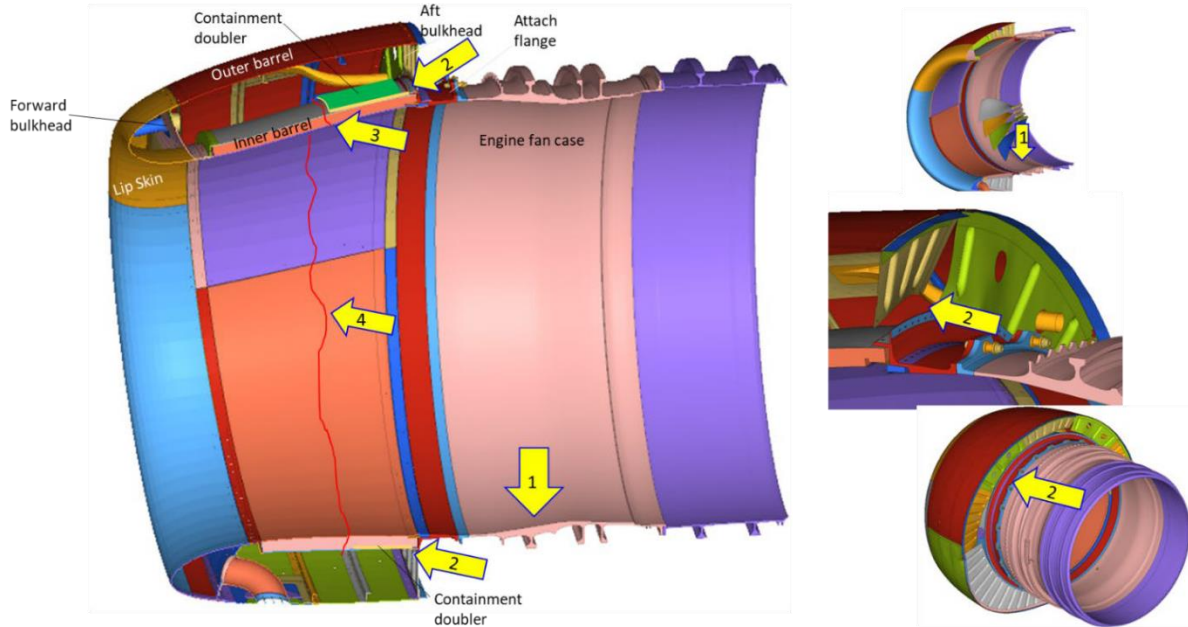
The predicted results of the accident event analysis were consistent with the inlet experiencing initial structural damage during the displacement wave and fan blade fragmentation, which then propagated during the engine run down, resulting in large portions of the inlet departing the aircraft. The analysis predicted, and the accident hardware examination confirmed, that the aft bulkhead-to-attach ring joint failed 360° circumferentially due to fastener shear caused by the displacement wave.

After the initial damage, the critical remaining inlet structural element was the 0.020 inch thick aluminum inner barrel back skin just forward of the containment doubler. During the run down, the remaining inner barrel, with the exception of the reinforced 3:00 and 9:00 o'clock splices, experienced a 360° circumferential failure allowing separation from the rest of the inner barrel.

FIGURE 13 and **TABLE 2** summarize an inlet damage scenario that is consistent with the structural analysis¹, including approximate time from fan blade release, until the parts of the inlet departed the airplane. The numbers referenced in **FIGURE 13** correspond to the numbers referenced in **TABLE 2**.

Figure 13 – Predicted Inlet Failure Sequence

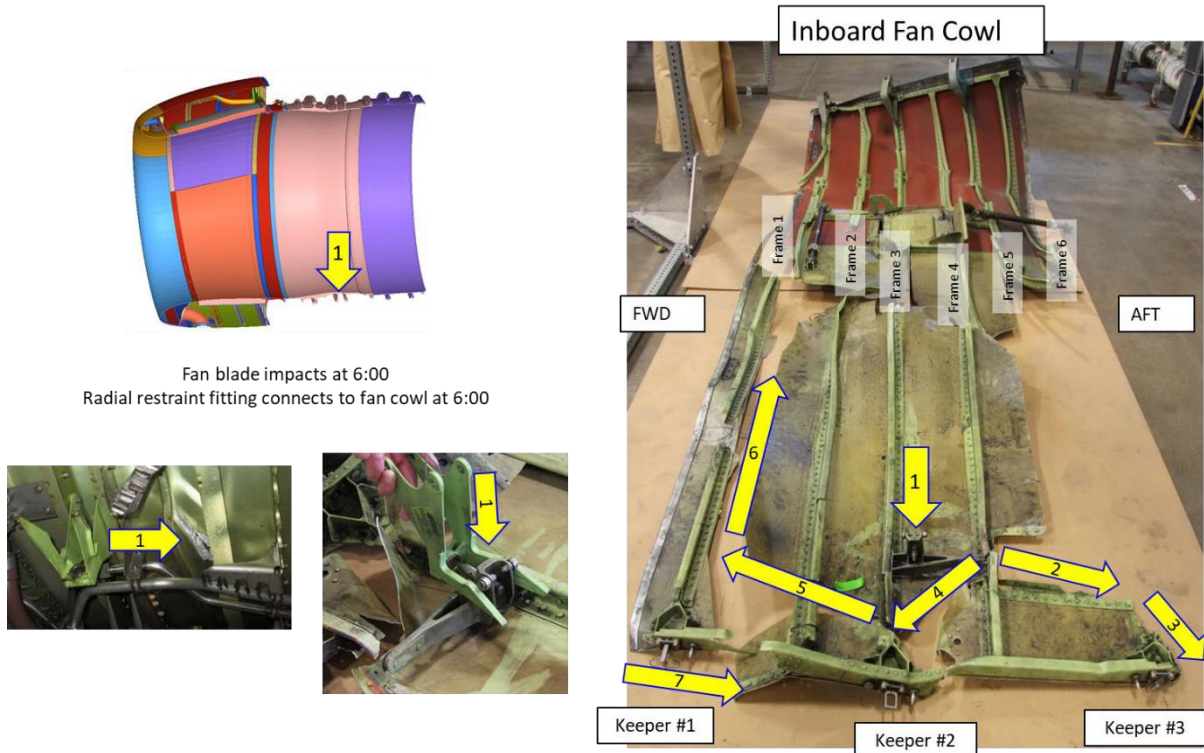
The predicted results of the accident event analysis were consistent with the observed damage in the fan cowl near the radial restraint fitting near the bottom of the fan cowls. This damage was caused by the fan case displacement wave transmitting load through the radial restraint fitting. This load caused cracks to form in the fan cowl skin and frames near the radial restraint fitting. This damage then propagated forward and aft, severing all three latch assembly load paths,

culminating in large portions of the lower part of each fan cowl half separating and departing the airplane. The observed fan cowl damage was consistent with the predicted results. **FIGURE 14** and **TABLE 3** summarize the failure sequence in this scenario. The numbers referenced in **FIGURE 14** correspond to the numbers referenced in **TABLE 3**.

Figure 14 – Predicted Fan Cowl Failure Sequence

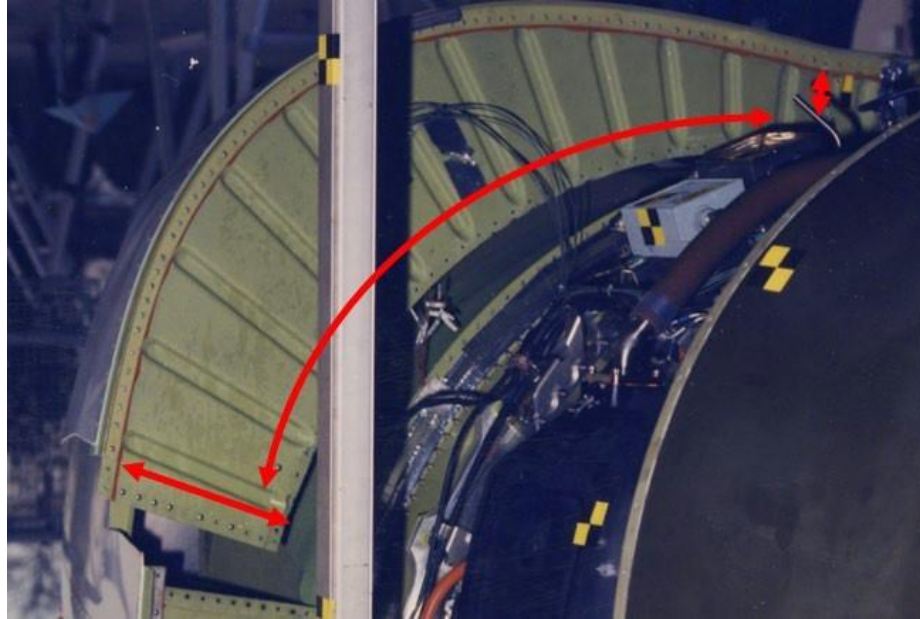
Review of the high speed camera footage from the CFM56-7B engine FBO containment certification test, which included a production-representative inlet installed but no fan cowls, showed that in the first 2-3 fan revolutions following the blade release (about 25-40 milliseconds) all the aft bulkhead-to-attach ring joint fasteners had failed, together with several aft bulkhead web panel-to-panel joint fasteners failures (FIGURE 20) which correlates well with the simulation results discussed above and depicted in FIGURES 18 and 19. For a more comprehensive discussion of the CFM56-7B engine FBO containment certification test results, refer to the NTSB Powerplant Group Chairman's Factual Report for this accident.

Figure 20 – Engine FBO Containment Certification Test – Inlet Aft Bulkhead Damage

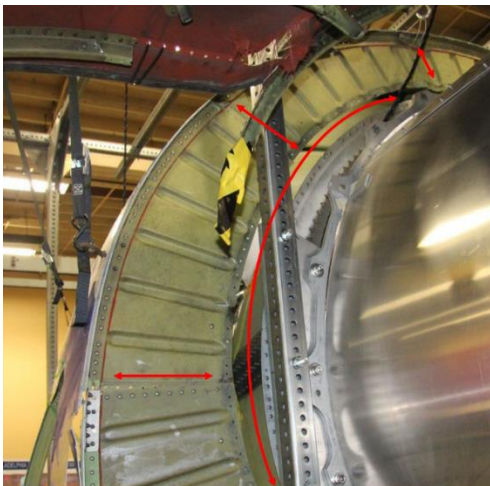
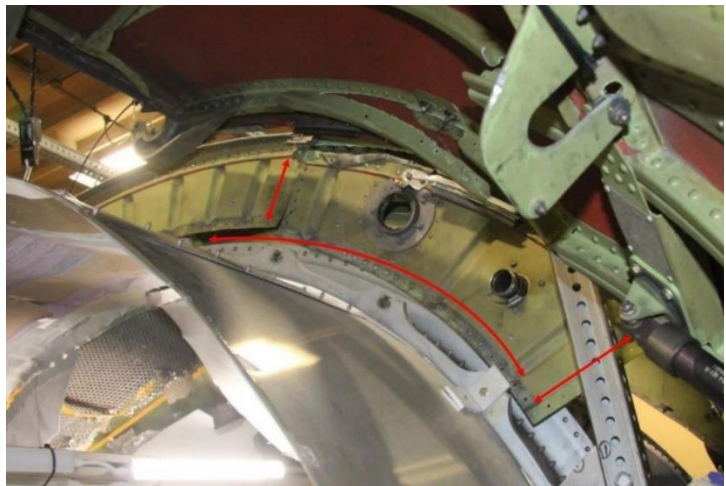
3) The displacement of the engine fan case transmitted deformations into the inlet A-flange and aft bulkhead, resulting in all the aft bulkhead-to-attach ring rivets to fail in shear, and the outer barrel skin to become cantilevered from the inlet forward bulkhead (See **FIGURES 21** and **22**).

Visual observation of the recovered inlet hardware indicated that all the fasteners that connect the aft bulkhead to the attach ring fitting failed, consistent with damage expected from the displacement wave.

Inlet hardware that departed the airplane and was later recovered on the ground was reconstructed together with hardware remaining on the airplane to enable observations of accident event damage. Similar to the engine FBO containment certification test, the accident hardware exhibited a full 360° circumferential fastener shear failure in the aft bulkhead-to-attach ring joint (FIGURES 21 and 22). The aft bulkhead web panel splice joints failed also by fastener shear. Based on the engine FBO containment certification test observations, and structural analysis in support of the accident investigation, the accident inlet hardware observations were, for purposes of the structural analysis, attributed to the displacement wave loading.

Figure 21 – Aft Bulkhead Joint Failure – Accident hardware Left Hand View (Aft Looking Forward)

Figure 22 – Aft Bulkhead Joint Failure – Accident hardware Right Hand View (Aft Looking Forward)

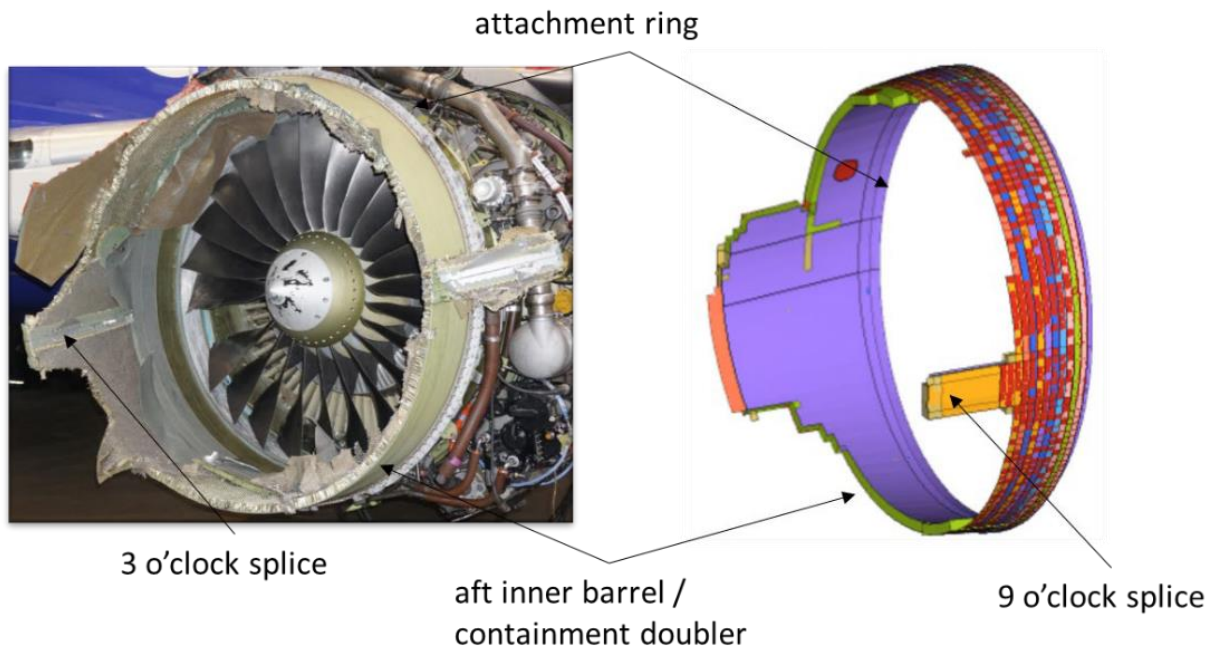
FIGURE 27 shows the side-by-side comparison of the accident event inlet (**FIGURE 27 LEFT**) in the as-landed condition and final state of the inlet progressive failure analysis simulation for the load conditions previous discussed (**FIGURE 27 RIGHT**). The simulation model correlated well with the accident event inlet.

Figure 27 – Inlet Simulation Result (right) Versus Accident Event Inlet Condition (left)
SIMULATION FIGURE COURTESY OF BOEING

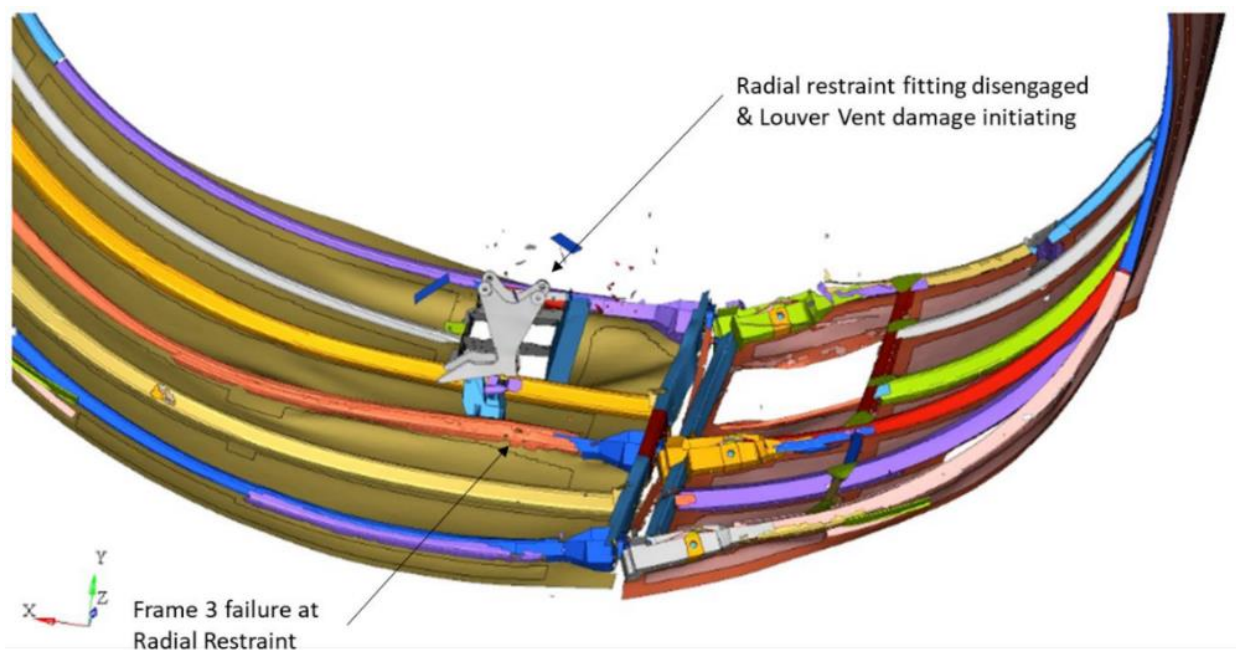
In the original loading assumptions used at the time of the engine and airplane certification, it was assumed that the radial restraint fitting failed immediately, prior to transmitting loads to the fan cowl. The remaining structure was assessed and the cowls were predicted to sustain the FBO loading without departure.

**Figure 30 – Fan Cowl Progressive Failure Analysis
Radial Restraint Disengages and Fan Cowl Damage Initiates**

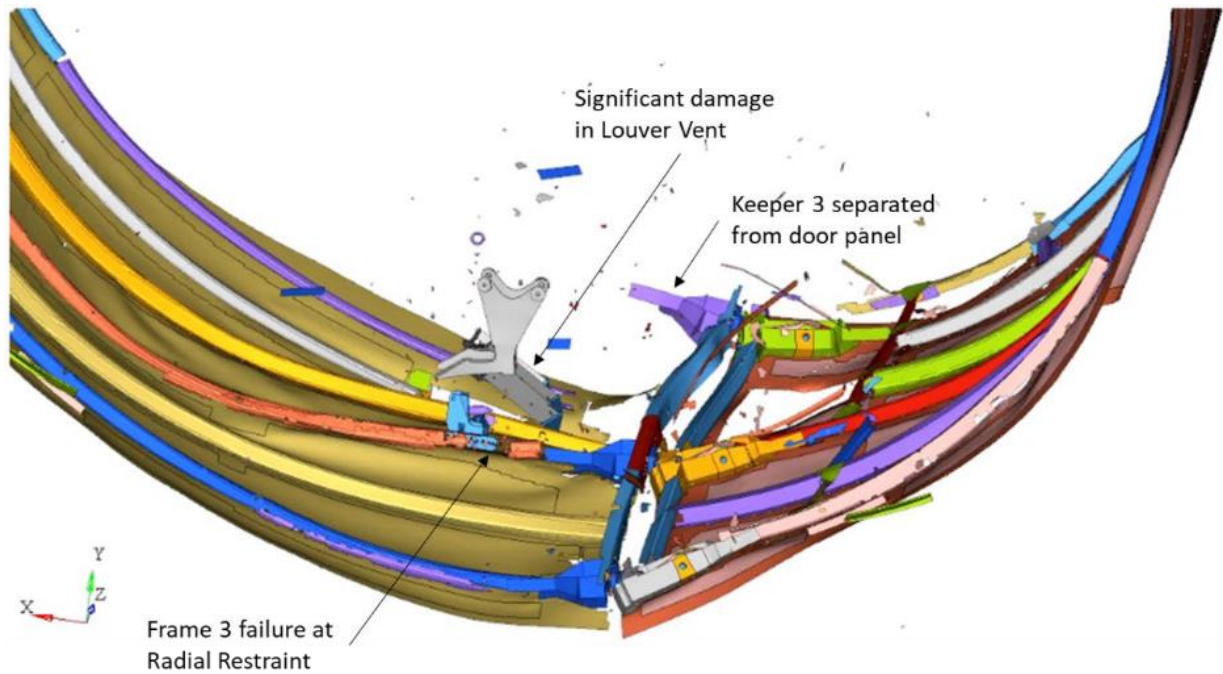
FIGURE 31 shows the total load path failure around the aft keeper (keeper 3) fitting and the separation of the louver vent from the fan cowl due to failures at the joint locations. The impact loads and external aerodynamic pressure loads resulted in further crack propagation and the opening of the fan cowl. The structural failures lead to a progressive total fan cowl failure with latch 2 and then latch 1 connections failing. All latch load paths failed leading to fan cowl opening and partial separation from the airplane by approximately 0.070 seconds after fan blade release. The results of the simulation were consistent with the documented damage on the accident event fan cowls (See **FIGURES 11** and **14**).

Figure 31 – Fan Cowl Progressive Failure Analysis – Louver Vent and Aft Latch Keeper Failure
FIGURE COURTESY OF BOEING
