Boeing EQA Report AS11733:

Examination of Nose Landing Gear Components Removed from
Southwest Airlines 737-300 Airplane PS765

Subject: EQA Report – Southwest Airlines 737-300 N379SW Wheel Well Structure
Fracture at El Paso – 27 July 2012

SUBJECT: *Examination of Nose Landing Gear Components Removed from Southwest Airlines 737-300 Airplane PS765*

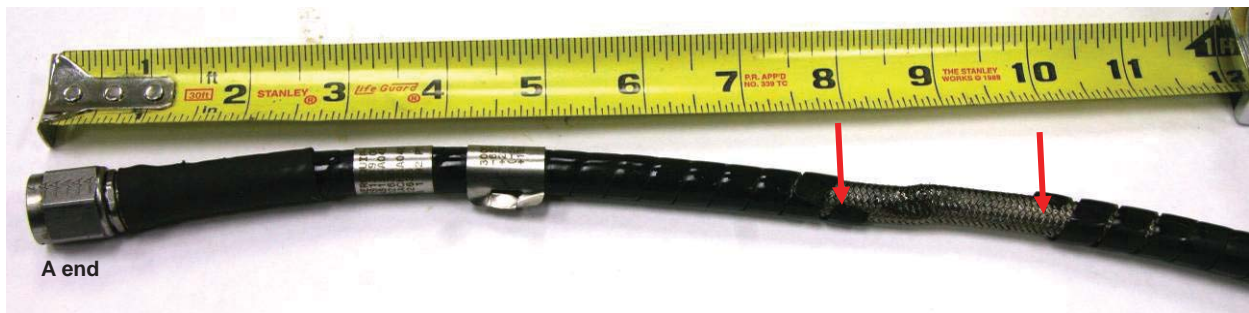
The hose was covered with a black spiral wrap, as required by the specification for hoses with an “S” suffix. A two-inch segment of the spiral wrap was missing approximately 8 to 10 inches from the “A” end of the hose; see Figure 17.

Figure 17: Missing spiral wrap.

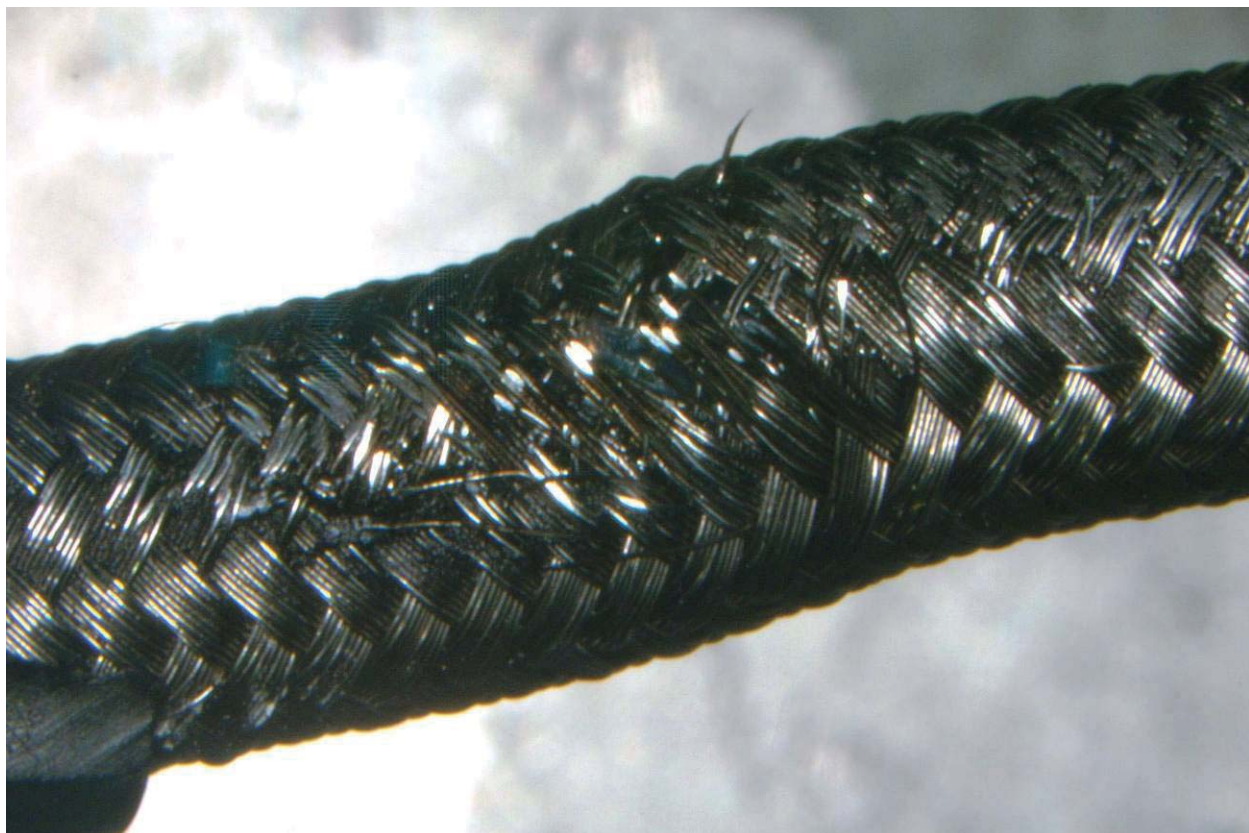
The CRES reinforcement wires in the area with no spiral wrap were worn in an oval shape running lengthwise along the hose. The damage extended approximately 1.25 inches in length. The worn area was widest in the center and tapered towards both ends; see Figure 18. Multiple CRES wires were worn through. In the center of the area where the CRES wires were missing a rupture in the polytetrafluoroethylene (PTFE) inner liner could be seen; see Figure 19. Some of the CRES wires were bent over in one direction; towards the “A” end of the hose. The hose was also slightly bent in the area of the damage as can be seen in Figure 18. A black substance was noted surrounding the rupture. The substance was soft but dense; see Figure 20

Figure 18: The damaged area to the CRES wires.

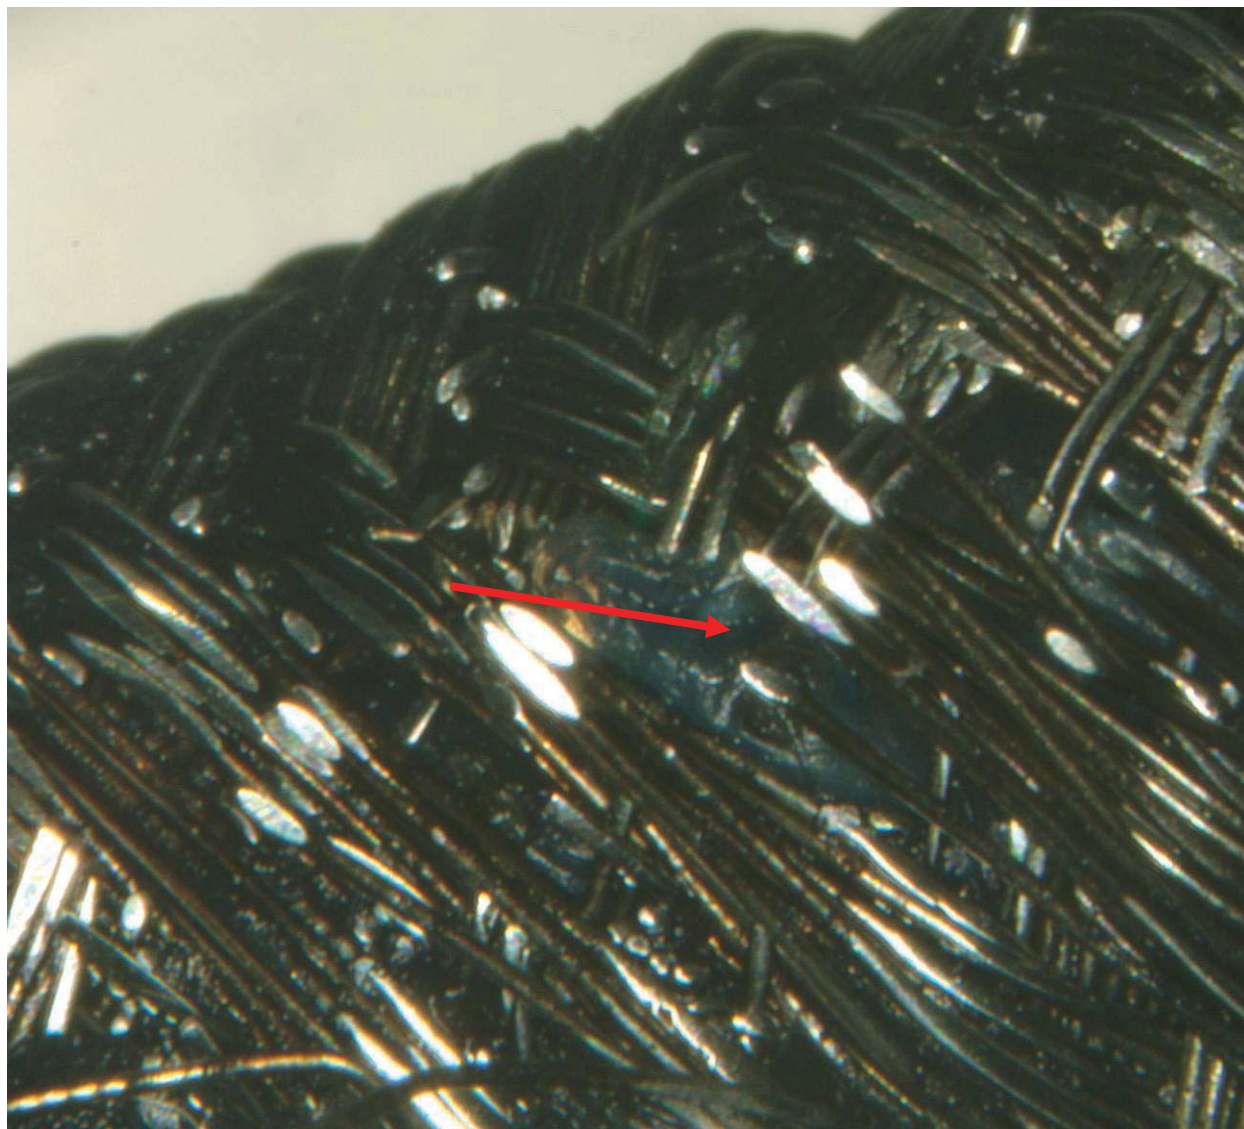
The BACH8A04EE-0263S hose assembly was found to have a rupture approximately 8.5 inches from the "A" end of the hose. The "A" end of the hose is the end with the identification tag attached. The rupture was coincident with section of missing spiral wrap and abrasion marks on the corrosion resistant steel (CRES) wire braids. The wire braids were also noted to be bent over towards the "B" end of the hose. A black substance was embedded in the CRES wires in and near the abrasion. Samples of the black material were extracted from the CRES braids and submitted to BR&T for analysis. The BR&T analysis concluded that the black material was consistent with a nose gear tire sidewall material. See Enclosure A for the full BR&T report.

Figure 19: The PTFE inner liner is ruptured in the area of damaged CRES wires. Note the ends of individual CRES wires are worn to a point.

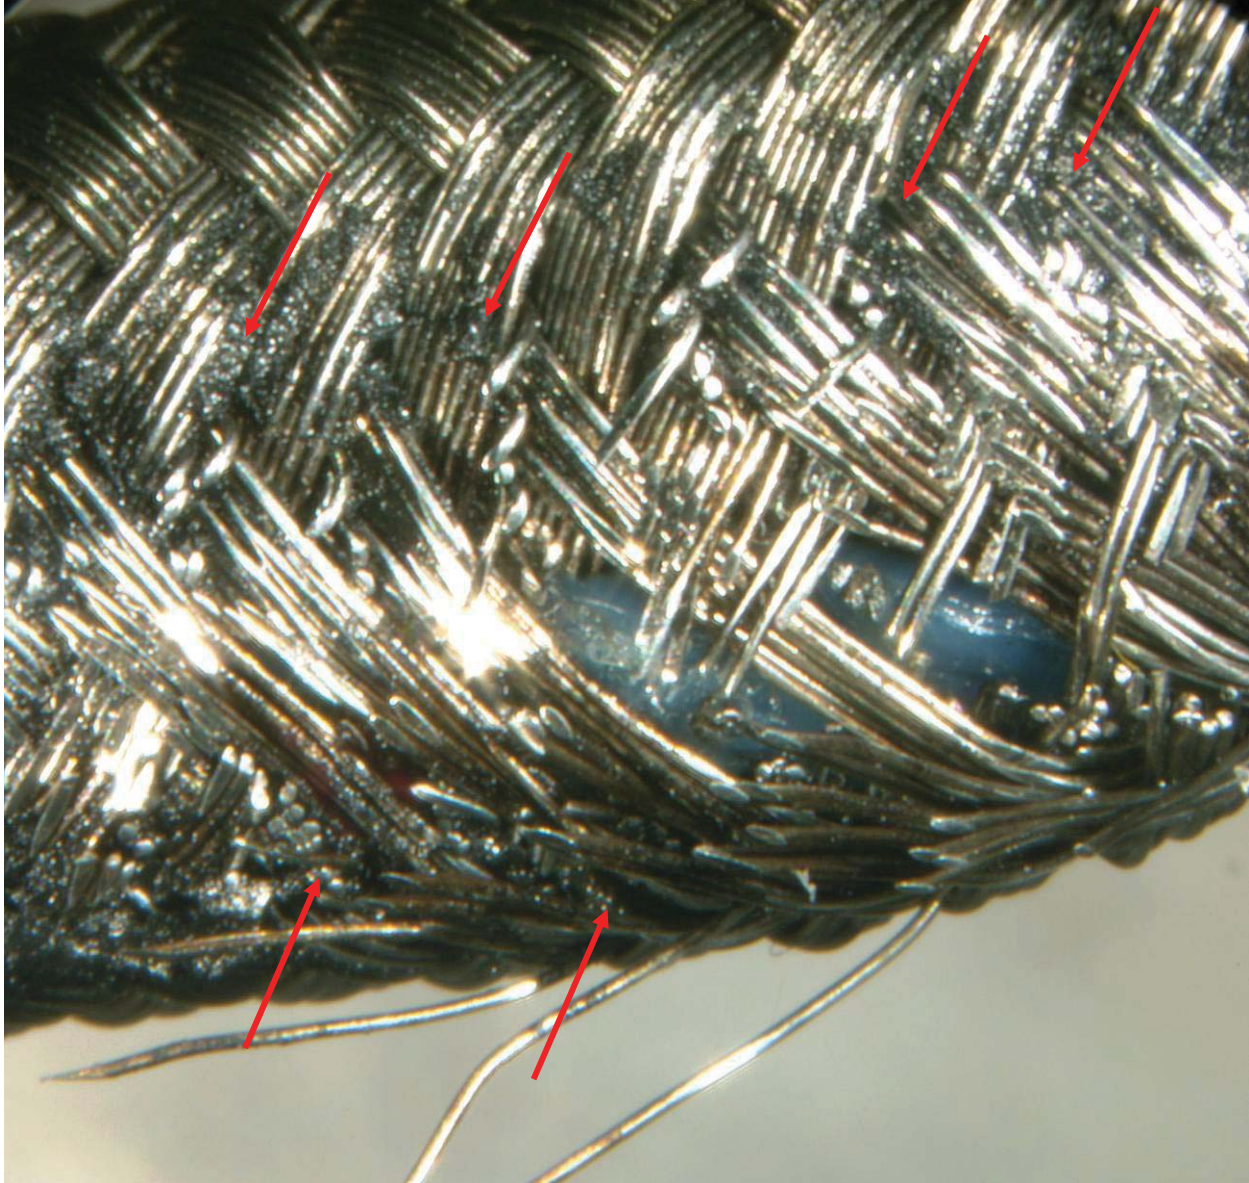
Figure 20: Black material surrounding the rupture. Also note the bent CRES wires.

Samples of the black material were collected and submitted to the BR&T Chemical Analysis group for identification. BR&T identified the material as being consistent with rubber from a tire sidewall. See Enclosure A for the full BR&T report.

The black material removed from the retract actuator hose assembly was analyzed by BR&T. The results of the BR&T analysis concluded that the material was consistent with a tire side wall material from an exemplar Goodyear 275K22-1/276K22T1 nose gear tire.

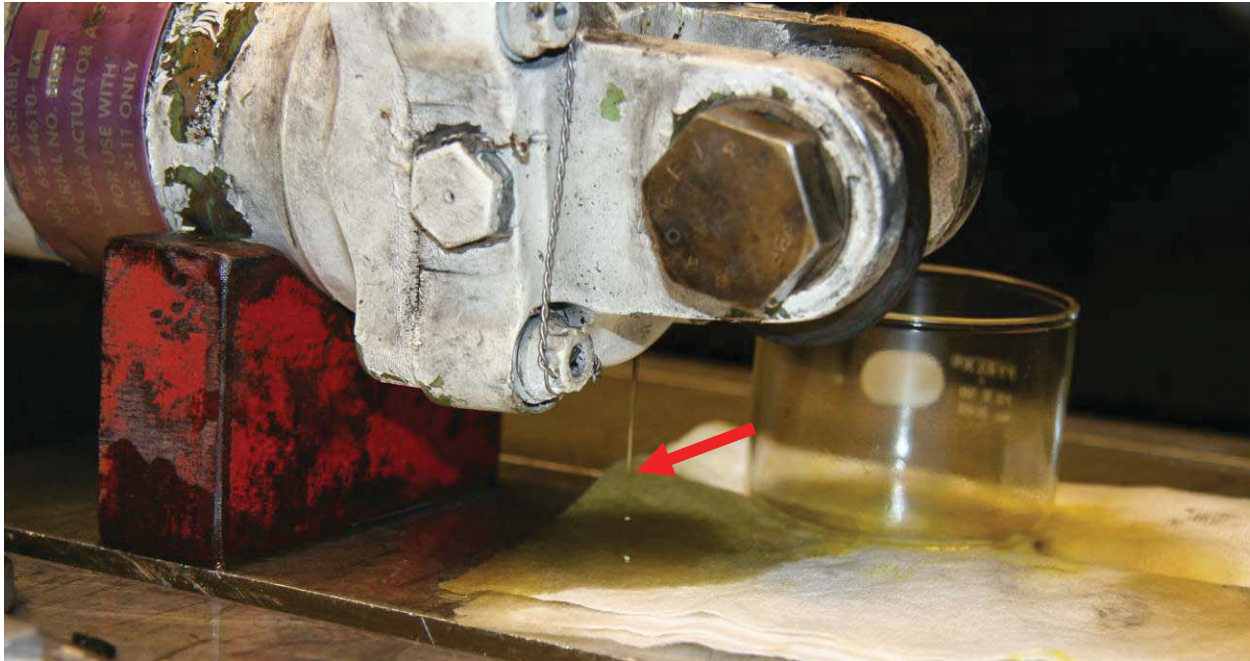
Based on a discussion amongst the participants of the analysis, additional testing beyond the CMM was conducted on the actuator. The actuator was extended as if in the gear retract position. Then, without hydraulic pressure applied, the gear retract hose was removed, which would be similar to opening the cylinder retract port to atmosphere, in an attempt to simulate a ruptured hydraulic hose. Leakage started as a drip and progressed as a steady stream; see Figure 21.

Figure 21: With the hose removed, the cylinder leaked at a full stream.

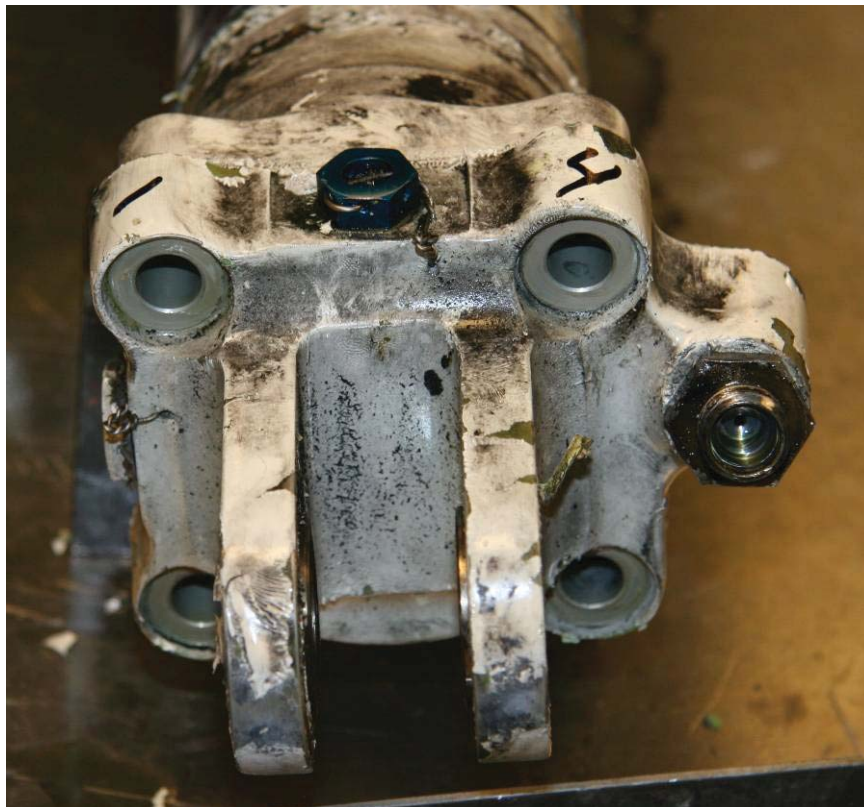
The eight bolts were removed (items 1 and 38) from the head (item 4) and the cap (item 36). The torque value required to loosen each bolt was recorded and is shown in Table II. The actuator was marked with a black felt marker adjacent to the bolts to identify where they were removed from; see Figure 23 showing the head end. All eight bolts were in good condition. The parts were unremarkable.

Figure 23: Bolts removed from head (item 4) end. Bolt locations are marked in counter-clockwise orientation.

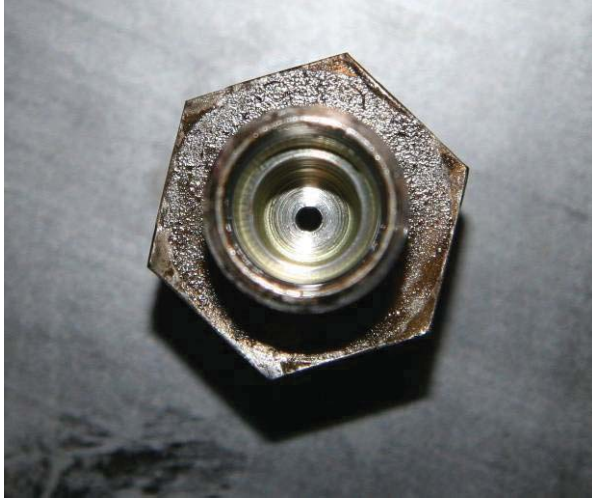
the 25 cycles called out in item 3. The actuator appeared to function normally and snubbing was observed in both directions. During disassembly of the unit, it was found that the 66-22711-1 restrictor had been installed where the MS21902-6 union should have been installed and vice versa.

The fitting was removed from the head end. It was noted that the fitting had a restricted orifice; see Figure 24. Per the IPL, the fitting in the head should have been a non-restricted union. The fitting installed in the cap was removed. A visual examination of

the fitting noted that it was a restrictor fitting. An examination of the fitting under magnification found a vibro-engraved part mark on the fitting; 66-22711-1. The orifice was measured using pin gages; the orifice measured 0.070 inch which is correct for the 66-22711-1 restrictor. Per the IPL, the non-restricted union should be installed in the cap.

Figure 24: Restrictor fitting installed in the head end.

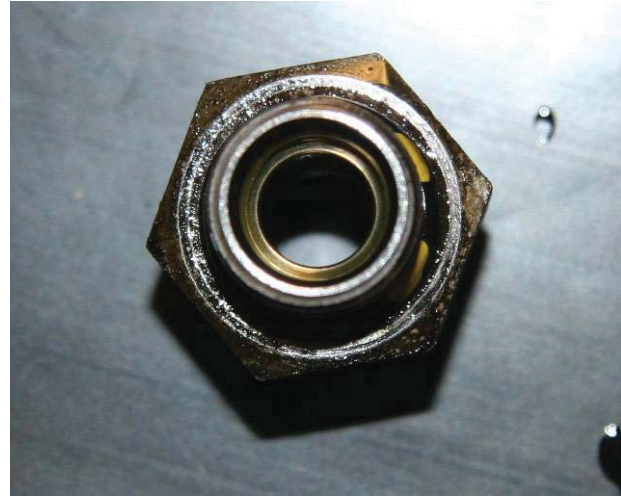
The fitting from the cap end was removed. The fitting removed was not a restricted fitting; see Figure 25. Per the IPL, the 66-22711-1 the restrictor fitting should be installed in the cap.

Figure 25: Union fitting installed in cap end.

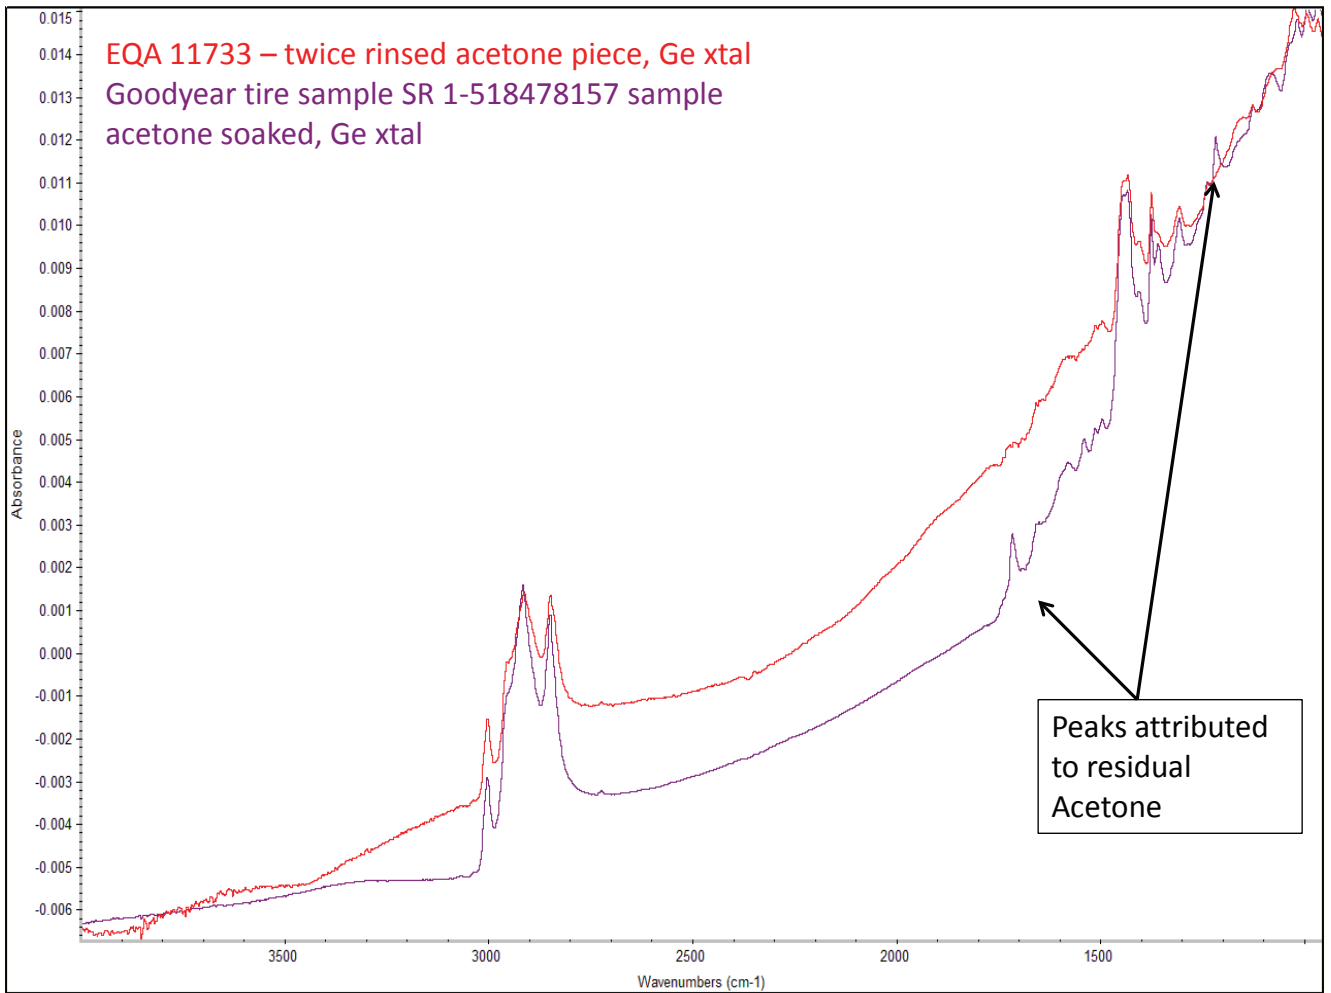
FTIR comparison of the reference nose gear tire material and the EQA 11733 sample material indicates the materials are consistent. EPMA data also indicates common elements between the reference material and the samples; there are no elements contained in the reference material that are not contained in the sample material. The sample contains additional elements, however environmental exposure may explain the presence of those elements. EPMA scans of the surface of the black spiral wrap on the outside of the braided wire are very similar to the EQA 11733 samples material, while internal scans indicate the material does not contain any inorganic fillers. This suggests similar environmental exposure which accounts for additional elements observed on the EQA 11733 samples

Figure X. FTIR comparison between EQA 11733 dark spongy material and Goodyear tire sidewall reference sample

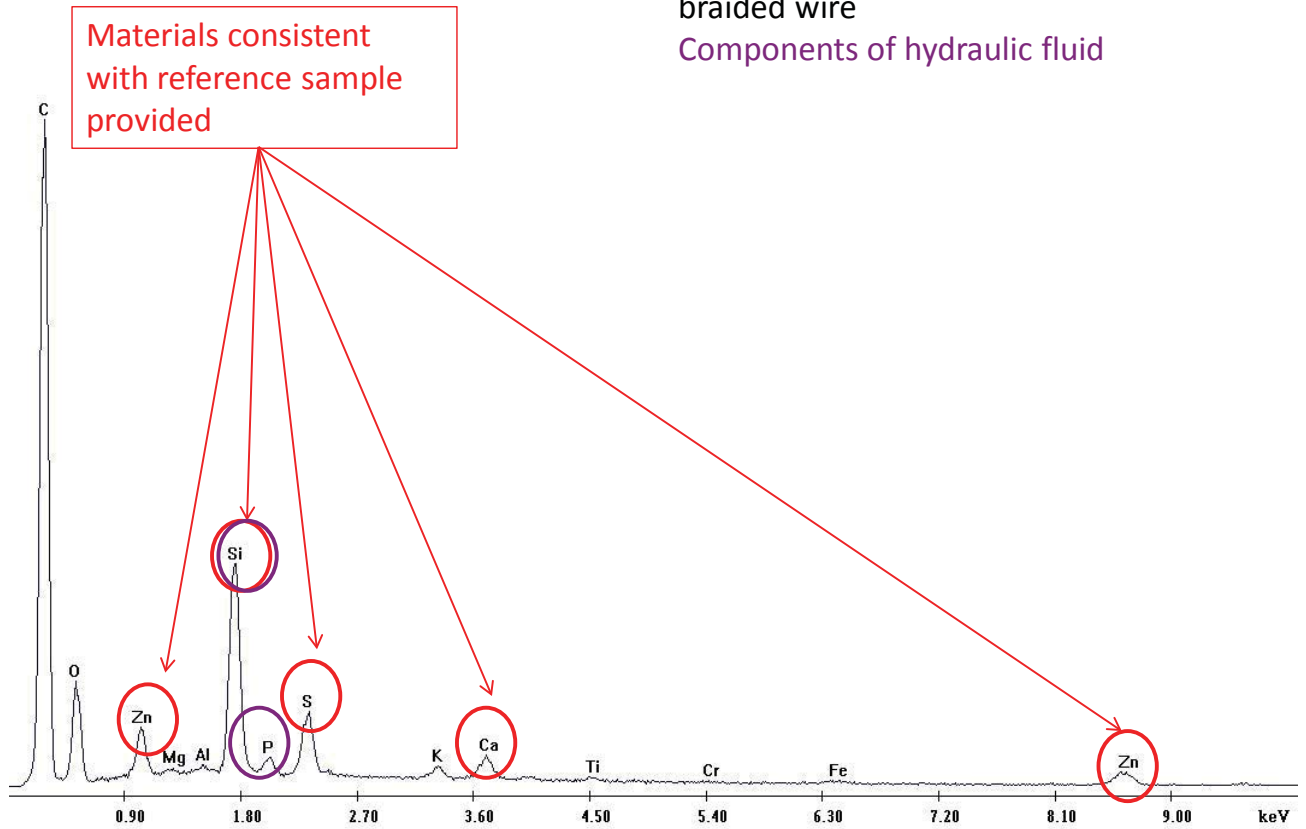
Figure X. EPMA scan of acetone rinsed particle, indicating similarities to the reference material

The dark spongy material recovered from the hydraulic fluid line was analyzed and compared to nose gear tire side wall reference material provided. FTIR and EPMA analysis indicate the dark spongy material is consistent with the nose gear tire side wall reference material provided.
