**Submission of CFM International
To the National Transportation Safety Board**

**Accident Involving
Southwest Airlines Flight 1380
17 April 2018**

NTSB Public Docket: DCA18MA142

July 17, 2019

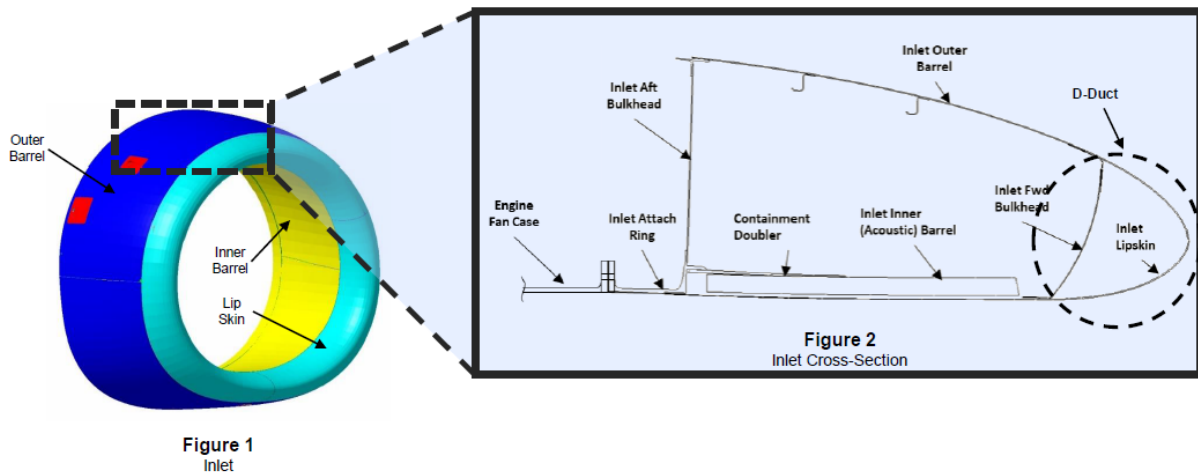
Figure 5 : Inlet structural overview¹²

inlet using a containment doubler in the inner barrel of the inlet. They also stiffened the inlet attach ring as well and increased its axial length (See Figure 5).

CFM shared the fan blade fragmentation test results with Boeing. The containment doubler on the inlet designed by Boeing and UTAS was intended to contain the fan blade tip fragment since testing revealed it to be the highest energy, forward traveling fragment.

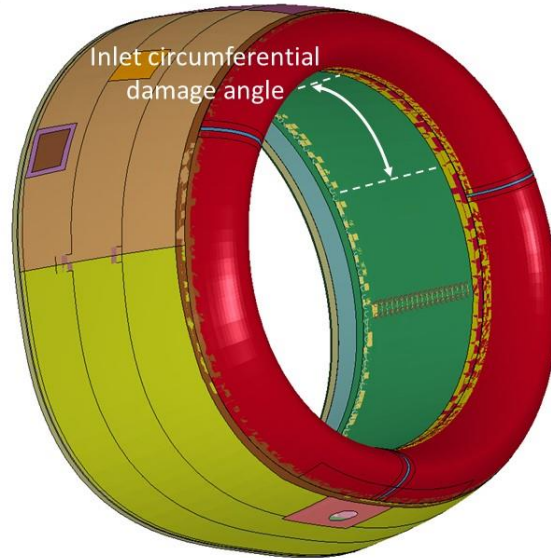
Figure 6 : inlet circumferential damage angle definition

A mid-span fragment subsequently passed through this penetration area, which is demonstrated by the markings on the hardware.

Additional inner barrel backskin damage cited in the Structures Report as located in the 11:30-12:45 o'clock (ALF) zone²⁶ is not supported by the physical evidence. There is no radial outward deformation, no radial crushed honeycomb, or trajectory markings in this zone.²⁷ The condition of the inlet in areas away from the 10:30-11:30 o'clock (ALF) zone is likely due to the tearing from the applied inlet loads. Microscopic traces of Titanium existing on the separation plane cannot be conclusively attributed to fan blade high energy fragments as there are other sources of Titanium including the inlet forward bulkhead, which after the inlet separated, likely impacted the separation surface.

CFM inlet damage analysis supports the inner barrel back skin damage from primary blade fragment penetration is limited to 30 degrees (10:30 to 11:30). Data does not support that fan blade fragment created damage beyond 30 degrees to the inner barrel back skin.

CFM, as part of the Structures Group, agreed with a circumferential 70-degree penetration damage level as a starting value to permit Boeing to launch the Progressive Failure Analysis. CFM further analysis of the physical evidence gathered during the course of this investigation does not support the initial 70-degree assumption adopted by the Structures Group Team. The evidence supports, at most, 30 degrees of circumferential damage.

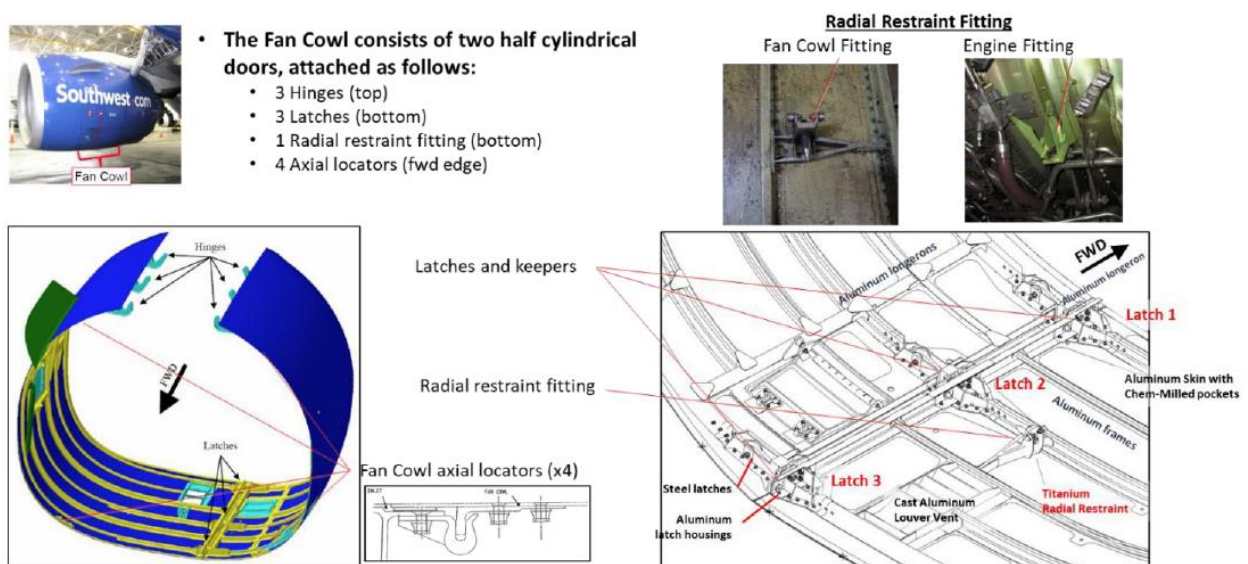
Figure 7: fan cowl structural overview²⁹

- a) For the fan cowl, the displacement wave transmitted loads and energy into the fan cowl via its radial restraint feature (see Figure 7):

This behavior was different than the original assumption used by Boeing/UTAS at the time of the airplane certification. It was assumed then that the radial restraint fitting would fail prior to transmitting high loads to the fan cowl.³⁰ In the Flight 1380 event, the loads were

sufficient to initiate cracking at corners of the vent cutout which then propagated into the fan cowl skin, which resulted in portions of the fan cowl being liberated.

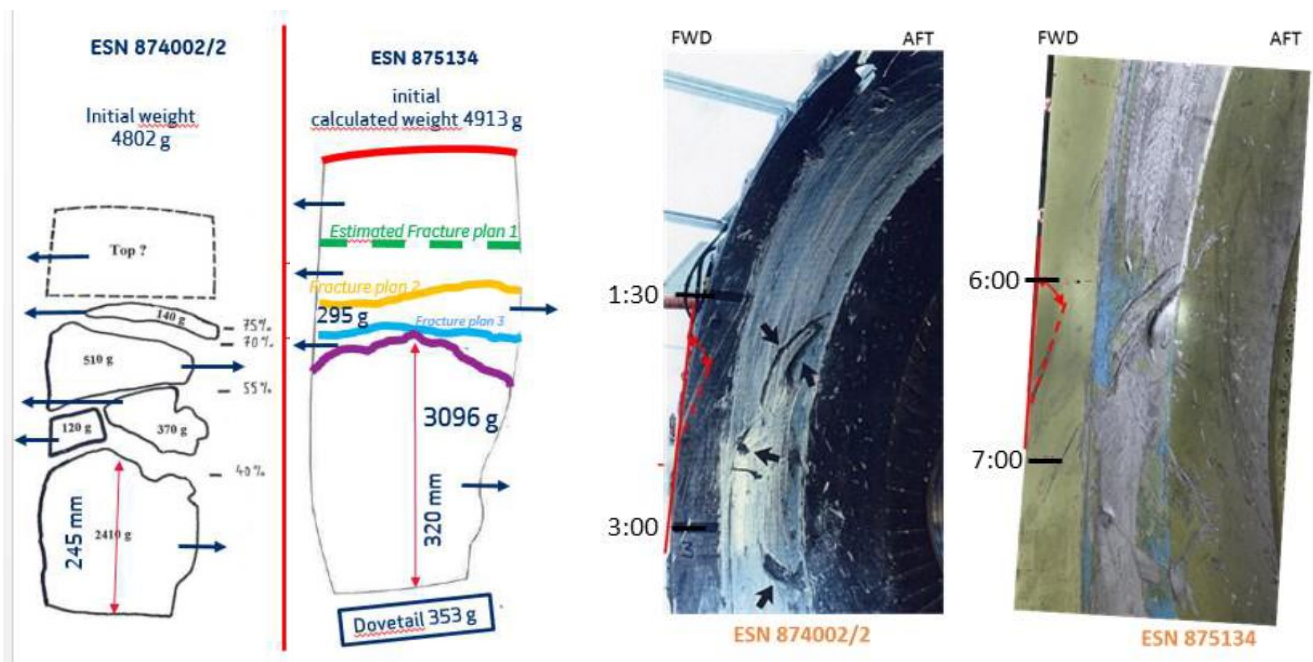
Figure 8 : CFM56-7B fan blade fragmentation and tip fragment imprints at A1 flange – Certification experience versus Flight 1380 event³³

The fan case impact pattern (based on marks, physical evidence on the fan case, and recovered blade fragments) of the Flight 1380 event is very similar to the pattern observed after certification test 874 002/2. The angular position of the impact varied because of the location of the released blade (see Figure 8– ESN 875134 refers to Flight 1380). The impact pattern was located at 6:30 o'clock position for Flight 1380 due the fan blade release angle estimated at 3:30-4:00 o'clock (ALF). For certification test 874-002/2, the fan blade release angle was 12:30 o'clock and the resulting impact pattern was between 3:00 and 3:30 o'clock (ALF).

The fragmentation (quantity and mass) and direction of the fragments in the Flight 1380 event were very similar to the fragmentation and direction of the fragments during the FBO certification test. In the 874-002/2 certification test (performed with Boeing’s type design production inlet), three mid-span fragments and the tip fragment exited forward of the A1 flange with the root panel fragment and one mid-span fragment exiting aft (see Figure 8).

In terms of fragment trajectory, there was a slight difference in helix angle at the exit of the fan case between the certification test and the Flight 1380 event. During certification test, the tip fragment edge crossed A1 flange with an angle of 15°. Continuous marks observed on fan case and inlet suggest that the tip fragment center of gravity (CG) had same trajectory as tip fragment edge.³⁴

In the Flight 1380 event, the blade tip fragment edge crossed the plane of the A1 flange at an approximate helix angle of 15 degrees but the tip fragment center-of-gravity trajectory was at a slightly higher helix angle (~20 degrees). This somewhat higher CG helix angle, and/or the impact on the A1 flange inlet lip, may have caused the tip fragment to travel forward of the containment doubler which did not occur in the certification test.

In the Flight 1380 event, the fan blade tip fragment penetrated the inlet inner barrel back skin and the generated damage propagated under subsequent displacement wave and flight loads.³⁵
