**INTERIM REPORT 12 NOVEMBER 2019 ON THE INVESTIGATION INTO THE LOSS
OF PROPULSION AND NEAR GROUNDING OF VIKING SKY, 23 MARCH 2019**

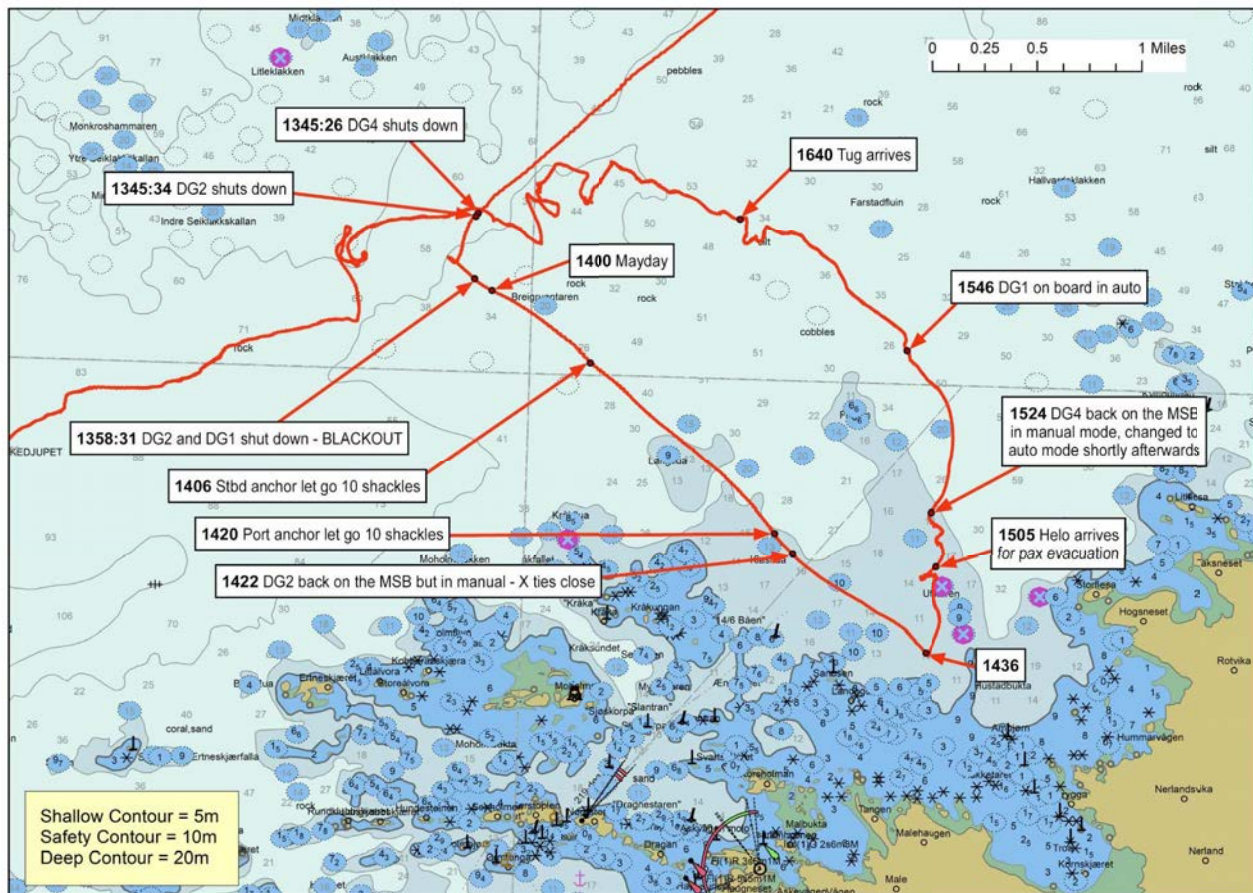
Figure 1: Sequence of events. Source: MAIB

On the morning of 23 March, between 0500 and 0904, 18 lubricating oil low level and low volume alarms were registered by the operational DGs. Each alarm, having been accepted, cleared within a few seconds.

No more alarms were registered until 13:37:04 when DG4 registered an alarm indicating that the DG was shedding load as a result of low lubricating oil pressure. A few seconds later it registered a low lubricating oil pressure alarm. At 13:39:52, DG1 registered a low low lubricating oil sump level alarm. A little over five minutes later, at 13:45:26, DG4 shut down followed by DG2 eight seconds later. DG2 was restarted after approximately 11 minutes, but shut down again along with DG1 at 13:58:31, causing a complete blackout and loss of propulsion.
