NATIONAL TRANSPORTATION SAFETY BOARD

Group Chairman's Factual Report

OPERATIONAL FACTORS

ANC15FA049

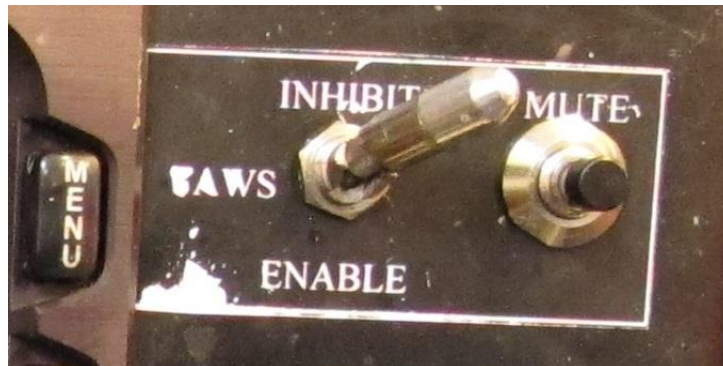
functions is desired. The TAWS inhibit switch on the accident airplane was found in the “inhibit” mode at the accident site.

Figure 1: Photo of TAWS inhibit switch as found at accident site
