Subject: Boeing Submission for FedEx MD-10-10F N370FE Left Main Landing Gear
Collapse at Fort Lauderdale, Florida - 28 October 2016

Submission to the
National Transportation Safety Board
for the

**FedEx MD-10-10F N370FE
Left Main Landing Gear Collapse at
Fort Lauderdale, FL
28 October 2016**

**The Boeing Company
27 April 2018**

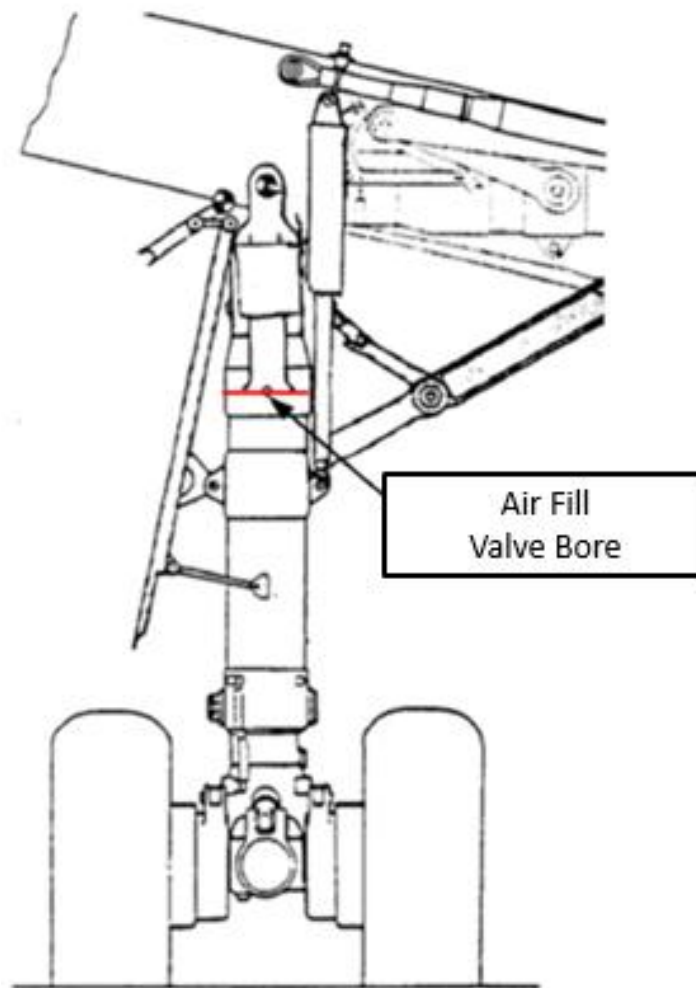
On-site post-accident inspection found the left main landing gear cylinder had fractured around its entire circumference and the fracture was noted to pass midway through the air fill valve bore's boss. The upper portion of the cylinder remained attached to the airplane at the forward and aft trunnion lugs. The lower portion of the cylinder, and the landing gear's piston, remained attached to the airplane by the side braces. Three pieces of the left main landing gear's outer cylinder were found on the runway. Two of these pieces were from the air fill valve bore's boss.

**Left Main Landing Gear Looking Forward
Red Line Indicates Fracture Location**

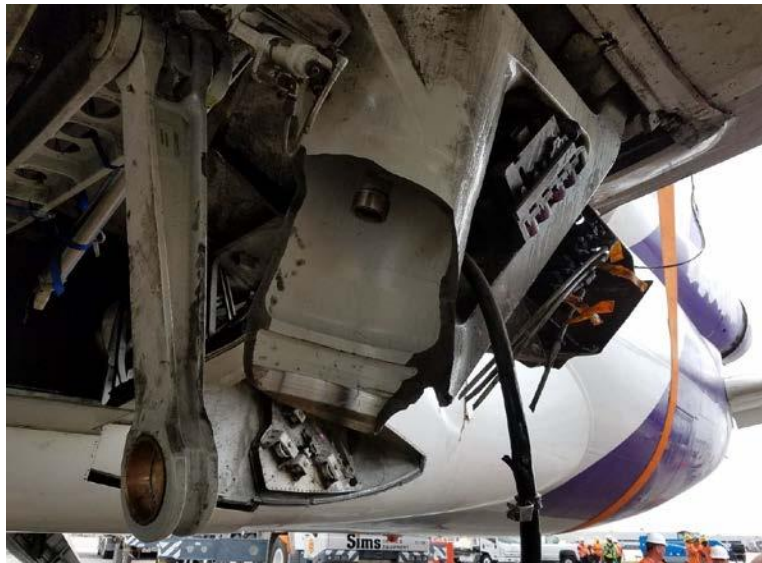
**Upper Portion of Left Main Landing Gear Cylinder Attached to the Airplane
(looking aft and inboard)**

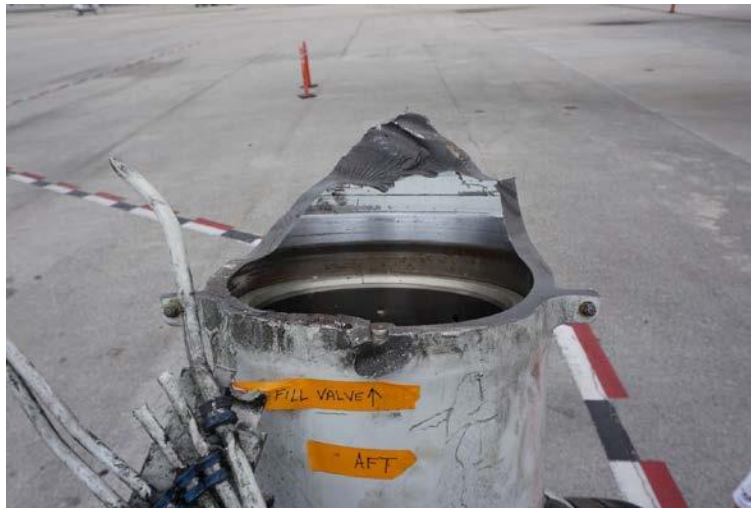
Aft Side of Lower Section of Left Main Landing Gear Cylinder and Air Fill Valve Bore

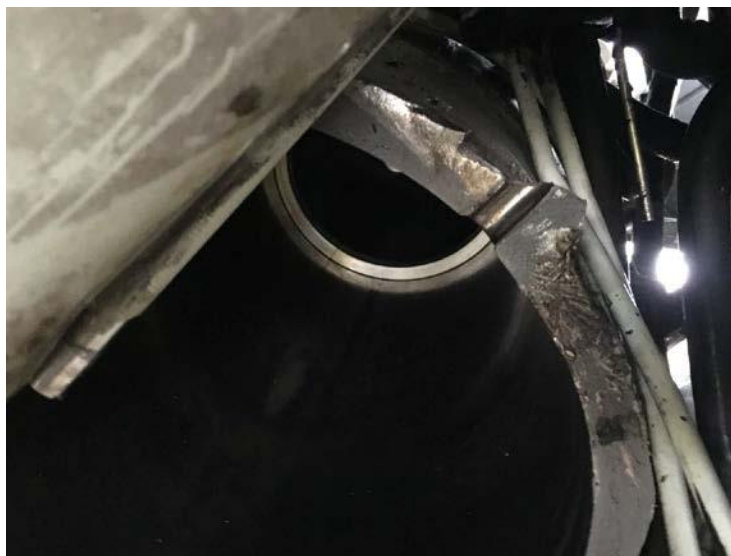
Fracture Surface on the Lower Section of the Left Main Landing Gear Cylinder

The recovered pieces of the left main landing gear cylinder were examined in the laboratory. Almost all of the fracture surfaces exhibited a dull luster with a rough surface, with radial lines and chevron marks. These features were consistent with overstress fracture in low ductility (hardened) metal alloys. These features were consistent with the fracture originating at the air fill valve bore on the landing gear. At the bore location was a flat, thumbnail-shaped crack. This feature was consistent with a pre-existing crack prior to complete fracture of the landing gear.³ All of the overstress features were consistent with having emanated from the thumbnail crack near the bore.⁴

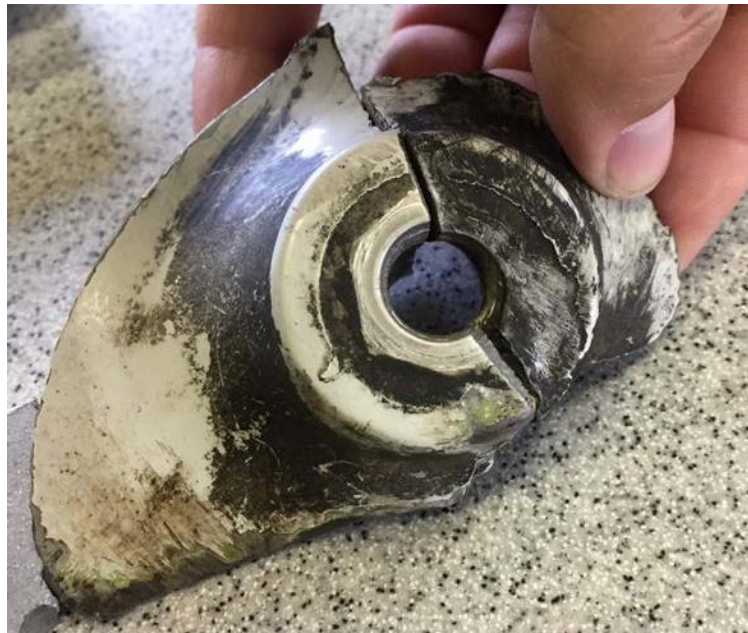
Air Fill Valve Bore Boss Pieces Recovered From Runway

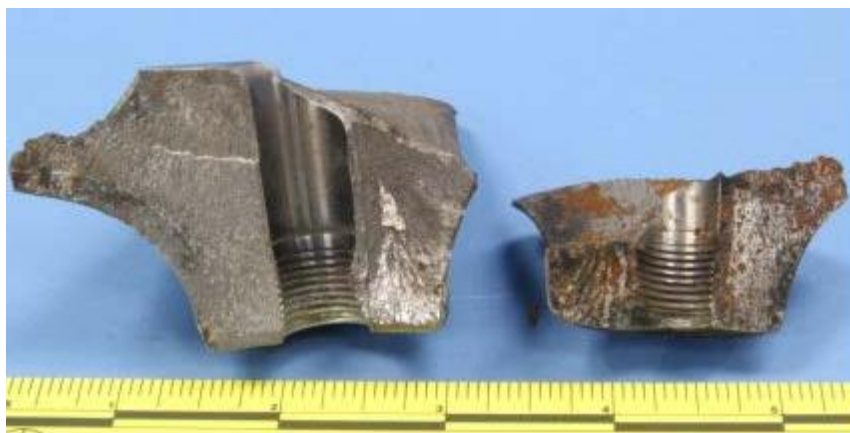
When used for corrosion protection, cadmium is sacrificed to protect the base metal. Therefore, in environments prone to corrosion, cadmium is lost to corrosion over time and may eventually not be present on the base metal. When that occurs on a part manufactured from 300M steel, base metal corrosion will be observed as red rust. The amount of time required for the cadmium to corrode is directly related to the corrosiveness of the environment to which the cadmium is exposed. Red rust in the air fill valve bore was not noted in the laboratory analysis and very little red rust was found in photographic evidence from the laboratory.

Picture of Two Pieces with Air Fill Valve Bore Taken In Laboratory
