**HIGHWAY FACTORS GROUP CHAIRMAN'S
FACTUAL REPORT**

HWY18FH011

**NATIONAL TRANSPORTATION SAFETY BOARD
OFFICE OF HIGHWAY SAFETY
WASHINGTON, D.C.**

Location: Southbound US Highway 101 (US-101) south of North Shoreline Boulevard at the exit ramp transition to State Route 85 (SR-85), milepost 48.38, Santa Clara County, Mountain View, California.

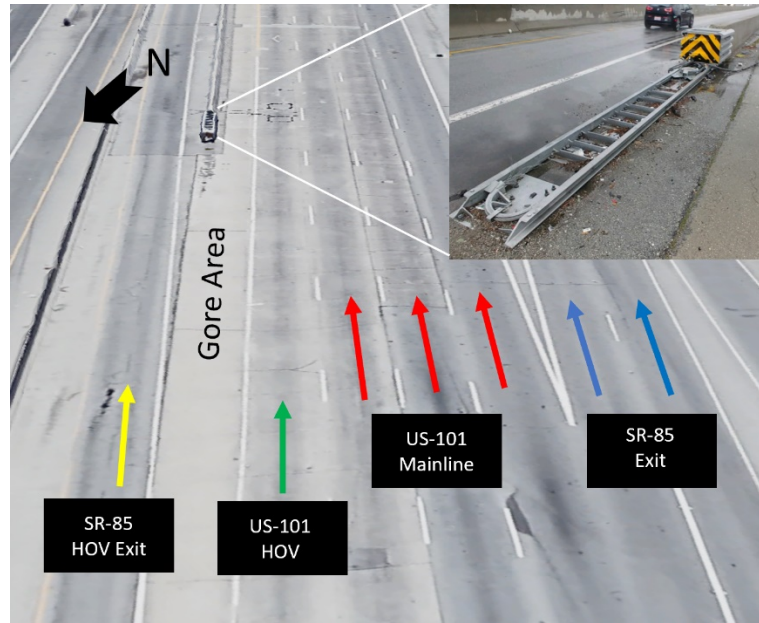
Figure 1B – Depiction of travel lanes and gore area at US-101–State Route 85 interchange. The crash cushion was damaged on March 12, 2018 and had not been repaired at the time of the crash. (Source: Google Earth, image date March 28, 2018. The inset photo was taken by Caltrans on March 20, 2018 – 3 days before the crash)

⁴ The SCI1000 GM impact attenuator is manufactured and marketed by Work Area Protection Corporation. On the date of the crash, the crash cushion was non-operational due to prior damage sustained in a crash on March 12, 2018.

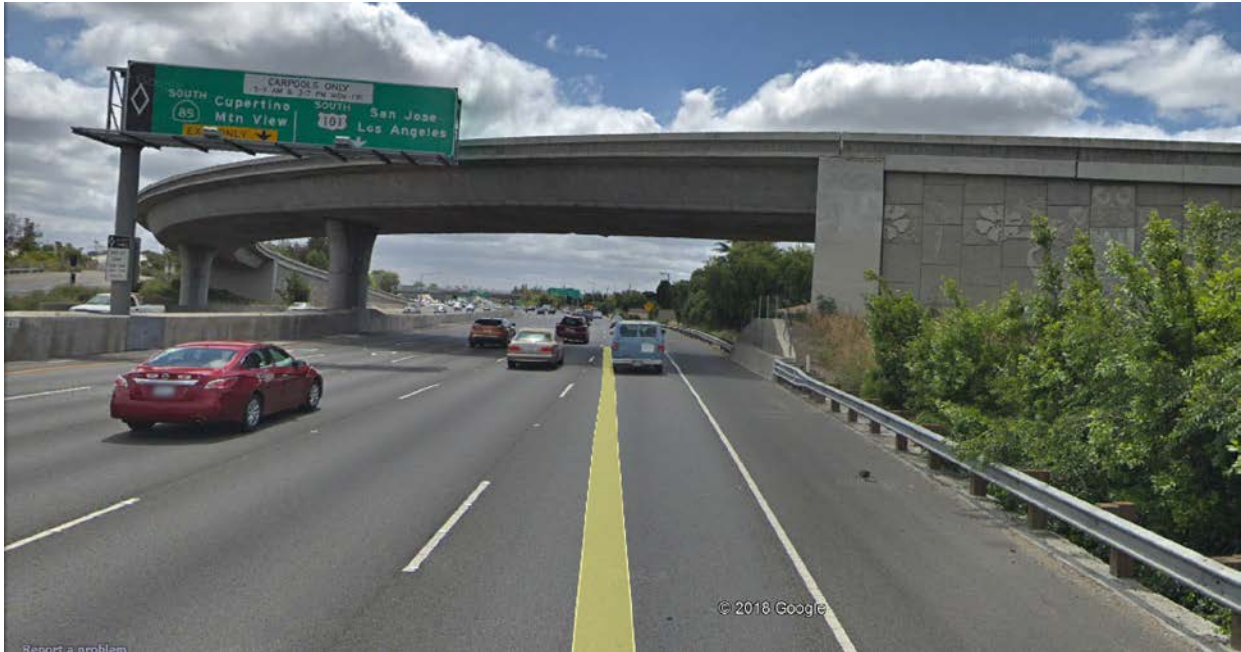
Figure 2A – This guide sign was in the median of US-101 southbound at milepost 48.98 about 0.60 miles north of the crash location (Source: Google Maps Street View image from March 28, 2018).

¹¹ Guide signs depicted in figures 2A and 2B were also out of compliance with the MUTCD requirements pertaining to left exit plaques. The fact that the signs were out of compliance does not mean that this condition contributed to the cause of the crash.

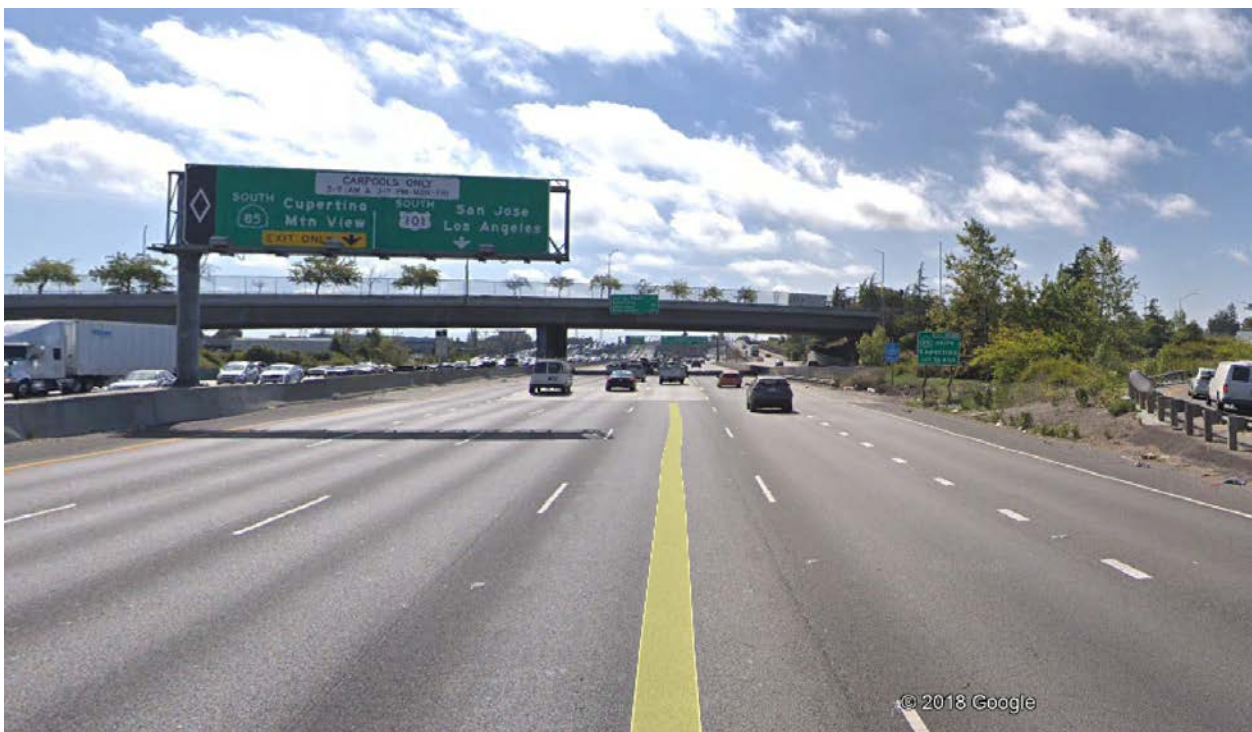
Figure 2B – This guide sign was in the median of US-101 southbound at milepost 48.67 about 0.29 miles north of the crash location (Source: Google Maps Street View image from March 28, 2018).

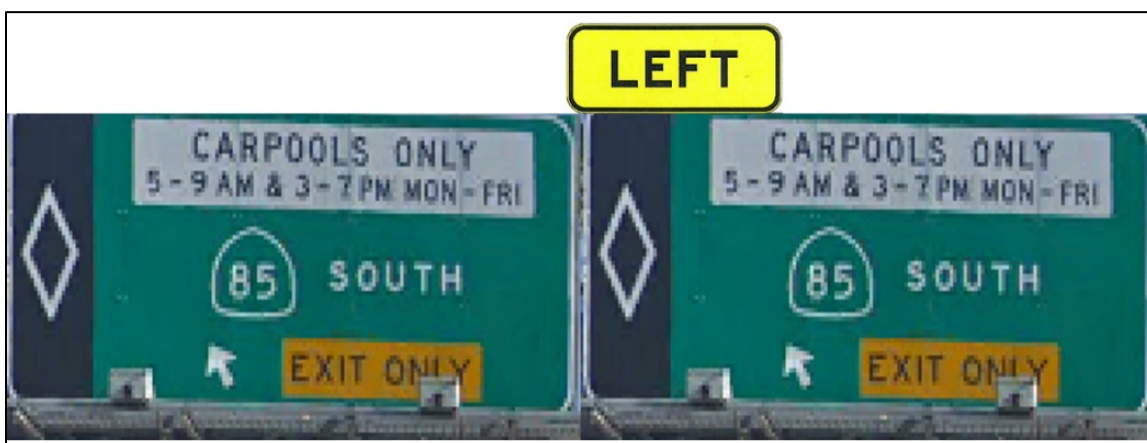
The FHWA acknowledged that left-side exits, in general, tend to violate driver expectations because of their infrequency.¹⁰ In 2009, the FHWA revised the *MUTCD* and included new standards pertaining to left exit and preferential lane signage. The compliance date for the ruling was December 21, 2014. As shown in the left image of figure 2E, the sign for the left exit HOV lane for SR-85 was not in compliance with the *MUTCD* standard for left exit plaques; the “LEFT” plaque should have been added to the top of the sign by December 21, 2014.¹¹ Figure 2F is a graphic from the California *MUTCD* depicting an example of advance guide signs and exit direction signs at a left HOV exit.

Figure 2E – Sign for left exit HOV lane at crash location (left) and example of compliant sign with required “LEFT” plaque (right).

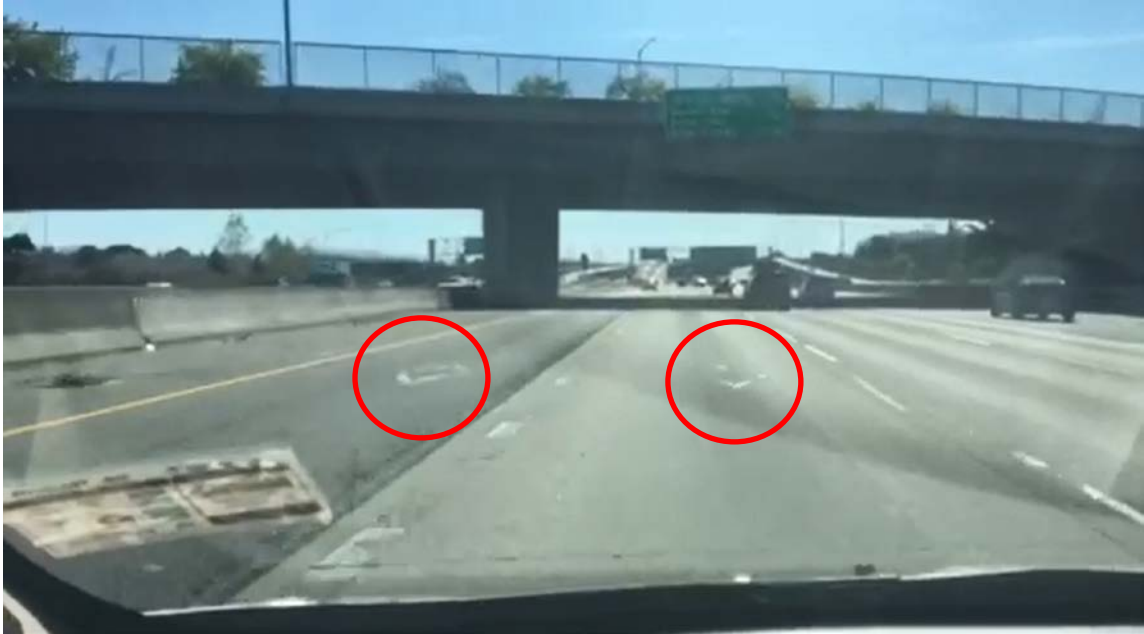
Figure 3C – Still image from video drive through at 1,365 feet from crash cushion. The painted HOV diamond symbols (circled in red) designating the two left lanes were faded and partially obliterated.

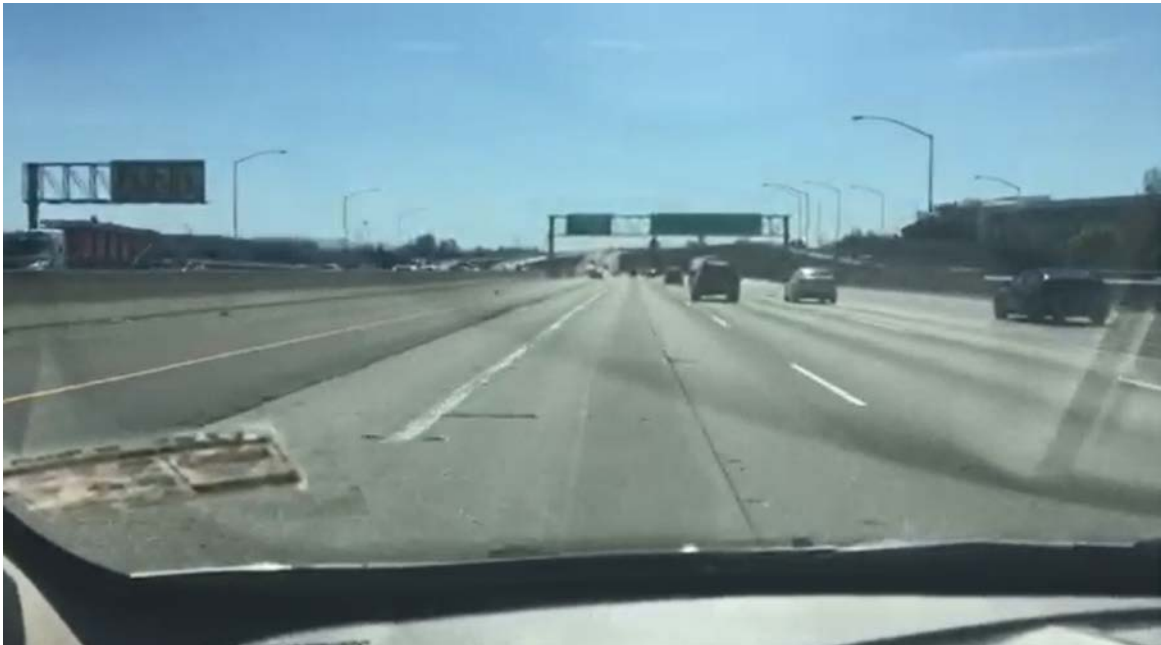
Figure 3D – Still image from video drive through at 950 feet from crash cushion. The beginning of the 8-inch wide solid white line can be seen in this image. Portions of the white line are faded with paint obliterated.

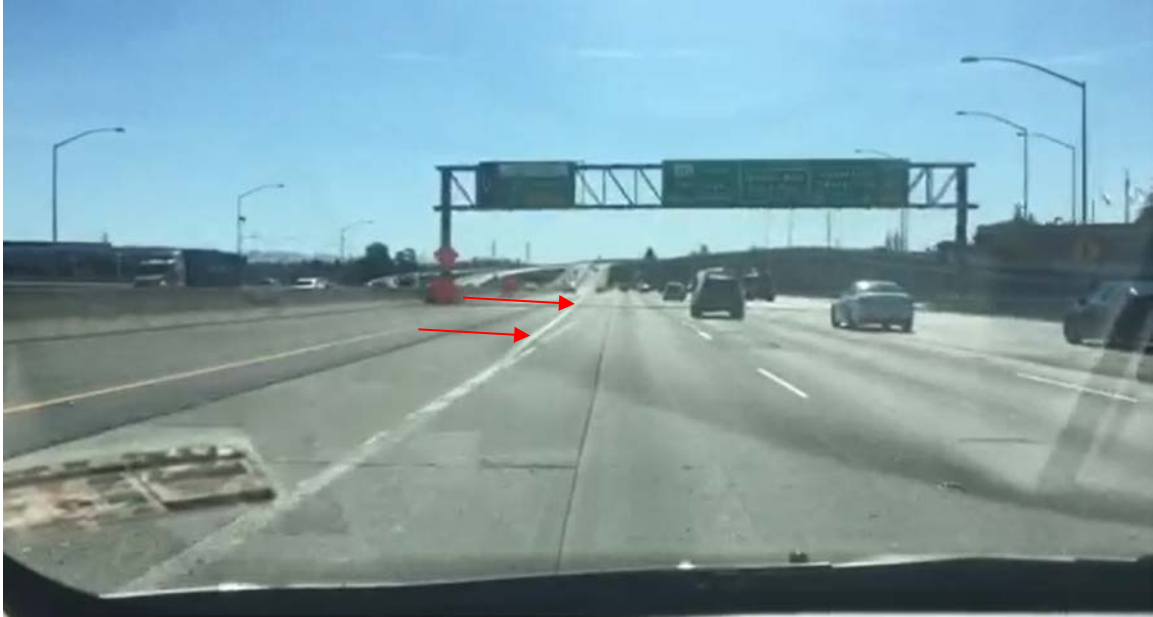
Figure 3E – Still image from video drive through at 685 feet from crash cushion. During the drive through the 8-inch wide solid white channelizing line (designated with red arrows) marking the left side of the gore area was the most prominent and visible.

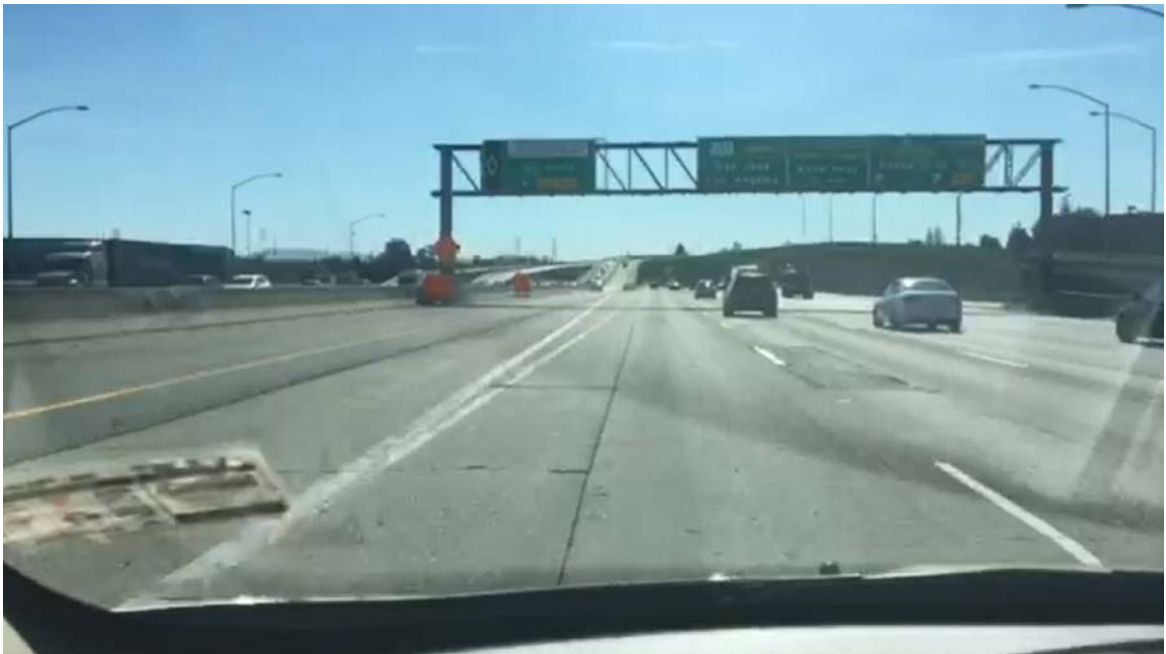
- 1,540 feet from the crash cushion: standard 4-inch wide painted broken white lane lines separating the two left HOV lanes transition to 8-inch wide painted broken white lane drop markings.¹⁵ The lane drop pavement markings continue for about 600 feet and provide information to motorists that the leftmost HOV lane is not a through lane and exits at the interchange ahead (see figure 3A and 3B).
- 940 feet from the crash cushion: the lane drop markings transition to an 8-inch wide solid white line.¹⁶ The solid white line continues for about 310 feet until it reaches the apex (bifurcation) of the gore (see figure 3D).
- 630 feet from the crash cushion: the solid white line bifurcated into two 8-inch white channelizing lines which formed a gore area. The neutral area (inside area) of the gore was not marked with optional diagonal cross-hatching or chevrons (see figure 3F).

Figure 3F – Still image from video drive through at 630 feet from crash cushion. The 8-inch wide solid white channelizing line marking the left side of the gore area was the most prominent and visible.

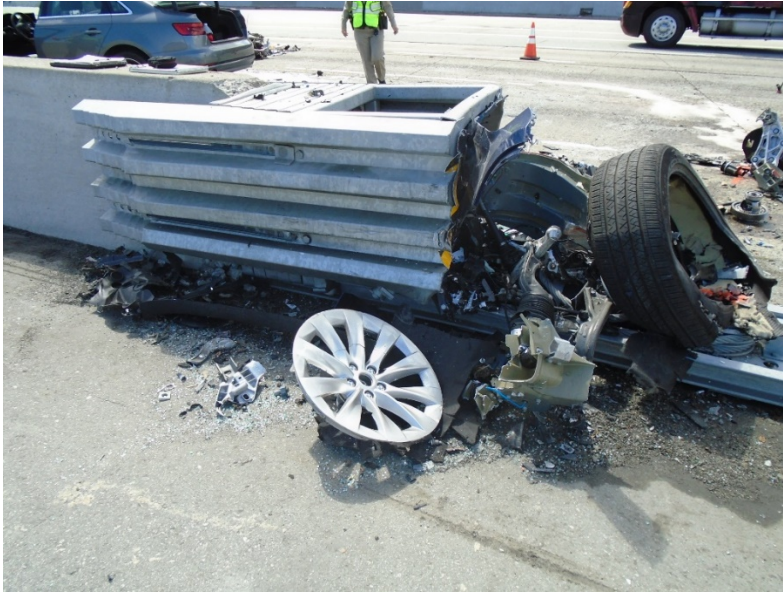
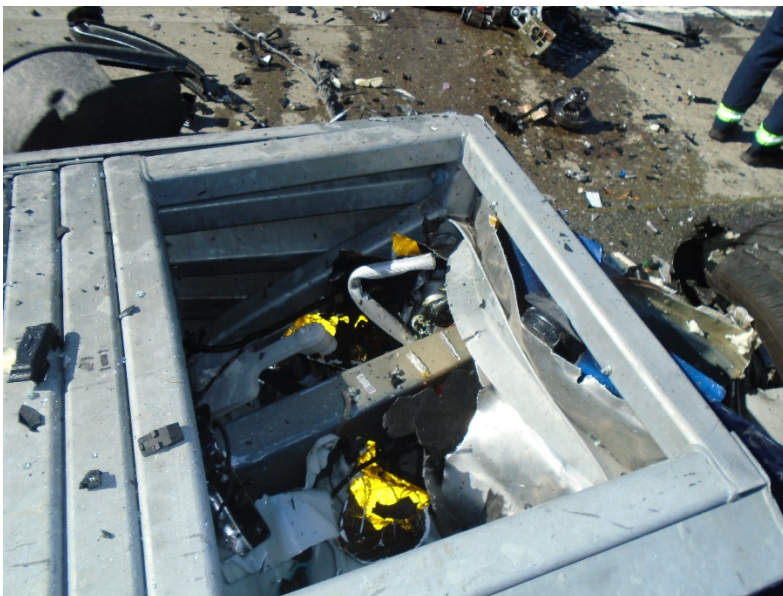
Following the crash, the crash cushion was fully compressed. The front delineator panel (with attached retroreflective object marker) and the sliding sled was compacted in an accordion-like manner over the seven collapsible bays to about 36 inches from the concrete median wall. Following the crash, Tesla Model X vehicle components were lodged inside the object marker and the hollow interior section of the crash cushion (see figures 6C and 6D).

Figure 6C – Postcrash picture of damaged crash attenuator with Tesla vehicle components lodged inside of the hollow interior section of the crash cushion.

Figure 6D – Postcrash picture of damaged crash attenuator with Tesla vehicle components lodged inside of the hollow interior section of the crash cushion.

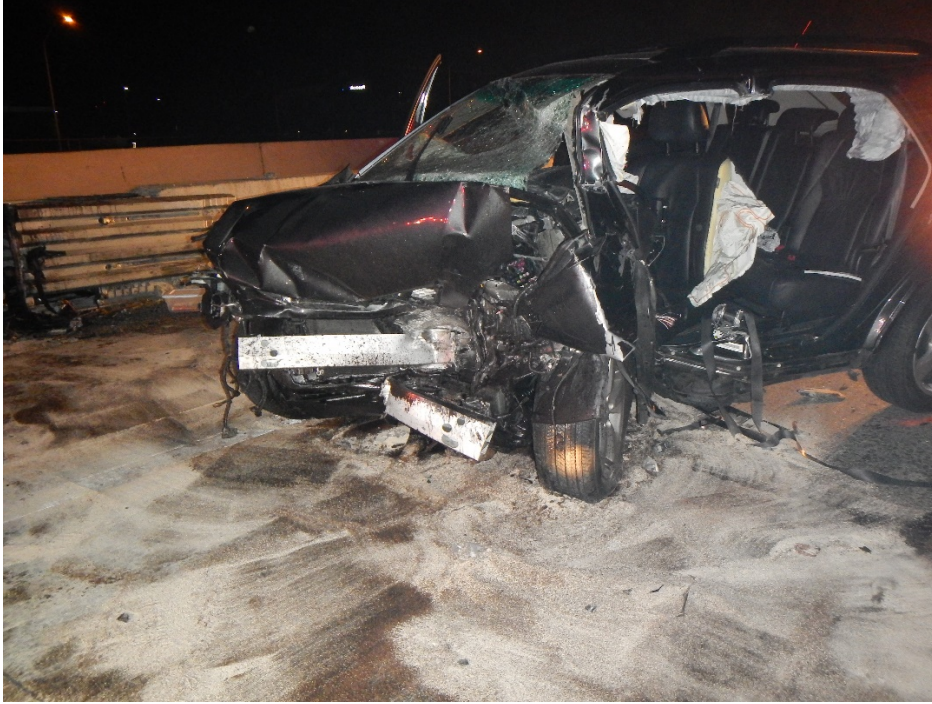
NTSB investigators reviewed the circumstances of this crash and determined that the SCI SmartCushion® SCI100GM crash cushion at the location was non-operational at the time of the collision due to being compromised (compressed) in a prior collision. Additionally, the crash cushion was missing its black and yellow retroreflective object marker at the end of the attenuator. The precrash damaged condition of the crash cushion was not reported in the CHP Traffic Collision Report 9330-2015-3996. After the crash, the crash cushion was replaced on December 23, 2015 (39 days after the crash).

Figure 7A – Postcrash picture of 2008 Lexus SUV on November 14, 2015, after colliding with non-operational crash cushion on US-101 southbound at the exit ramp transition to SR-85.

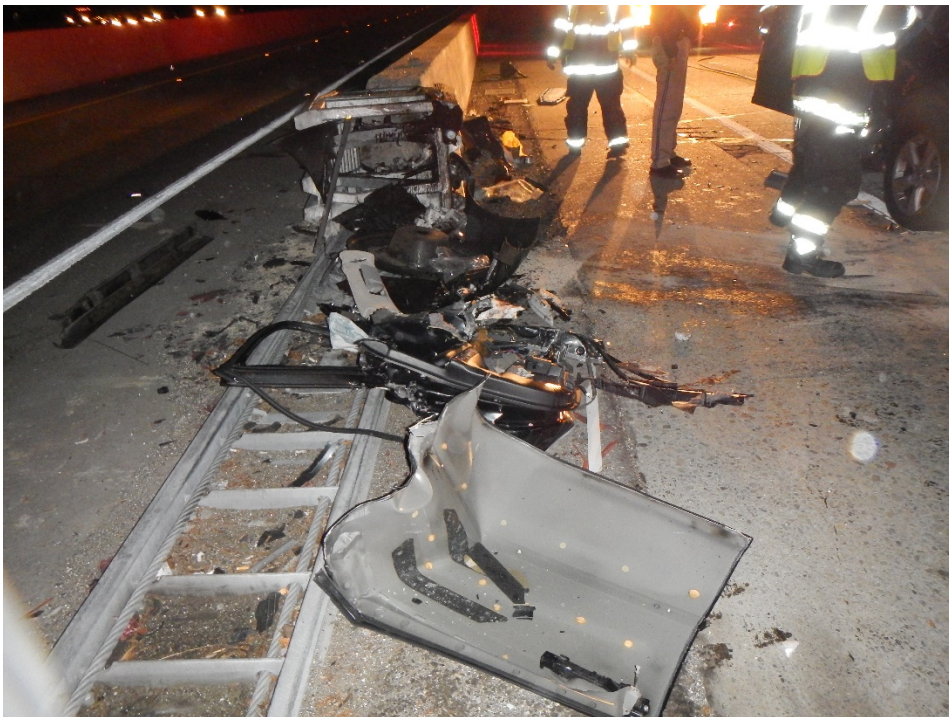
NTSB investigators made the determination that the crash cushion was in a damaged and collapsed condition prior to the November 14th crash based upon a review of Caltrans maintenance records, a review of Google Maps Street View imagery, and a review of photographs from the crash (see figures 7A and 7B). According to maintenance records, the crash cushion was repaired on August 18, 2015, and the next recorded maintenance was on December 23, 2015 when the crash cushion was replaced. Figures 7C – 7F depict images from Google Maps Street View of the crash cushion from September – December. All images depict the crash cushion being fully compressed and missing the retroreflective object marker during the months of October and November.

Figure 7B – Postcrash picture of crash cushion on November 14, 2015, at the exit ramp transition to SR-85.

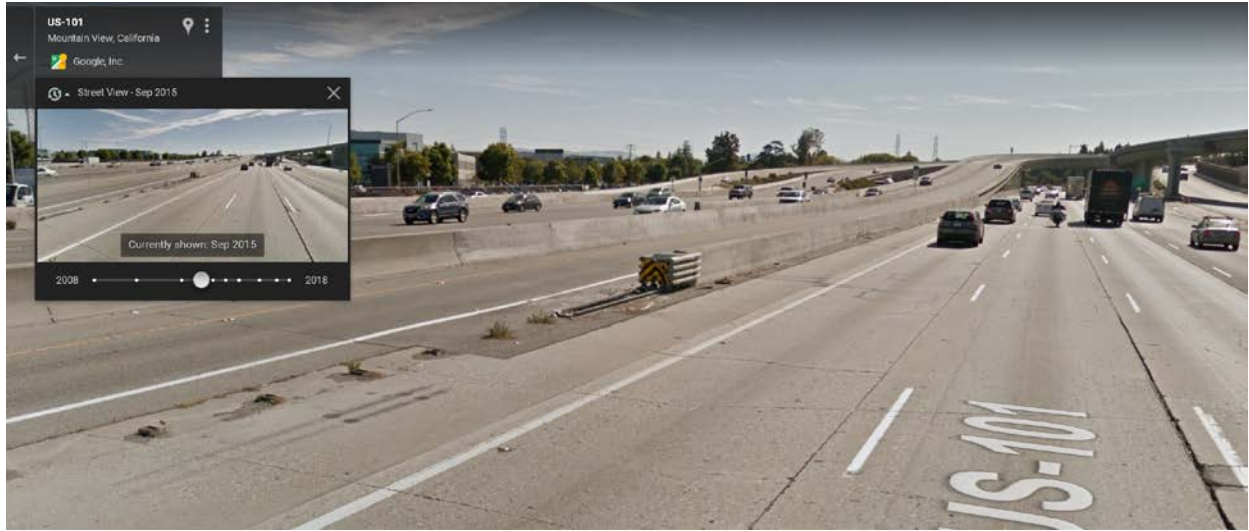
Figure 7C – Google Maps Street View image captured in September 2015 showing the crash cushion fully collapsed.

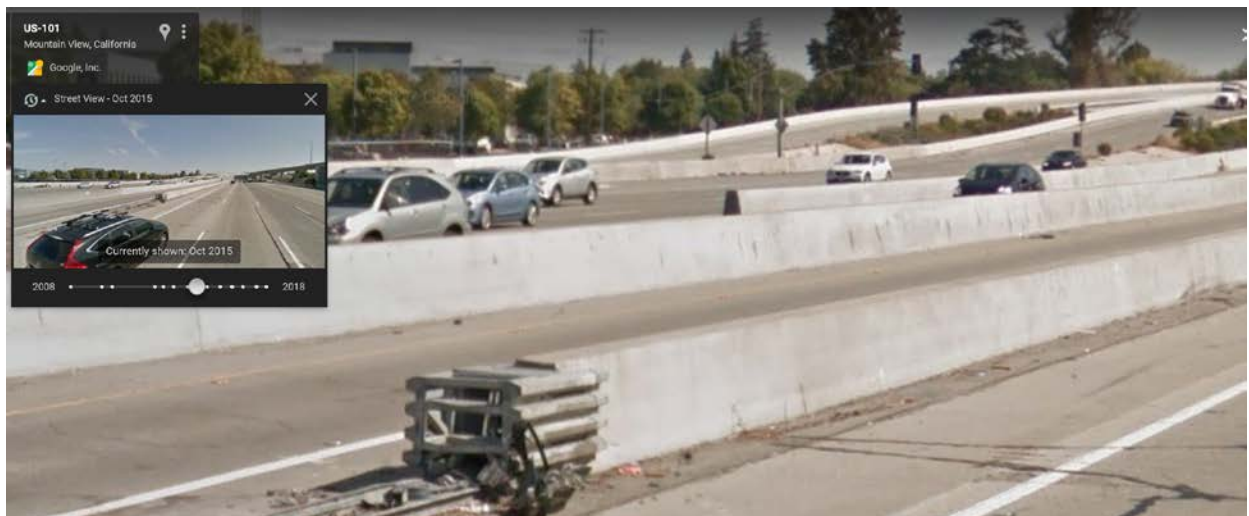
Figure 7D – Google Maps Street View image captured in October 2015 showing the crash cushion fully collapsed and missing the retroreflective object marker.

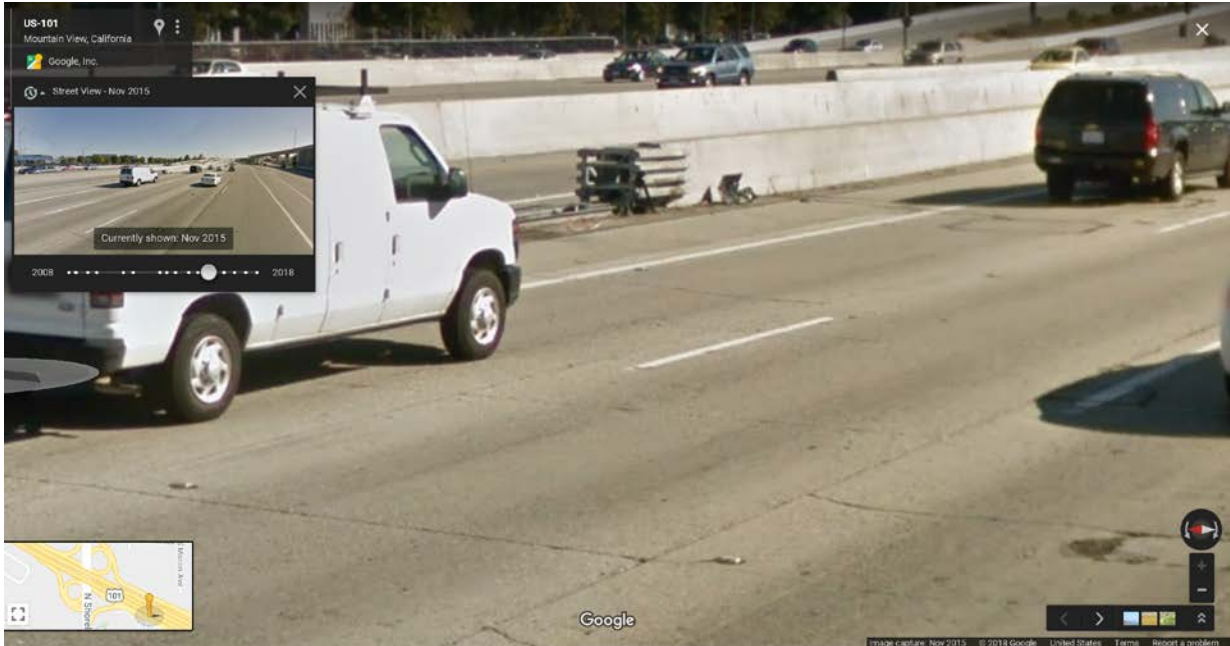
Figure 7E – Google Maps Street View image captured in November 2015 showing the crash cushion fully collapsed and missing the retroreflective object marker.

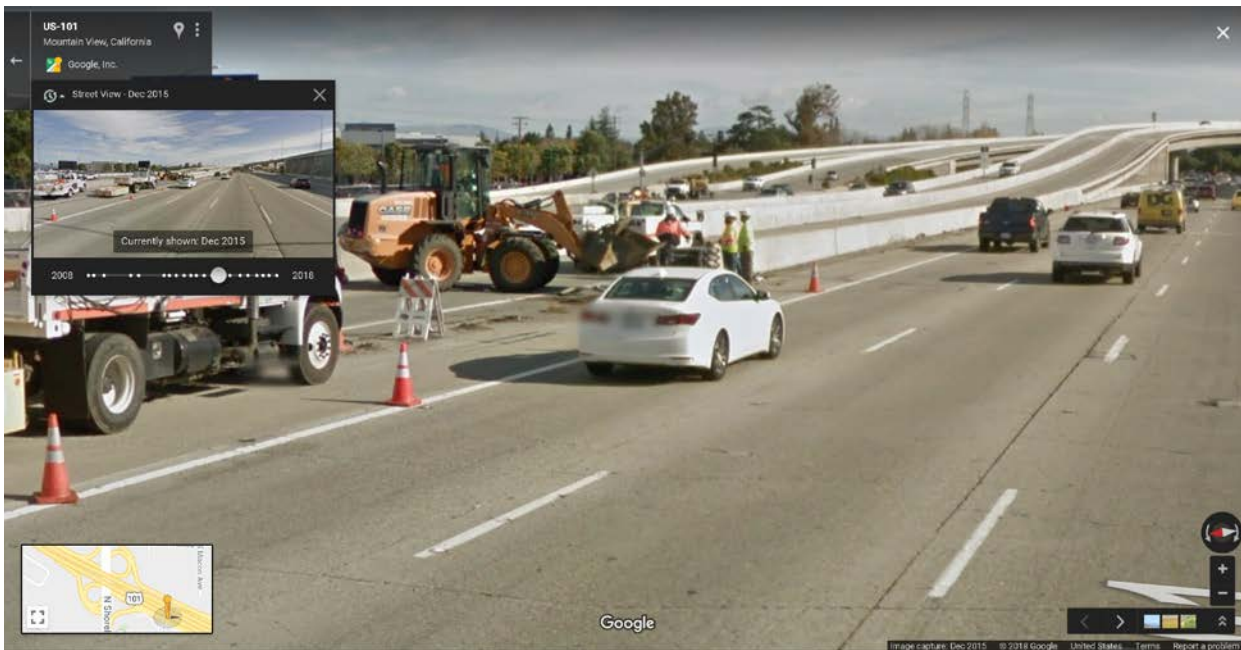
Figure 7F – Google Maps Street View image captured on December 23, 2015 showing the crash cushion being repaired by Caltrans.

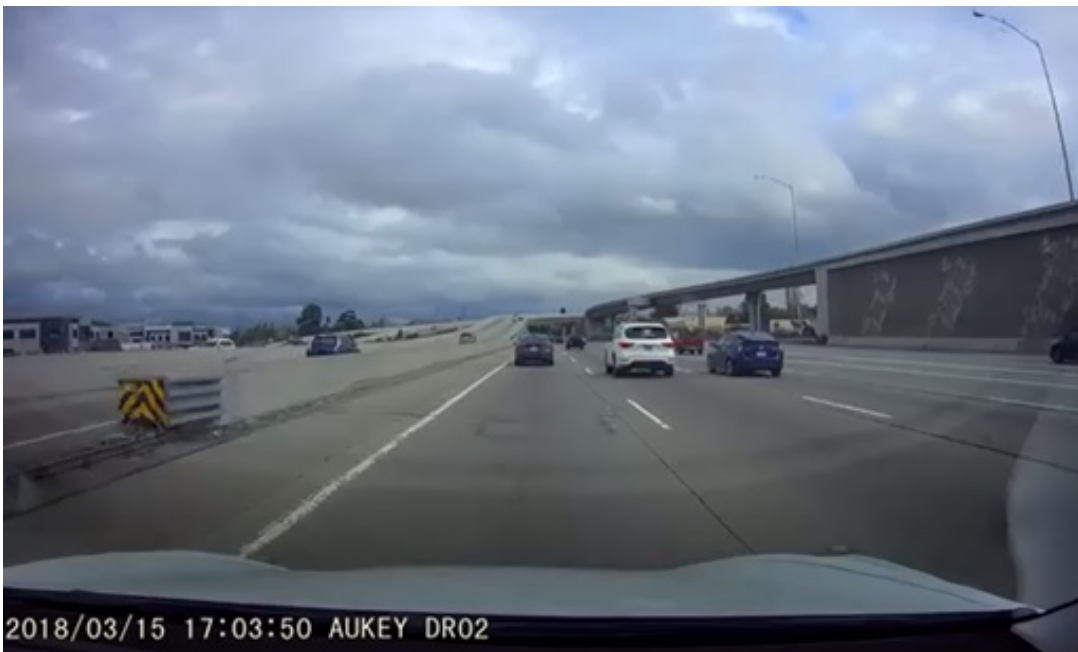
Figure 7E depicts a dashcam image of the damaged attenuator on March 15, 2018 which was provided by a witness traveling through the area. There was no evidence (cones or barricades) that Caltrans had yet visited the scene.

Figure 7E – Witness dashcam image of the crash cushion on March 15, 2018 at about 5:03 p.m.

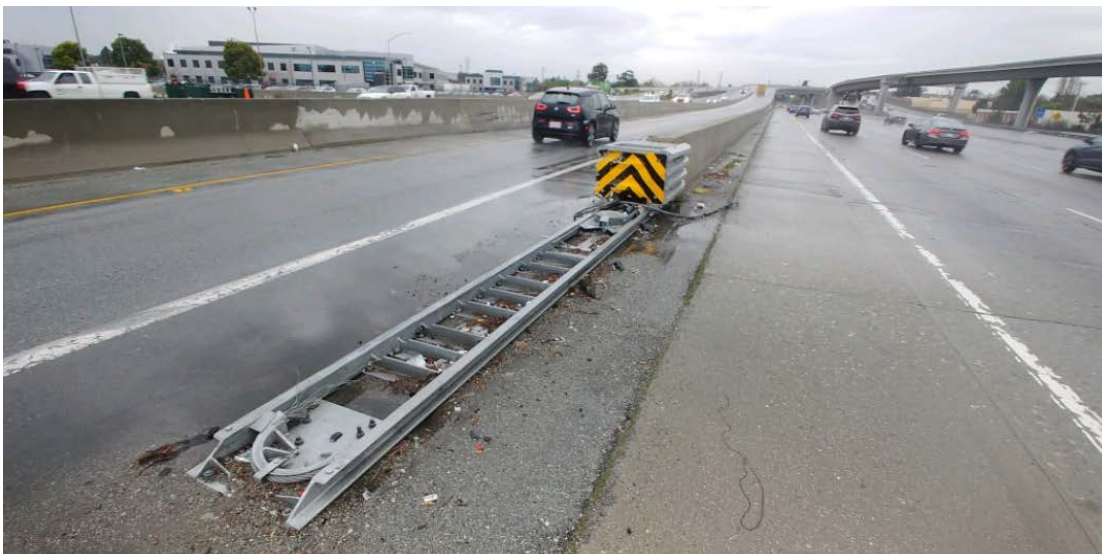
- Caltrans workers sent three pictures (see figures 7F to 7H) to the maintenance supervisor showing that resetting of the crash cushion was not possible due to a broken wire cable.

Figure 7F – Damaged crash attenuator photo taken by Caltrans worker on March 20, 2018.

- The maintenance supervisor advised workers to put cones and barricades up until a new crash cushion could be located to replace the damaged attenuator.

- On Monday, March 26th, the new crash cushion was installed at the crash location. The emergency closure of the highway and crash cushion replacement was completed at 3:30 p.m.

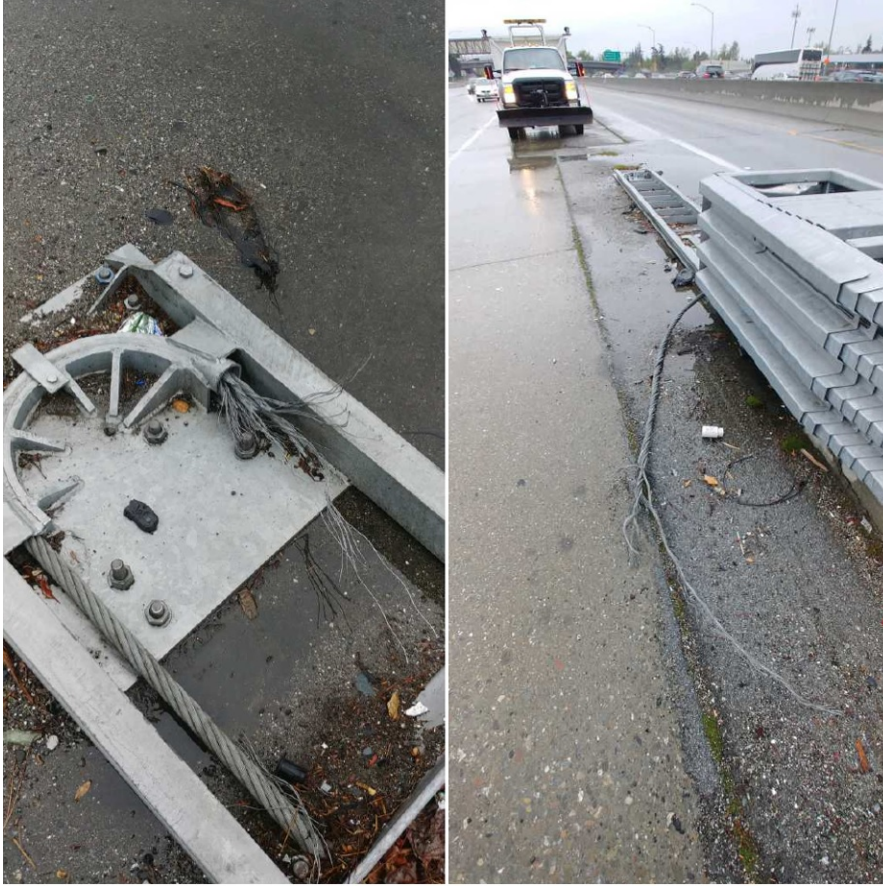
Figures 7G and 7H – Photos taken on March 20, 2018 by a Caltrans worker depicting the damage to the crash attenuator and wire cable.

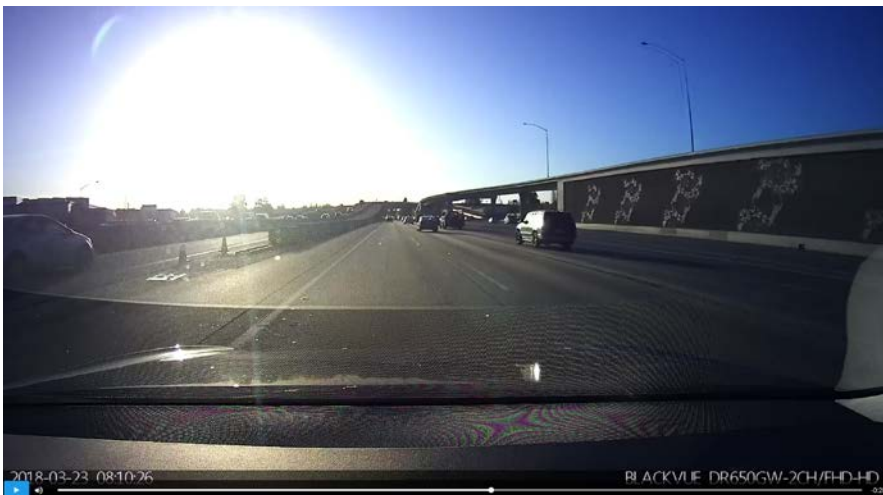
Figure 7I depicts a dashcam image of the damaged crash attenuator on the morning of the crash, 1 hour and 17 minutes before the fatal Tesla crash. In the photo a Type 1 sawhorse barricade is laying in the gore north of the crash attenuator. There was also two orange traffic cones and a knocked down cone in the vicinity of the crash attenuator.

Figure 7I – Witness dashcam image of the crash cushion on March 23, 2018 at about 8:10 a.m. (1 hour 17 minutes before the fatal Tesla crash).

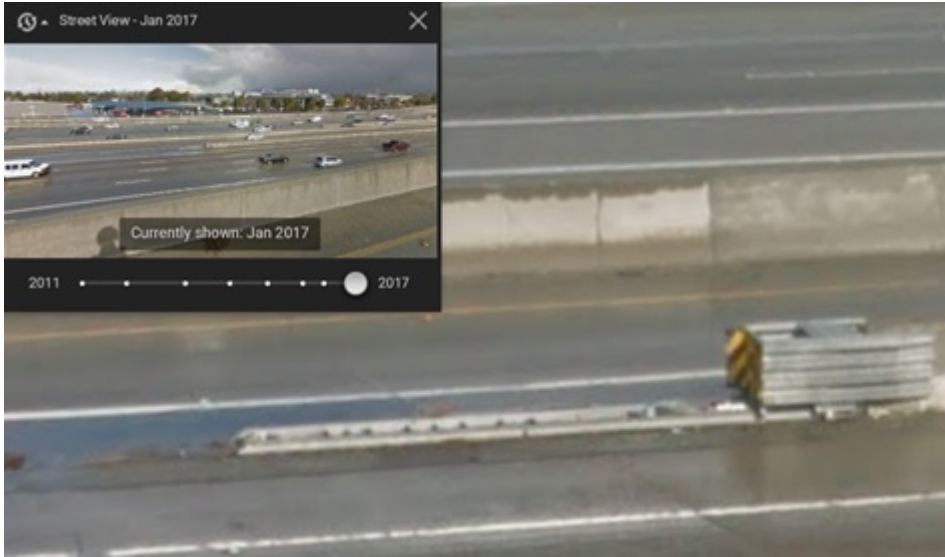
The SCI SmartCushion® SCI100GM crash cushion was damaged in a collision on January 3, 2017 (CHP TC #9330-2017-0017) and was not replaced until April 14, 2017 (Caltrans work order 4256817). Figures 7J – 7L depict the collapsed crash cushion in Google Maps Street View images in January, February and April.

Figure 7J – Google Maps Street View image captured in January 2017 showing the crash cushion fully collapsed.

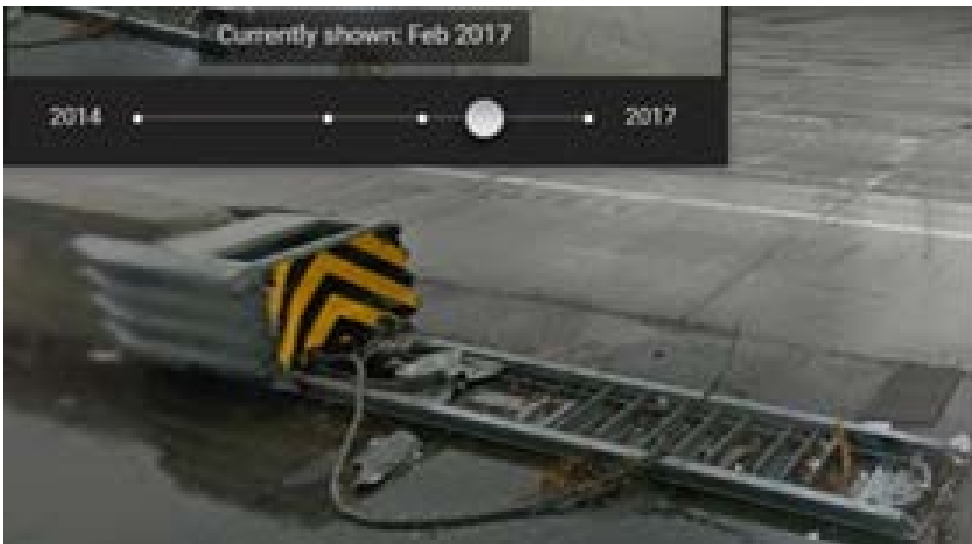
Figure 7K – Google Maps Street View image captured in February 2017 showing the crash cushion fully collapsed and the broken wire cable.

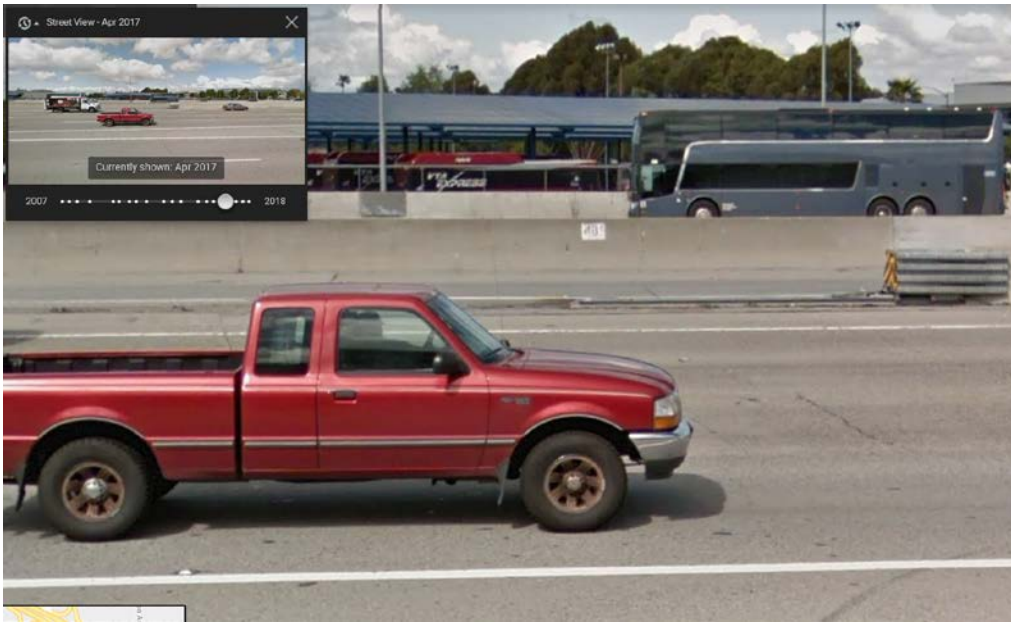
Figure 7L – Google Maps Street View image captured in April 2017 showing the crash cushion fully collapsed. Caltrans maintenance records show the crash cushion was replaced on April 14, 2017.
