**COLLISION WITH CRASH ATTENUATOR – NOVEMBER 14, 2015  
FACTUAL REPORT**

**Mountain View, CA**

**HWY18FH011**

**NATIONAL TRANSPORTATION SAFETY BOARD  
OFFICE OF HIGHWAY SAFETY  
WASHINGTON, D.C.**

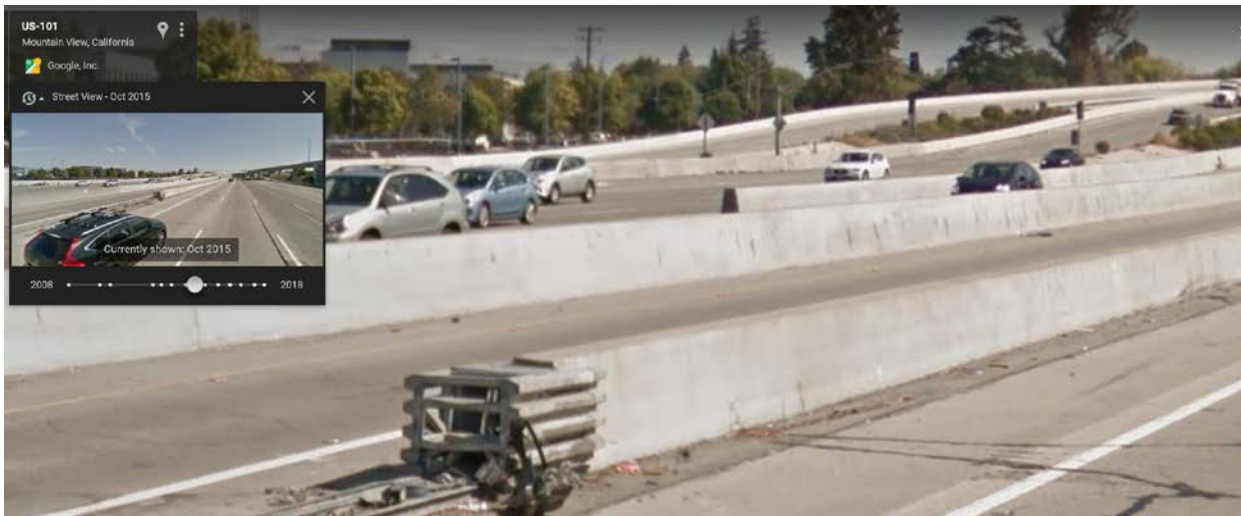
NTSB investigators reviewed the circumstances of this crash and determined that the SCI SmartCushion® SCI100GM crash cushion at the location was non-operational at the time of the collision due to being compromised (compressed) in a prior collision. Additionally, the crash cushion was missing its black and yellow retroreflective object marker at the end of the attenuator. The precrash damaged condition of the crash cushion was not reported in the CHP Traffic Collision Report 9330-2015-3996. After the crash, the crash cushion was replaced on December 23, 2015 (39 days after the crash).

**Figure 1** – Google Maps Street View image from October 2015 showing the crash cushion fully collapsed and missing the retroreflective object marker. This was the condition of the crash attenuator when the fatal traffic collision occurred on November 14, 2015.

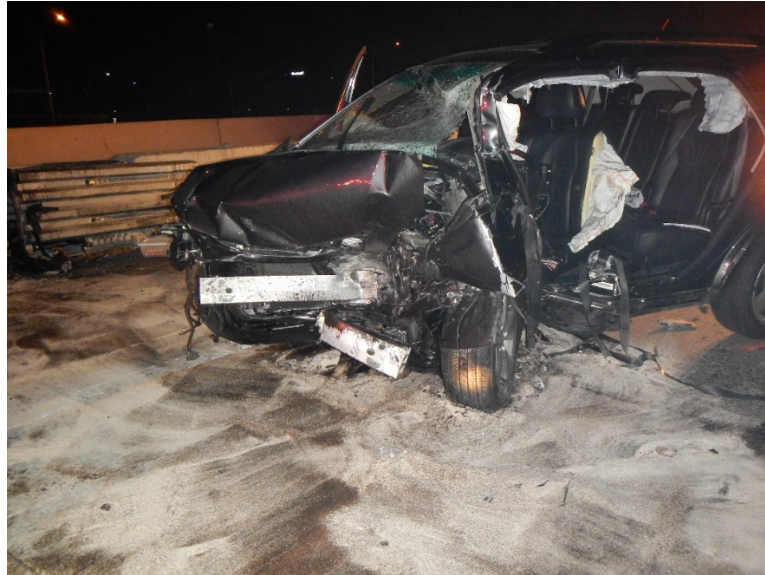
**Figure 2** – Postcrash photo of 2008 Lexus SUV on November 14, 2015, after colliding with non-operational crash cushion on US-101 southbound at the exit ramp transition to SR-85.

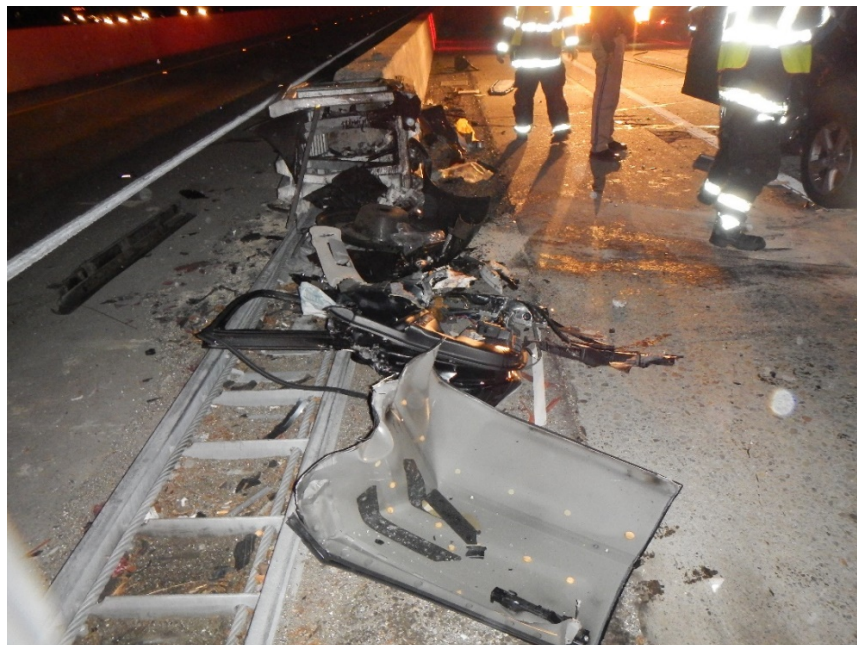
**Figure 3** – Postcrash photo of crash cushion on November 14, 2015, at the exit ramp transition to SR-85.

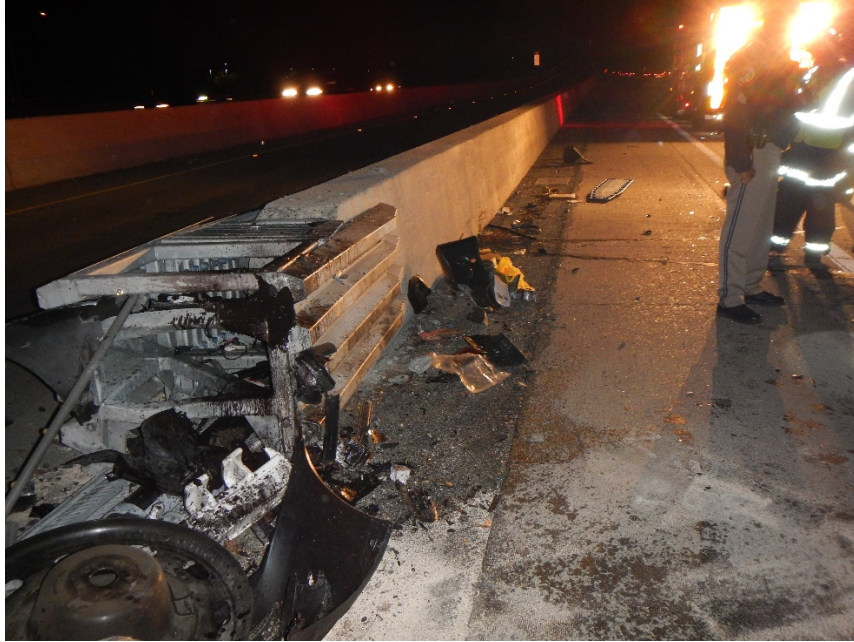
**Figure 4** – Postcrash photo of crash cushion on November 14, 2015, at the exit ramp transition to SR-85.

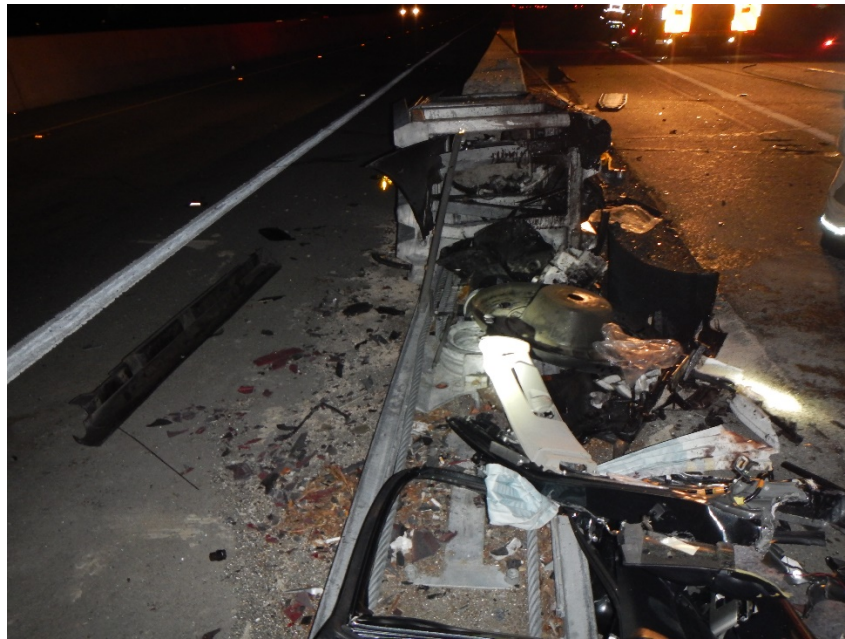
**Figure 5** – Postcrash photo of crash cushion on November 14, 2015, at the exit ramp transition to SR-85.

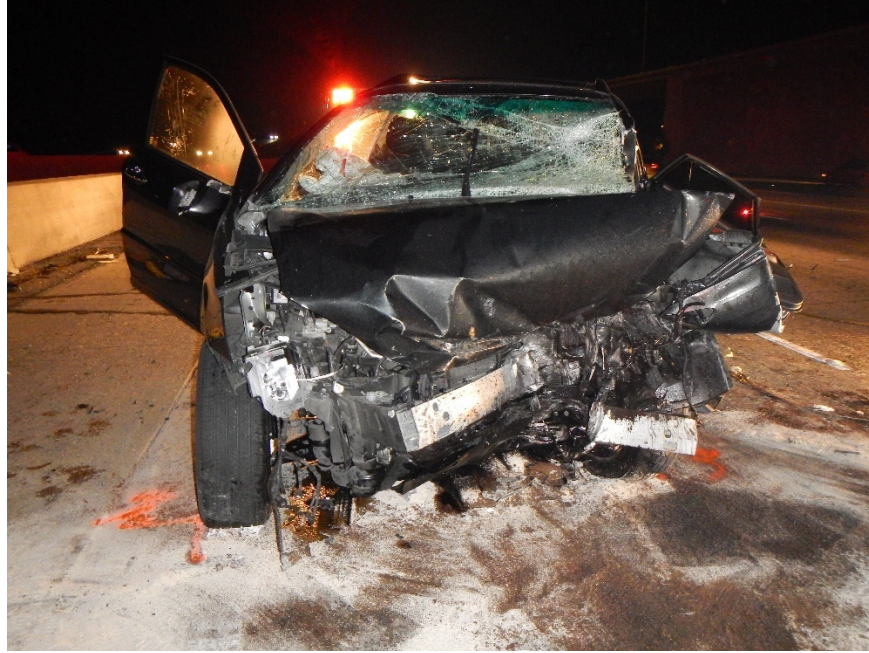
**Figure 6** – Postcrash photo of 2008 Lexus SUV on November 14, 2015, after colliding with non-operational crash cushion on US-101 southbound at the exit ramp transition to SR-85.

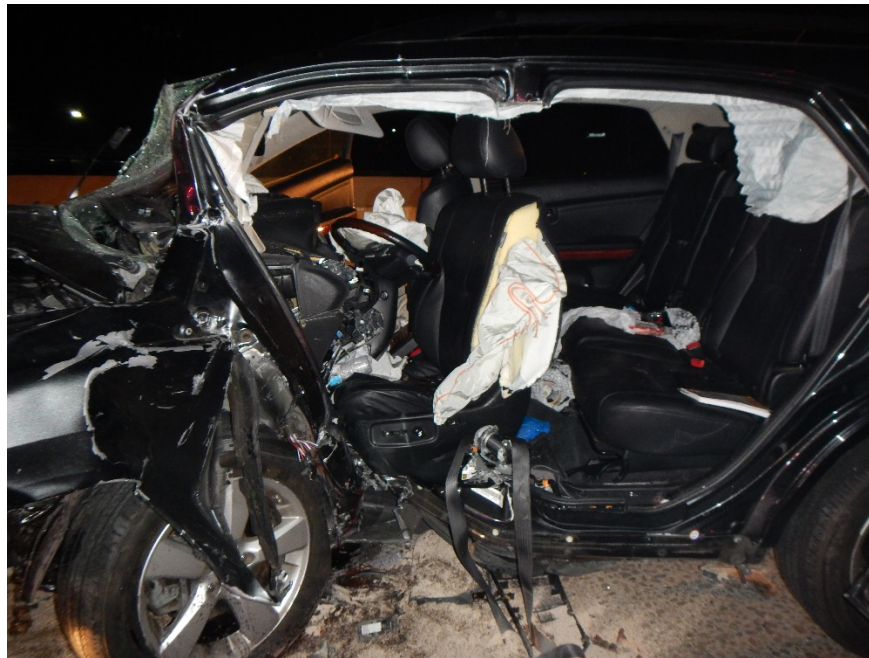
**Figure 7** – Postcrash photo of driver's side of 2008 Lexus SUV on November 14, 2015, after colliding with non-operational crash cushion on US-101 southbound at the exit ramp transition to SR-85.
