NATIONAL TRANSPORTATION SAFETY BOARD

Flight Data Monitoring (FDM) Device

Specialist's Factual Report
By Sean Payne

Location: Hertford, North Carolina
Date: September 8, 2017
Aircraft: Eurocopter MBB BK-177 C2
Registration: N146DU
Operator: Air Methods Corporation
NTSB Number: ERA17FA316

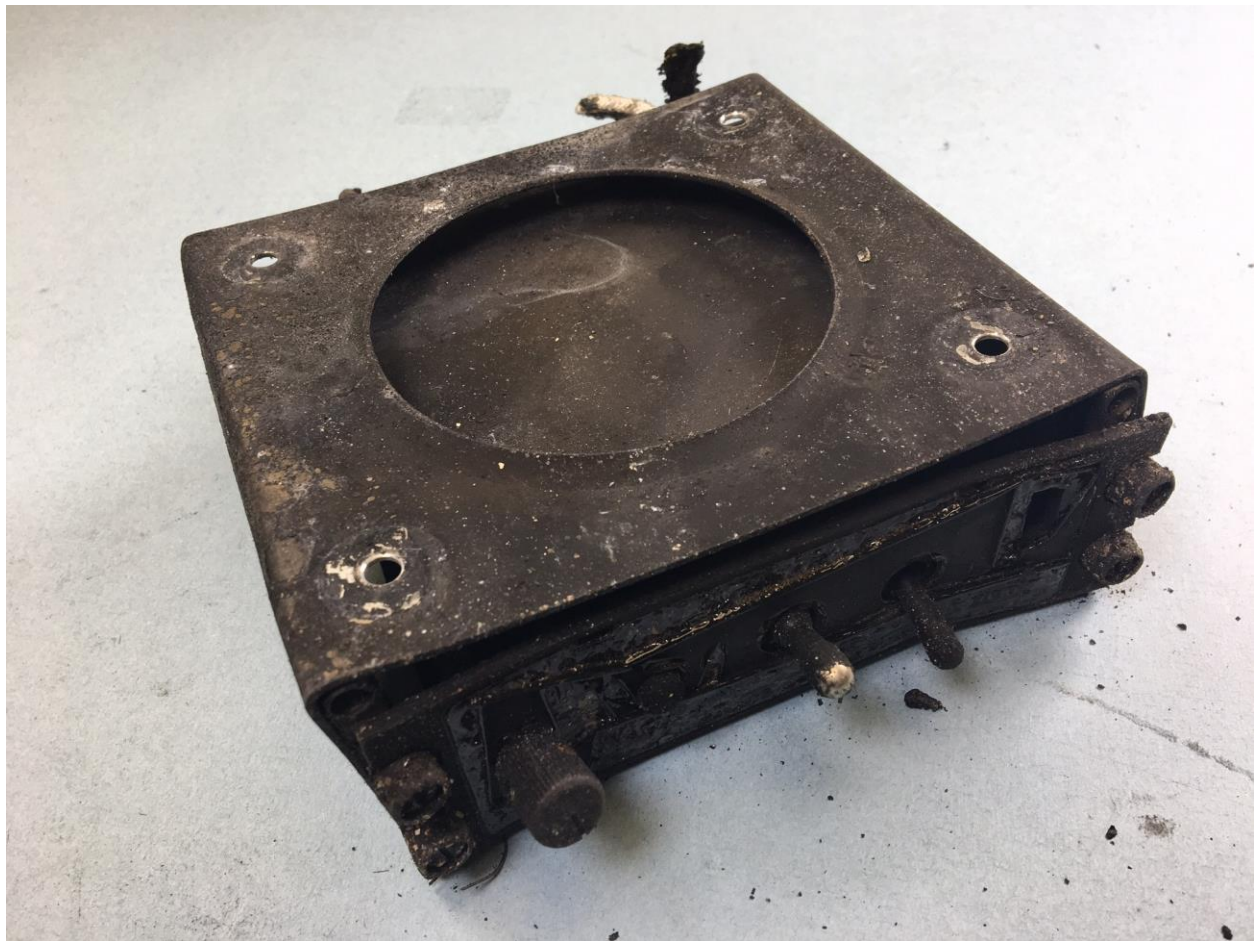
Upon arrival at the Vehicle Recorder Laboratory, an examination revealed the unit had sustained significant fire and impact damage. Figure 1 shows the unit's condition upon arrival.

Figure 1. Photo of damaged unit

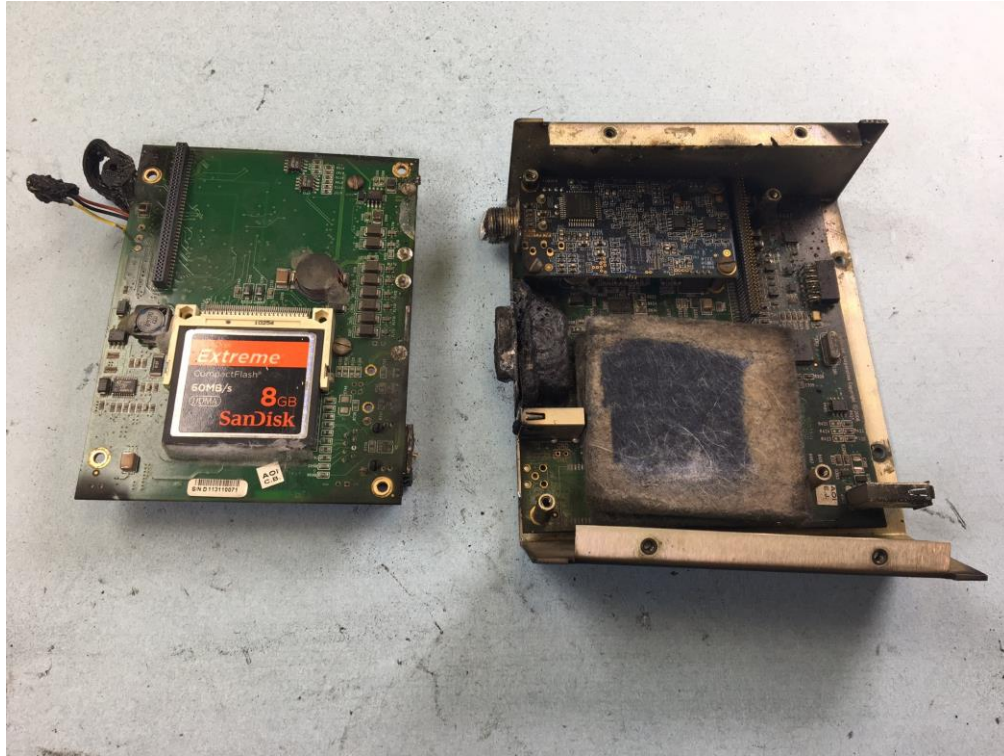
The unit was opened mechanically. Four phillips style screws holding a larger component board were first removed. Under that component board, a CF card was exposed after removing a lightweight fireproofing-like material. The fireproofing-like material exhibited thermal damage surrounding the area of which the CF card was mounted. Figure 2 shows the internal condition of the device after the top component board was removed as well as the lightweight fireproofing-like material.

Figure 2. Photo of the device after being mechanically opened.

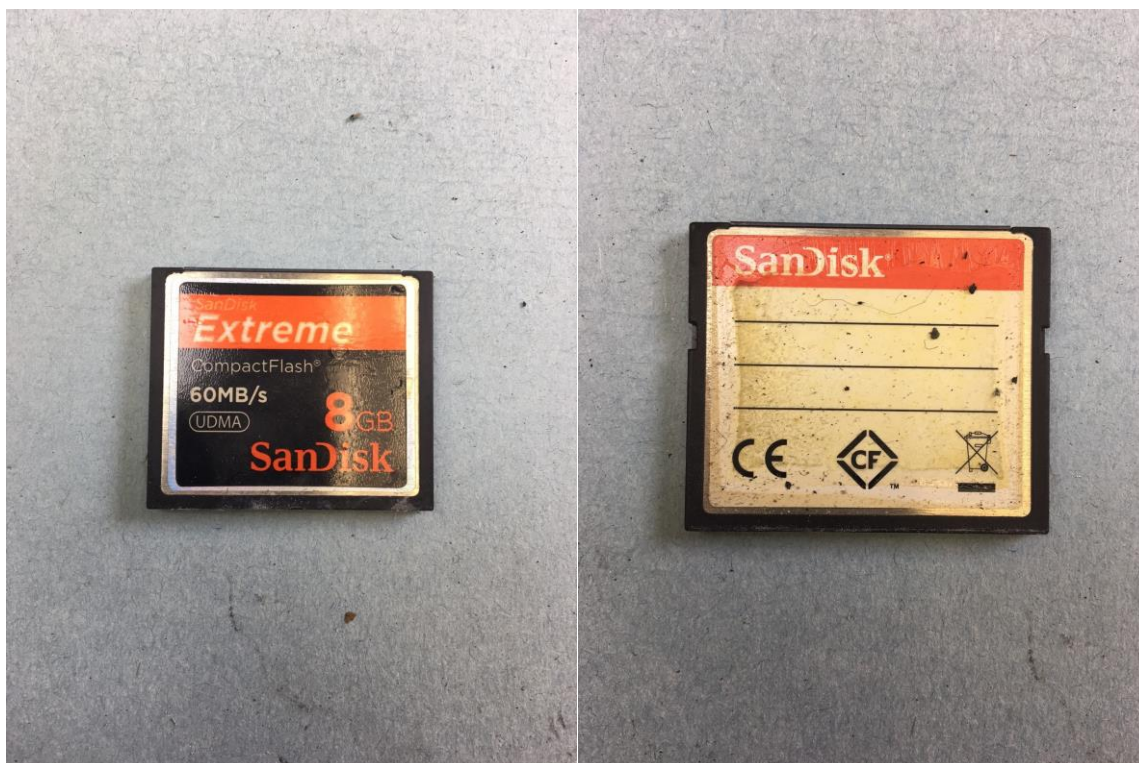
A bead of RTV silicon holding the CF card in place was removed and the CF card was able to be freed from its chassis. The CF card exhibited characteristics of high temperature exposure, but no obvious damage. The condition of the CF card is shown in figure 3 (front and back).

Figure 3. Photo of the device's internally mounted CF card.

This device is capable of storing data via an internally installed CF card. A failure of the internal battery caused the CF card to be corrupted. A search of recovered CF card data failed to produce data related to the accident. It is inconclusive how long prior to the accident that the internal battery failed. No data was recovered from the device.
