NATIONAL TRANSPORTATION SAFETY BOARD

Vehicle Engine Multifunction Display (VEMD)

Specialist's Factual Report
By Sean Payne

Location: Hertford, North Carolina
Date: September 08, 2017
Aircraft: Eurocopter MBB BK-177 C2
Registration: N146DU
Operator: Air Methods Corporation
NTSB Number: ERA17FA316

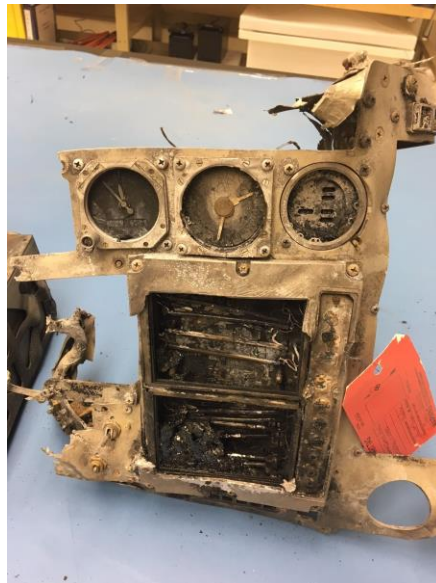
Upon arrival at the Vehicle Recorder Laboratory, an examination revealed the unit had sustained both impact and fire damage. The device is shown as received in figure 1. The device was later opened and two separate components of the device were segregated. The two separate components are referred to as “lanes” and the device has the ability to function on either “lane” should a failure occur². Figure 2 shows the “dual lane” characteristic of the VEMD after being opened.

Figure 1. Photo of damaged unit with three other instruments still attached.

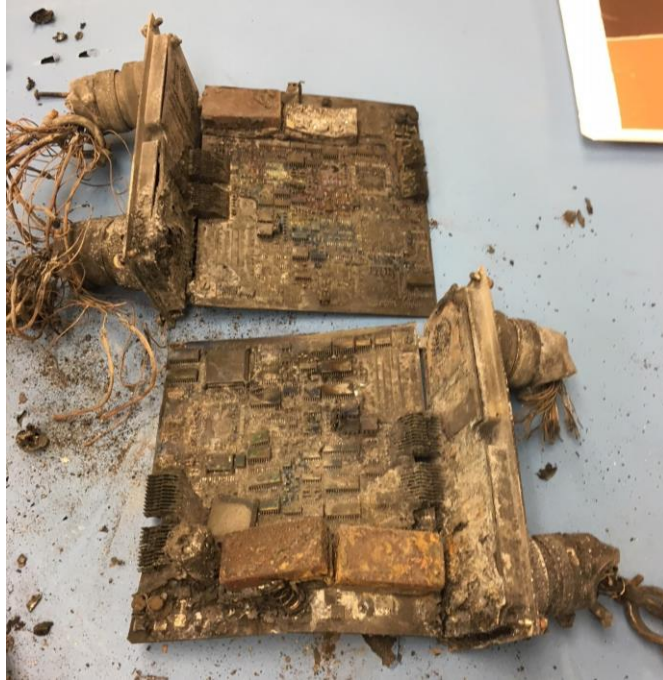
Figure 2. Photo of each lane of the VEMD after being removed and segregated.

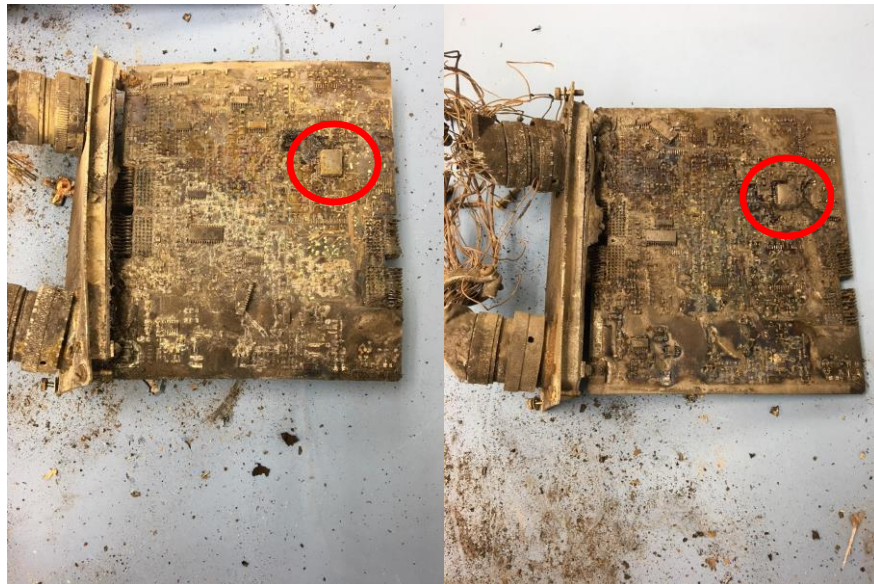
Figure 3. Photo of the unit's two internal boards after removal. The NVM chip is circled in red.

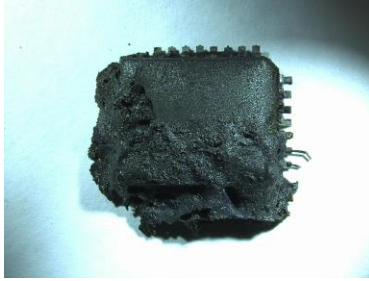
Figure 3. Front of Chip "A."

Visual inspection by S3IP revealed that both chips were burnt with “severe thermal degradation of the mold.” The molding damage potentially exposed the chip’s lead frame. The visual inspection found that the contact pins on both chips were also severely damaged.

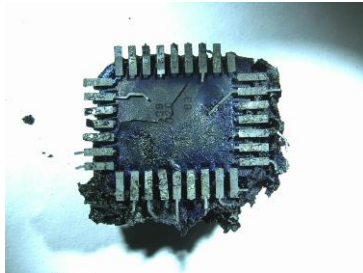
Figure 4. Back of Chip "A."

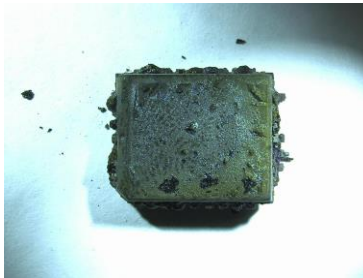
Figure 5. Front of Chip "B."

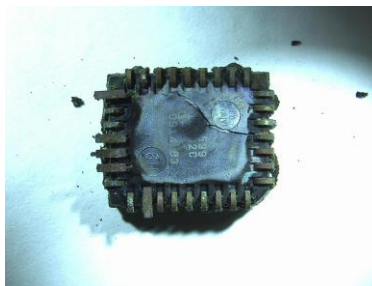
Figure 6. Back of Chip "B."

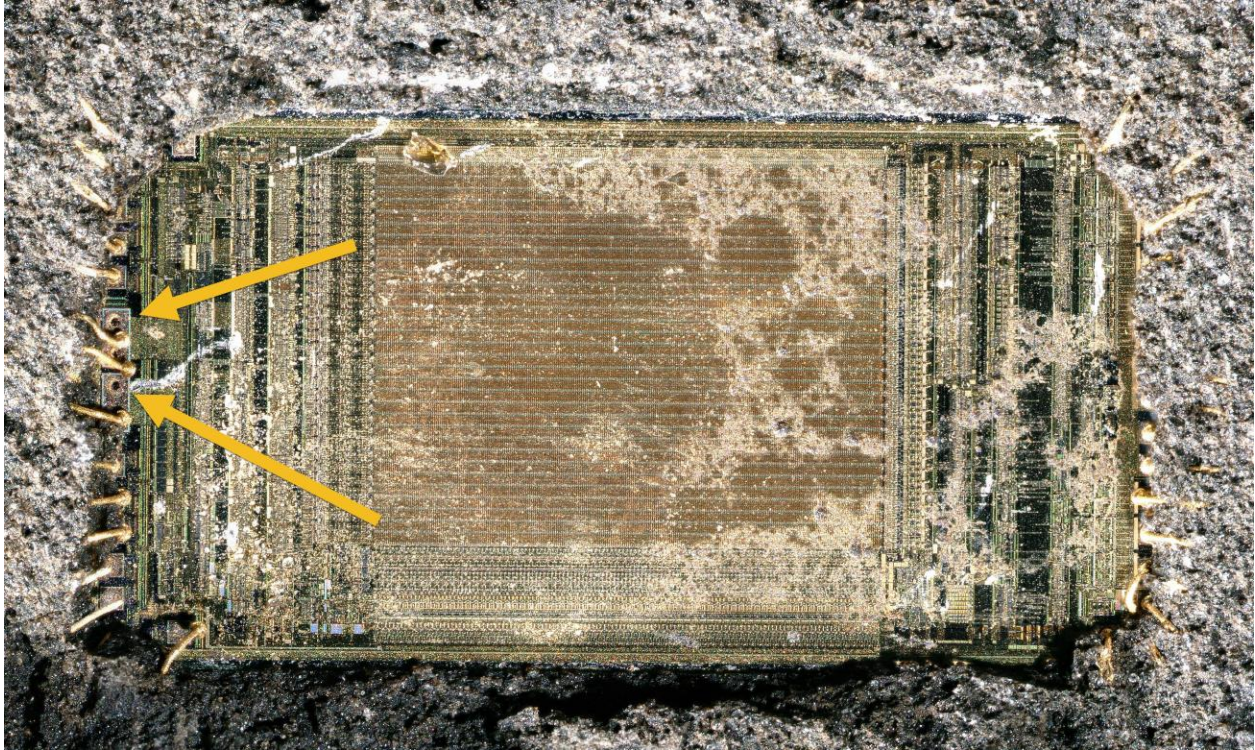
The chip A was then determined to be a candidate for mechanical decapsulation using a micro pneumatic tool and a stereoscope. Chip A was successfully mechanically decapsulated, with possible damage to the die existing as a result of the mechanical process. Figure 7 is a photo of chip A after mechanical decapsulation. The yellow arrows point to areas where bond wires have been found removed from the chip's die.

Figure 7. Chip A after having been mechanically decapsulated.
