**Bridge Factors Factual Report Attachment 74 – FHWA Turner-Fairbank Highway
Research Center Factual Report for Concrete Interface Under Members 11 and 12**

HWY18MH009

**TURNER-FAIRBANK HIGHWAY RESEARCH CENTER
FACTUAL REPORT**

Concrete Interface Under Members 11 and 12

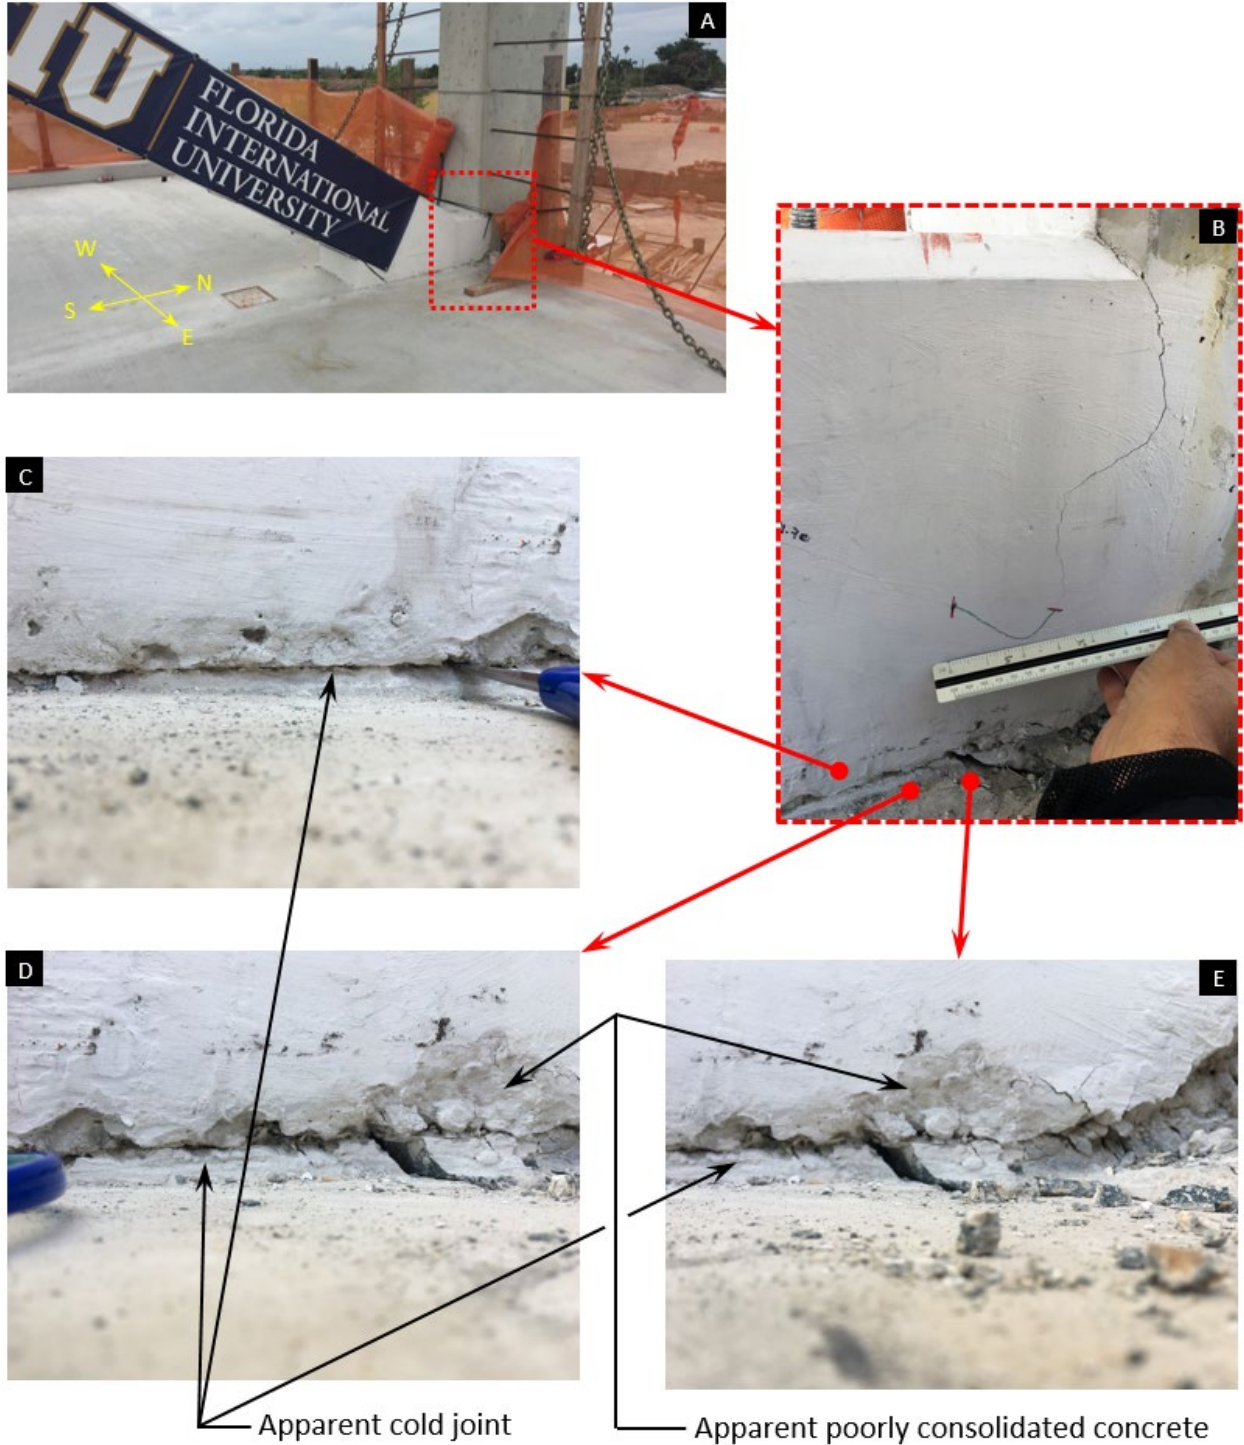
Figure 4 provides a set of photographs that document a portion of the east face of the interface in the days immediately before the collapse. The compound figure shows the overall location in the structure (Part A), followed by a local image of the structure (Part B), followed by three close-up photos of the interface between the bridge deck and the bottom of Member 11 (Parts C through E). The specific location shown in the three close-up photos is within the line of action of Member 11 near the intersection with Member 12. The three close-up images appear to show that the secondary pour sits slightly above the surface of the deck. It is also apparent that the secondary pour was not completely consolidated, with a small amount of less consolidated concrete visible on a portion of the bottom edge of the casting (annotated in Parts D and E). The indication of this less consolidated concrete is the observation of apparent paste-covered aggregates that reside in a void that is recessed from the vertical finished surface of the member. A small void of this type could occur at the bottom corner of a concrete casting, such as on a vertical surface adjacent to a horizontal cold joint.

These close-up images show that the interface, labeled as “Apparent cold joint” in Parts C through E, does not appear to be roughened. Additionally, the chamfer at the southern end of the interface between Member 11 and the deck appears to have remained connected to the deck, while the crack that runs along the northern portion of the interface departed from the interface and began following the extension of the southern face of Member 11. Thus, the cold joint at the southern end of the interface being investigated may have remained intact until the collapse began.

Figure 4. Annotated images demonstrating interface condition on east face of member 11 near member 12.

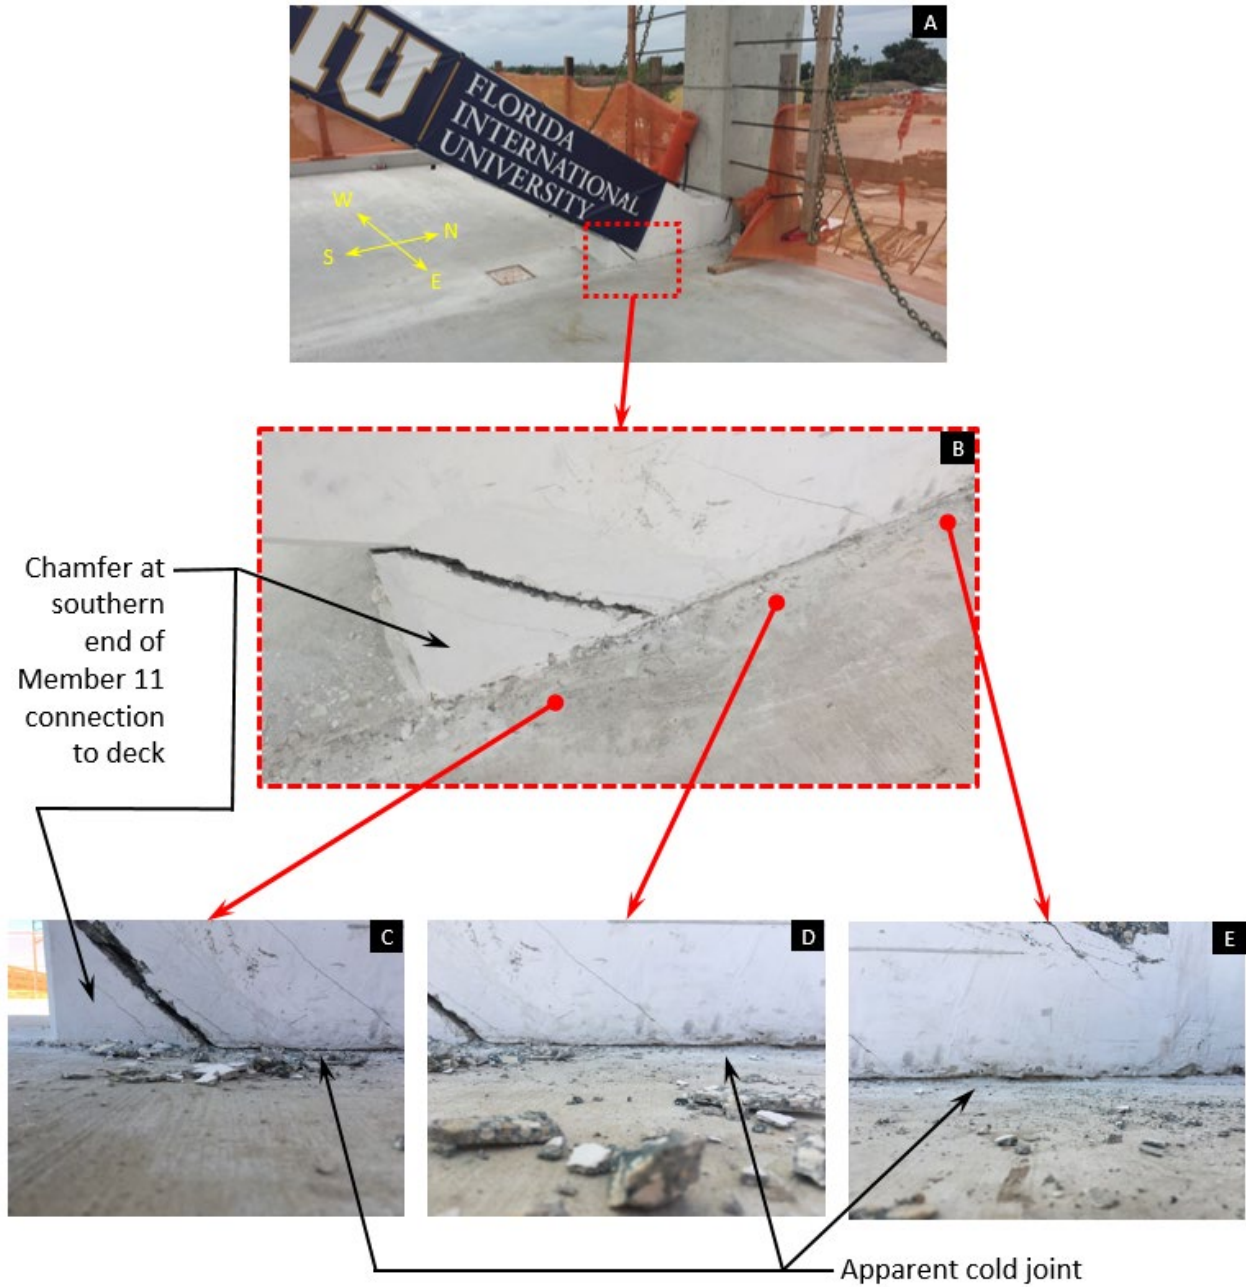
Figure 5 provides a set of photographs that also document a portion of the east face of the interface in the days immediately before the collapse. This compound figure shows the overall location in the structure (Part A), followed by a zoomed location in the structure (Part B), followed by three close-up photos of the interface (Parts C through E). The specific location shown in the three close-up photos is near the southern end of the east face of where Member 11 meets the deck.

Figure 5. Annotated images demonstrating interface condition near the south end of the east face of Member 11 with the deck.

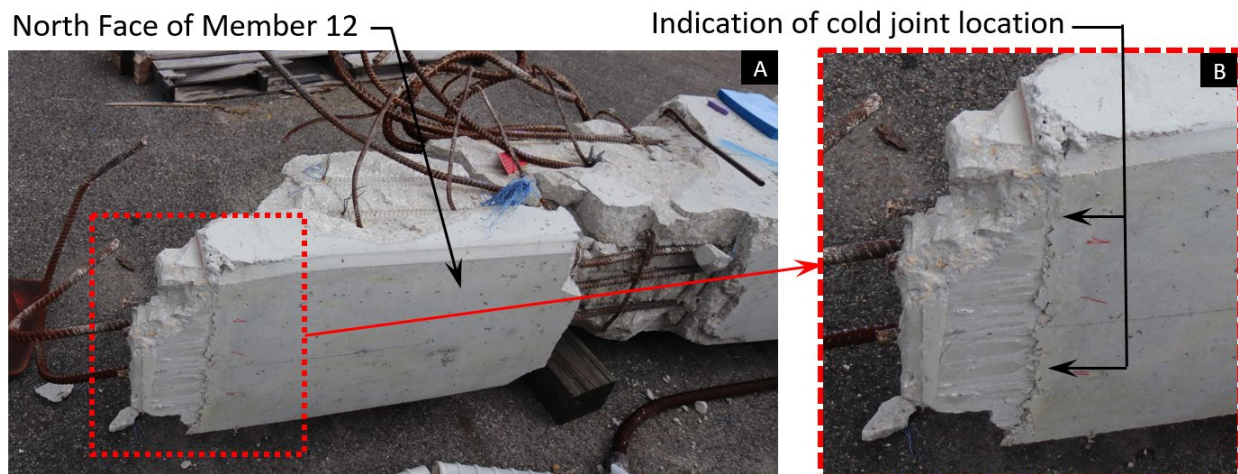
Figure 6 and Figure 7 provide a set of photographs showing the bottom end of Member 12. Figure 6 focuses on the north face of the member, with the left side of the photo in Part A showing the location where the member intersected with the bridge deck. Part B and the annotation call attention to the location of a cold joint interface between concrete pours. From a construction process standpoint, this surface feature indicates a location where vertical formwork for a secondary pour of concrete was nearly pressed against the existing hardened concrete of the first pour. The small gap between the formwork and the first pour allowed a small amount of concrete paste to flow slightly past the leading edge of the hardened concrete on the north face of the member, thus creating the ragged horizontal paste line at the cold joint location.

Figure 6. Indication of cold joint on north face of Member 12.

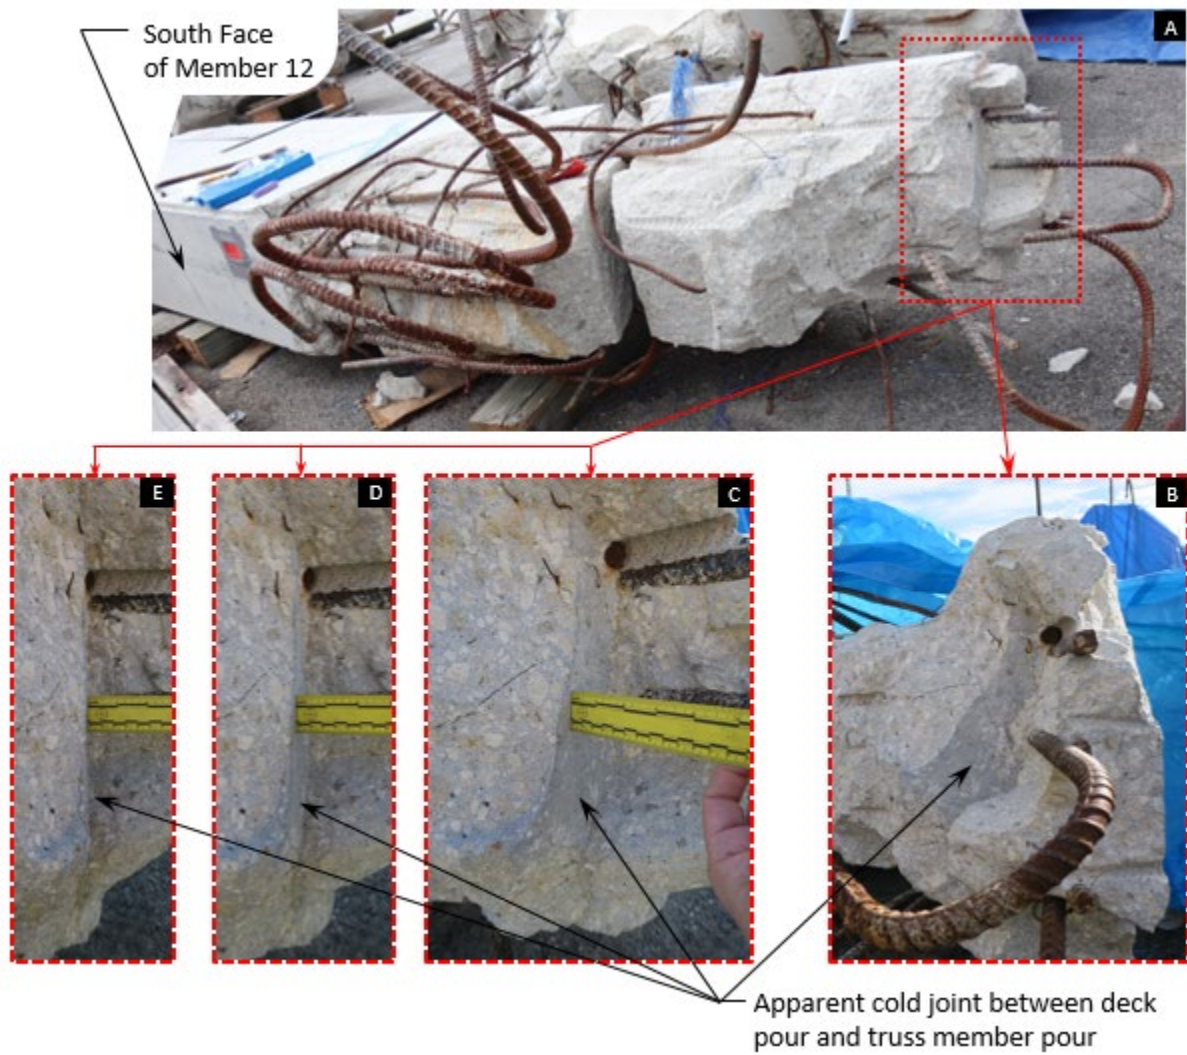
Figure 7 focuses on the same portion of Member 12 except viewed from the south and below. The boxed area in Part A draws attention to bottom end of Member 12 where it met the bridge deck. The key feature in this image is shown in Parts B through E. A flat, nearly smooth plane of concrete paste that aligns with the cold joint shown in Figure 6 is visible. As the viewpoint is rotated from below toward the south in Parts B through E, the scale shows that there is minimal roughness on the plane. This plane is part of the secondary casting of concrete that was placed and hardened against the first casting of concrete. The concrete in this plane and nearby appears well consolidated, indicating that this concrete replicated the surface geometry of the surface on which it was cast. Prior to or during the collapse, the concrete from the secondary casting debonded from the concrete from the original casting, leaving behind this preserved portion of the cold joint. This flat, nearly smooth plane does not show indications of abrasion or other mechanical actions that could have left a smoother surface than was originally present after the secondary pour of concrete was completed.

Figure 7. Indication of cold joint near the bottom end of Member 12.

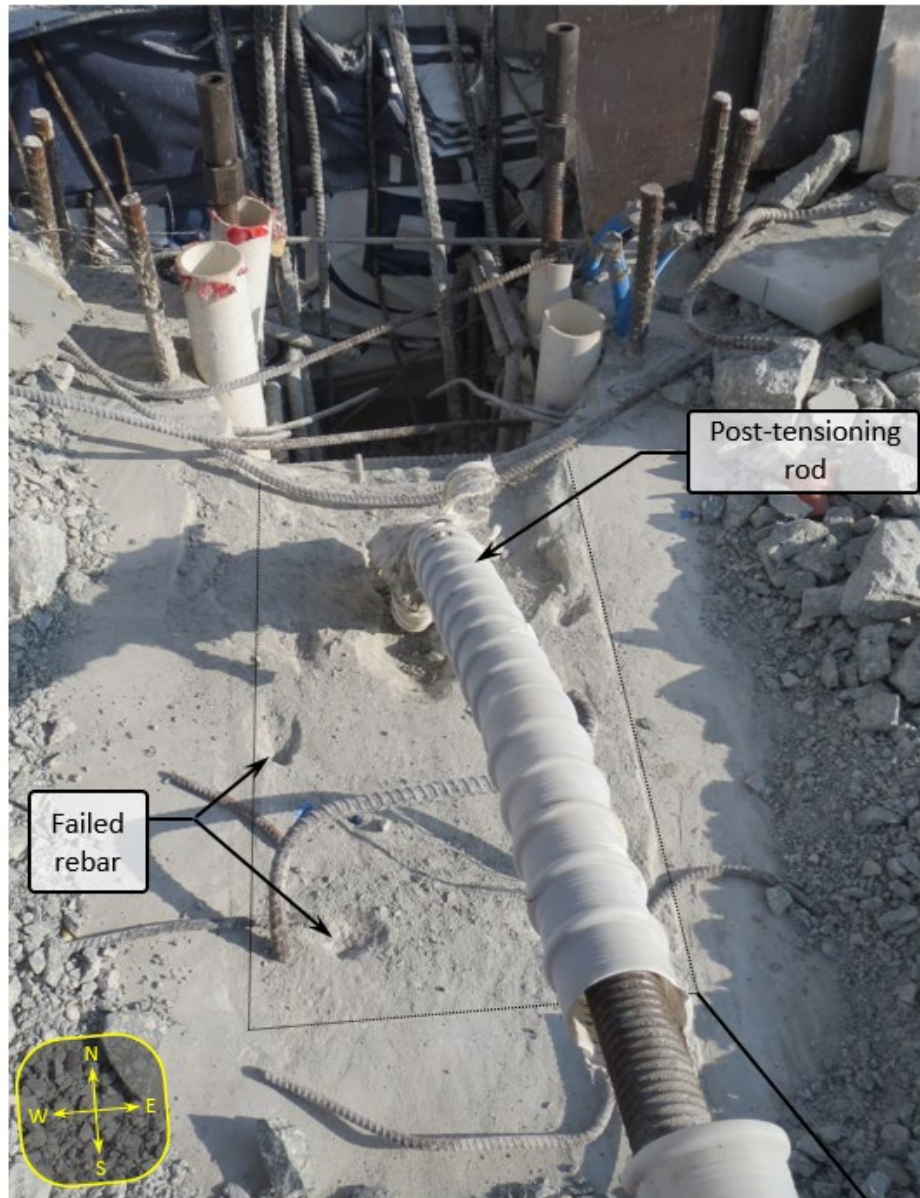
After the collapse, the deck under Member 11 was partially intact; this shown in Figure 8. This photo was captured in the days after the collapse once pulverized concrete and other debris created by the collapse had been carefully removed from the surface. This northward looking photo is taken from the vantage point of where Member 11 was heading diagonally toward the deck. The hole in the north end of the deck is the location where Member 12 met the deck. The visible post-tensioning rod was the lower rod within Member 11.

The portion of the deck under the southern end of Member 11 is largely intact from the post-tensioning rod to the southern end of the interface. This surface appears relatively smooth. The isolated depressions on the concrete surface, identified in Figure 8, are locations where reinforcing bars previously passed upward through the interface between the base of Member 11 and the deck.

Footprint of Member 11 on deck indicated with superimposed dotted line

Figure 8. Interface under Member 11 after loose debris removal.

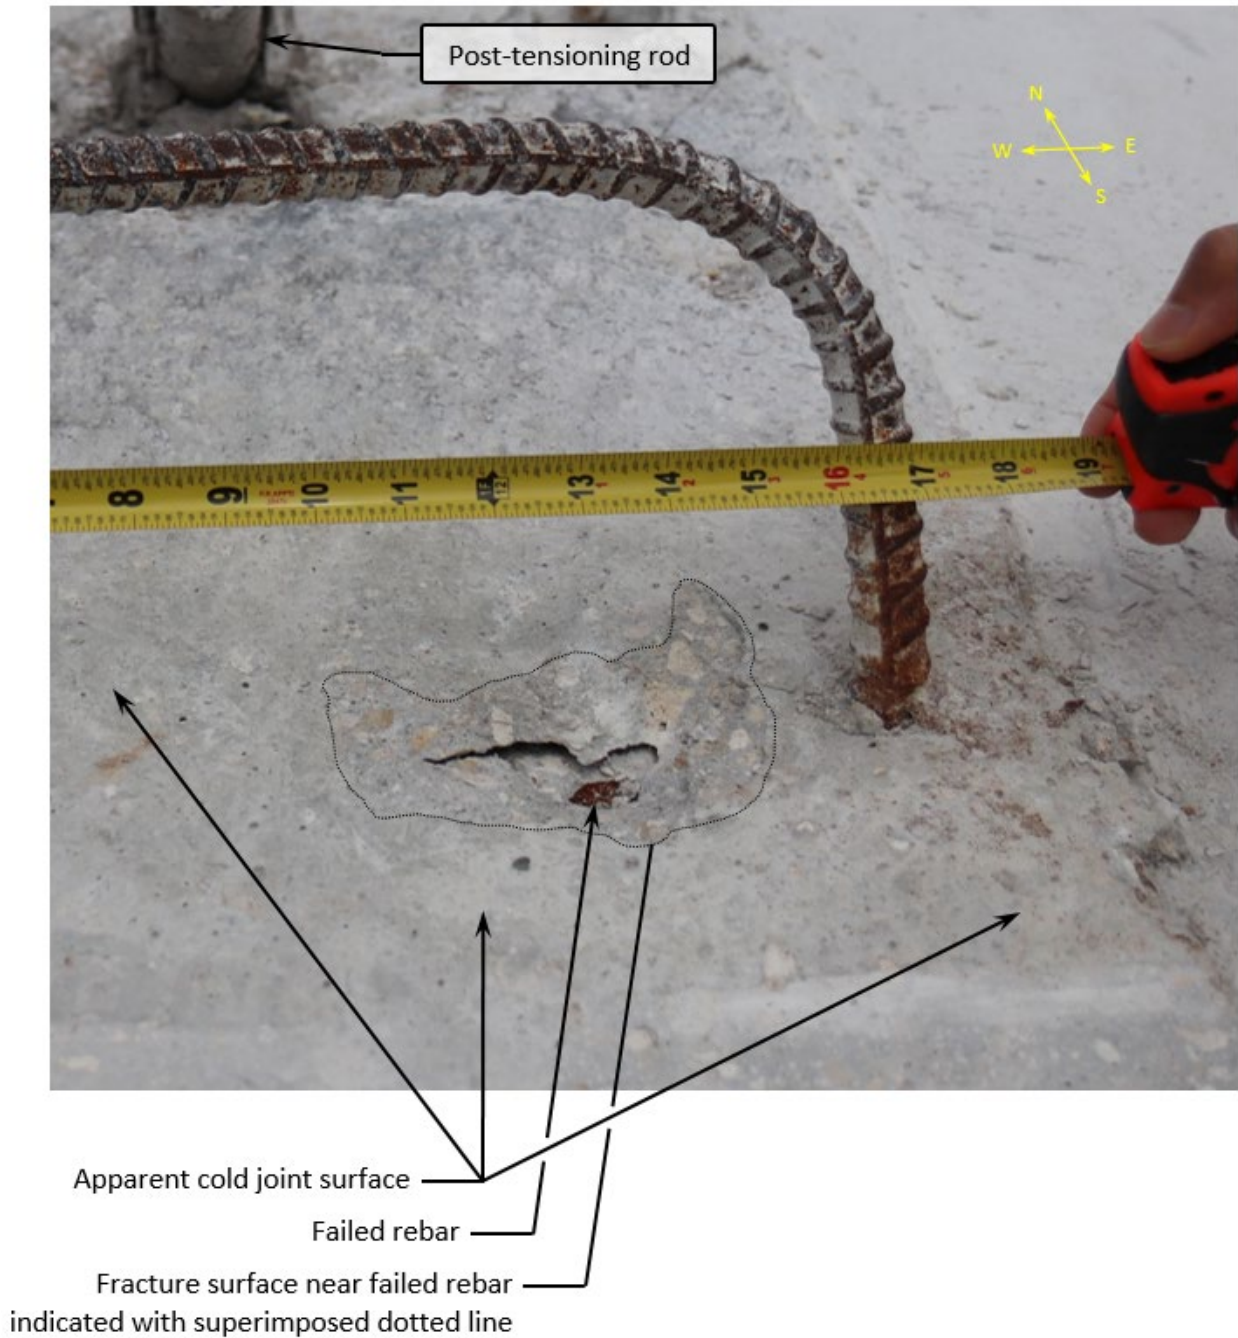
Further photographic evidence of this surface is provided in Figure 9 which shows the southeast corner of the interface after the surface had been washed with water. The foreground includes the southern end of the interface near the interface shear rebar that remained intact through the collapse. The upper portion of the photo includes the portion of the interface near the lower post-tensioning rod from Member 11. A concrete fracture surface within a cone of failed concrete near a fractured rebar is labeled. The apparent cold joint surface between Member 11 and the deck is also labeled. The visual difference between the fractured concrete surface near the fractured rebar and the apparent cold joint surface is notable. The fractured surface shows fractured aggregates as well as fractured paste, whereas the apparent cold joint surface is largely

covered in relatively smooth concrete paste. It is also important to note that the apparent cold joint surface does not show scratches or gouges near the southern end of the interface; scratches and gouges begin to appear as one traverses northward toward the lower post-tensioning rod. These scratches and gouges have a north-south orientation and appear likely to have occurred during the collapse as the concrete in the bottom end of Member 11 slid northward across the deck surface.

Figure 9. Interface under southeast corner of Member 11 after cleaning.

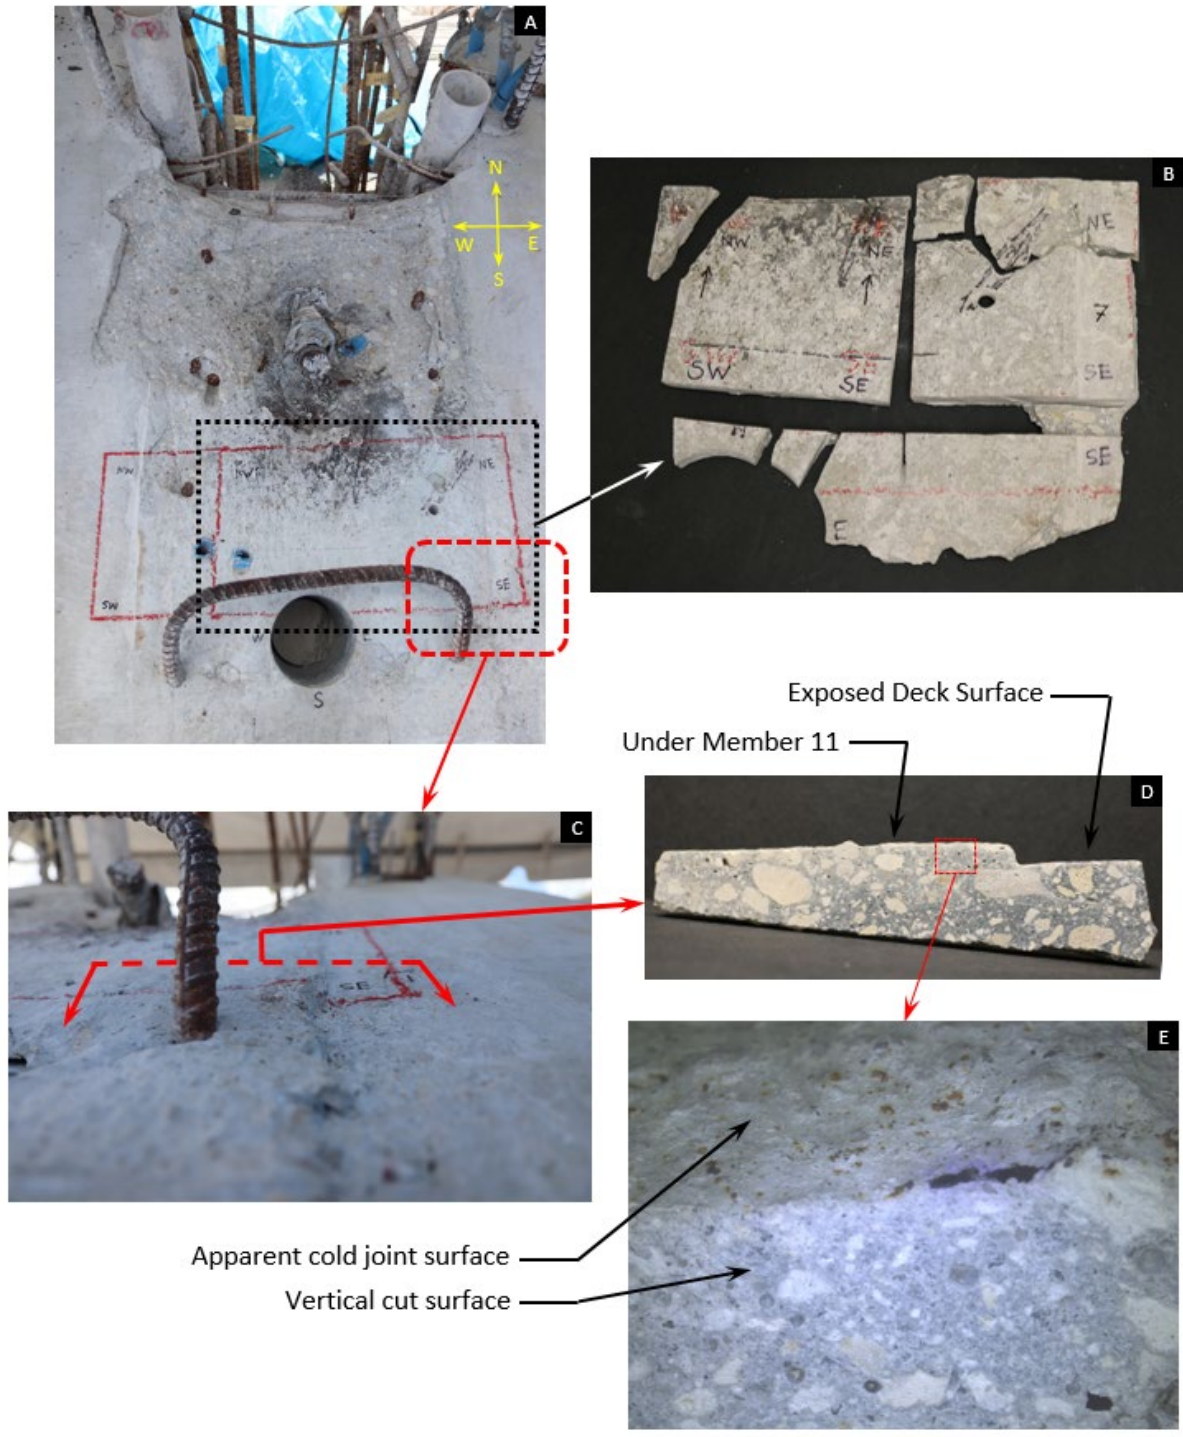
Further investigation was completed on the portion of the interface on the southern end of the connection between Member 11 and the deck. Figure 10 provides a series of photos related to the interface after it had been removed from the collapse site. The photo in Part A shows the interface, this time after the free length of the post-tensioning rod had been removed and a core hole had been cut into the south end of the interface. The concrete under the southern portion of the interface had become delaminated on a horizontal plane at a depth approximately 1 inch below the visible surface. A portion of that delaminated concrete was collected as evidence and is shown in the photo in Part B. Note that the delamination extended beyond the area under Member 11 into the area under the finished concrete surface of the deck. It is likely that this delamination occurred after the collapse initiated, quite likely in relation to the deck impacting the ground after falling off the pier.

The image in Part C shows a view along the deck looking south to north along the east edge of where Member 11 met the deck. An elevation increase from right to left is visible in the center of the photo; this location coincided with the eastern edge of Member 11. The relative smoothness of the surface of both the finished deck and the interface under Member 11 is evident.

The photo in Part D shows an east-west vertical slice of concrete that was cut from the delaminated concrete along the line identified in Part C. Note that the right side of the image shows concrete that was from the deck east of the member and the elevation change in the horizontal concrete surface indicates the eastern extent of where Member 11 met the deck. By looking at the combination of the paste and aggregates in this concrete slice, it is apparent that there is no other cold joint throughout this depth of concrete. The smoothness of the top surface of the interface is also apparent.

Part E shows a close-up isometric view of the concrete along a small portion of the interface. The vertical slice shows concrete paste and fine aggregates. The top of the image shows the interface surface. This surface is largely composed of cementitious paste, which in some locations appears to cover slightly protruding larger aggregates. Throughout the southern half of the interface between Member 11 and the deck there are relatively few locations where an aggregate piece in the concrete appears to have protruded through the interface and been sheared off prior to or during the collapse.

Figure 10. Interface surface under Member 11.

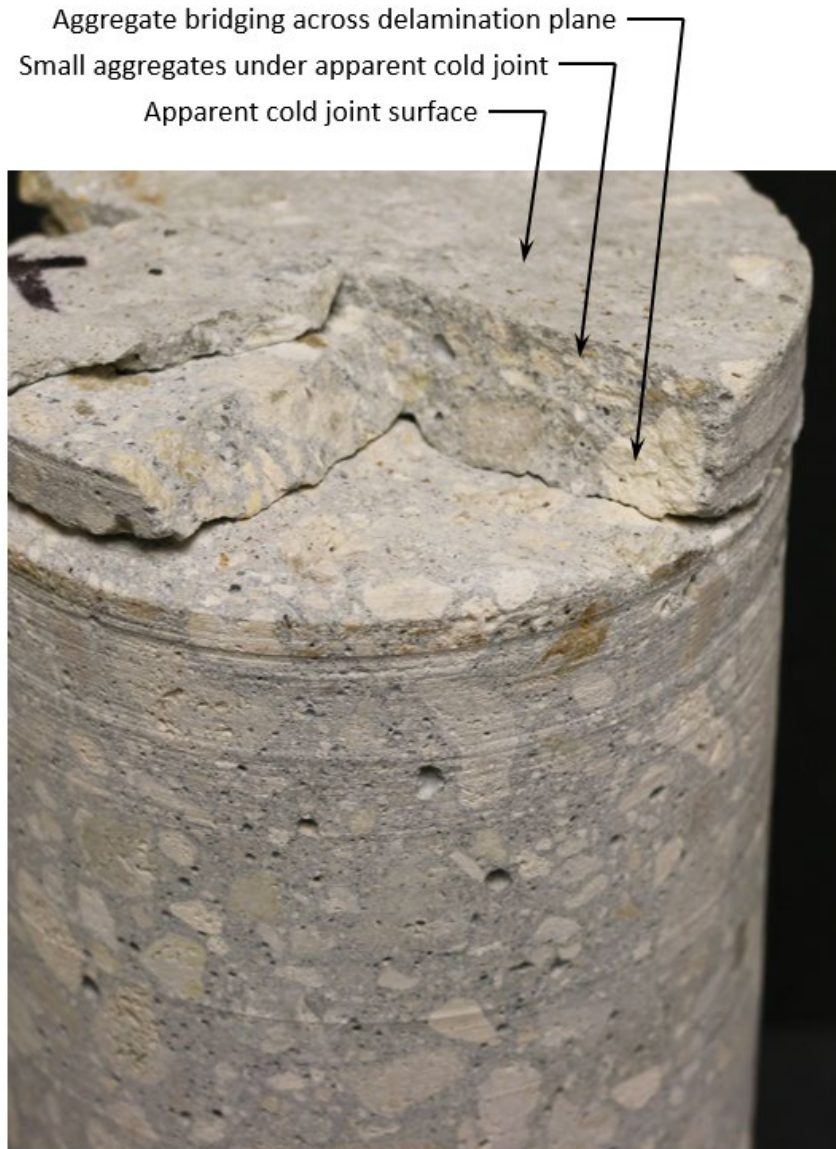
Further evidence related to the interface is provided by a core that was taken vertically down through the interface near the southern end of where Member 11 met the deck. This core is shown in Figure 11. As was discussed previously, there was a delamination layer under the interface surface. The photo in the figure is annotated to identify key features. The top of the core shows the apparent cold joint surface at the interface. This surface is largely concrete paste with a small number of fractured aggregates. The vertical fractured surface in the delaminated piece shows small aggregates immediately under the top surface. On this surface there are also a few larger aggregates, one of which is identified as being fractured where it crosses the delamination plane. This is indicative of the delamination plane having been caused by mechanical stressors and not by its having originally been a cold joint. Further examination through the depth of the core make apparent that 1) the concrete under Member 11 was well consolidated, and 2) the cold joint between the deck pour and the member pour was not at a location beneath the failure interface.

Figure 11. Annotated image of core extracted from south end of interface surface under Member 11.
