NATIONAL TRANSPORTATION SAFETY BOARD

HIGHWAY FACTORS GROUP CHAIRMAN'S FACTUAL REPORT

Location: 14000 block US 441, Delray Beach, Palm Beach County, Florida
Vehicle 1: 2019 International truck-tractor in combination with a 2008 Vanguard semi-trailer
Operator 1: FirstFleet, Inc., Murfreesboro, Tennessee
Vehicle 2: 2018 Tesla Model 3
Operator 2: Private operator
Date: March 1, 2019
Time: Approximately 6:17 a.m. (local time)
NTSB #: **HWY19FH008**

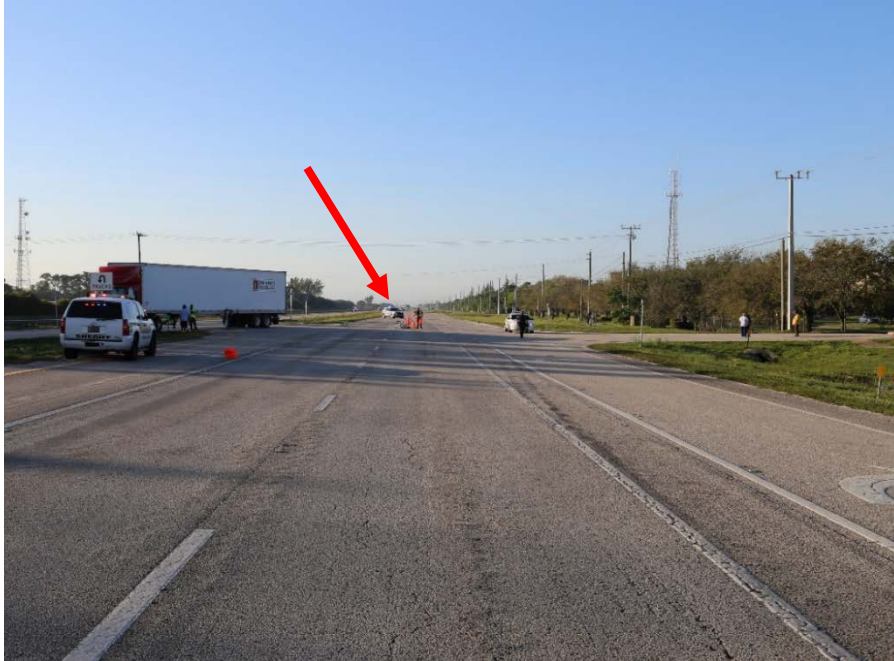
The agricultural facility, Pero Family Farms LLC, is a large agricultural firm that employs hundreds of workers and operates 24-hours a day, seven days a week. In addition to the corporation's own truck fleet, outside trucking companies provide support to the agricultural business. On average over one hundred large trucks enter or exit the facility. In addition to large trucks, a multitude of vans, smaller trucks and passenger vehicles enter and exit the facility dropping off or picking up workers. The large number of vehicles trying to enter the facility causes a traffic backup onto the highway shoulder. **Figure 2** shows the southbound view of US 441 as you approach the crash intersection. The combination vehicle struck by the Tesla is seen parked in the highway crossover area. The red arrow indicates the final rest location of the Tesla.

Figure 2 Southbound view of US 441 showing the approach to the crash intersection (PBSO)

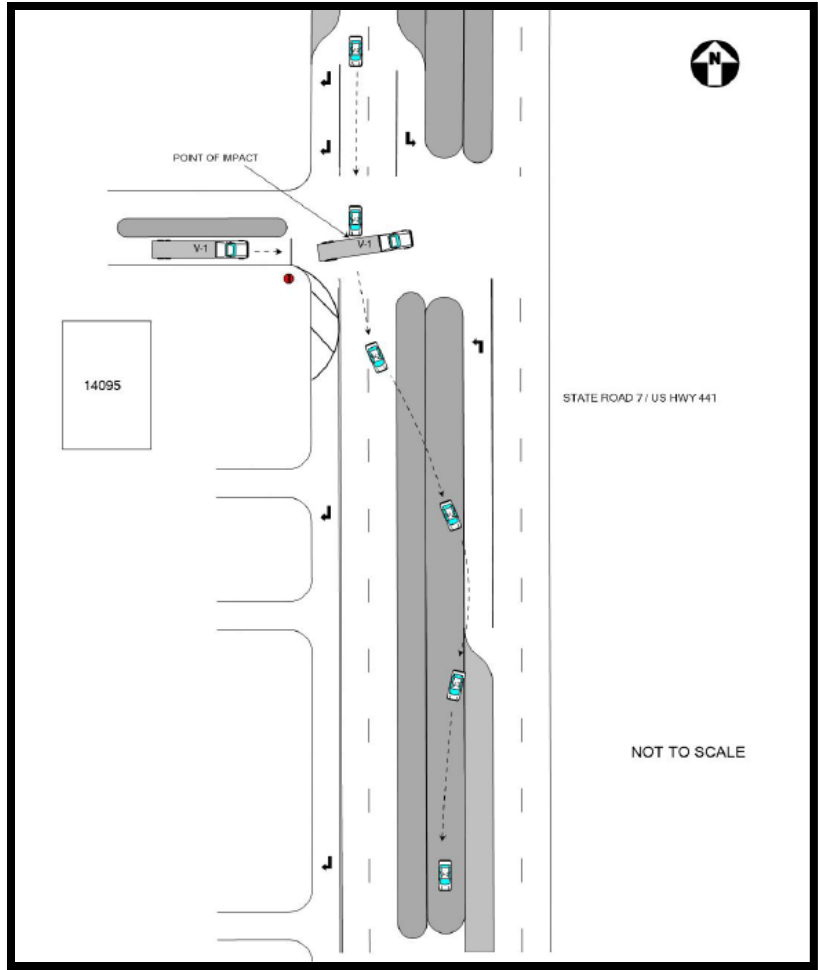
The crash occurred when a truck tractor in combination with a semi-trailer traveling eastbound from the agricultural facility entered the highway and attempted to cross over the southbound lanes. The driver of the combination vehicle stopped to yield to oncoming northbound vehicular traffic which resulted in his vehicle blocking all the southbound lanes. The driver of the Tesla failed to react to the truck in his path and struck the semi-trailer in front of the rear dual tandem wheels on the left side of the truck. The Tesla under-rode the semi-trailer and continued southbound before stopping in the earthen median. **Figure 3** is a diagram of the crash scene provided by the Palm Beach County Sheriff's Department.

Figure 3 Diagram of the crash scene by PBSO

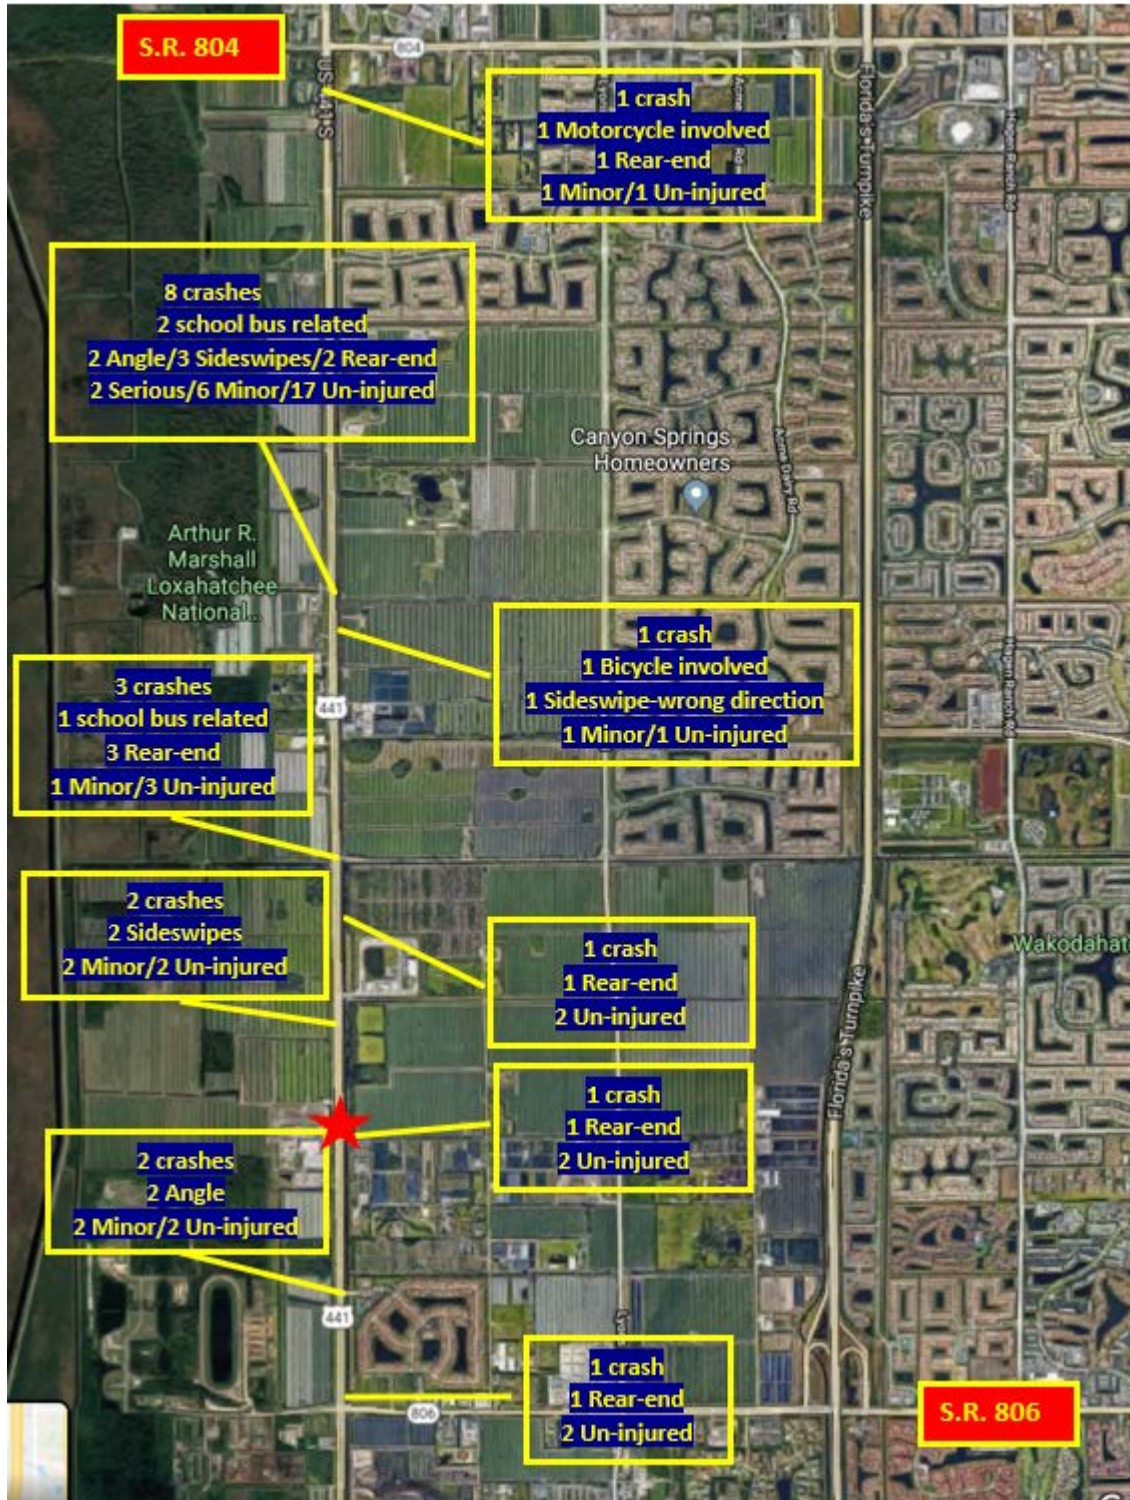
A closer examination of the crash data provided by FDOT for the five-mile corridor was conducted. Of the 34 collisions reported by FDOT to have occurred within the corridor, two crashes were found to have occurred outside of the specified area examined in this report and will not be discussed further. Only 32 of the crashes occurred within the U.S. 441 corridor between S.R. 804 and S.R. 806 and did not occur at the intersection of the two state roads. Six of the reported collisions occurred in the parking lots of various businesses adjacent to the highway, and one collision occurred inside of the recycling plant. Four crashes involved single vehicle “run off roadway” incidents and another three crashes involved roadway mishaps not related to the investigation. These mishaps include wildlife encursion onto the roadway, a vehicle colliding with an object that fell from a lead vehicle and the mechanical failure of a vehicle that resulted in the complete tire separation from the car. The remaining 20 collisions occurred on the highway. All the crashes occurred on U.S. 441 at the intersections of roadways, private driveways or within a hundred feet of these locations except one. **Figure 5** is a Google satellite map of the corridor, showing specific elements of the collisions. The crashes were broken down by their location, the involvement of unique vehicle types (i.e. bicycle, motorcycle, school bus), the type of collision sequence (initiating action) and the overall injuries sustained by the involved individuals. The red star denotes the location of the crash intersection.

Figure 5 Google satellite map showing crash locations, types and injuries that occurred within the U.S. 441 crash corridor between 2010-2015. (Note: the red star denotes the location of the intersection of U.S. 441 and the private driveway for Pero Farms.)

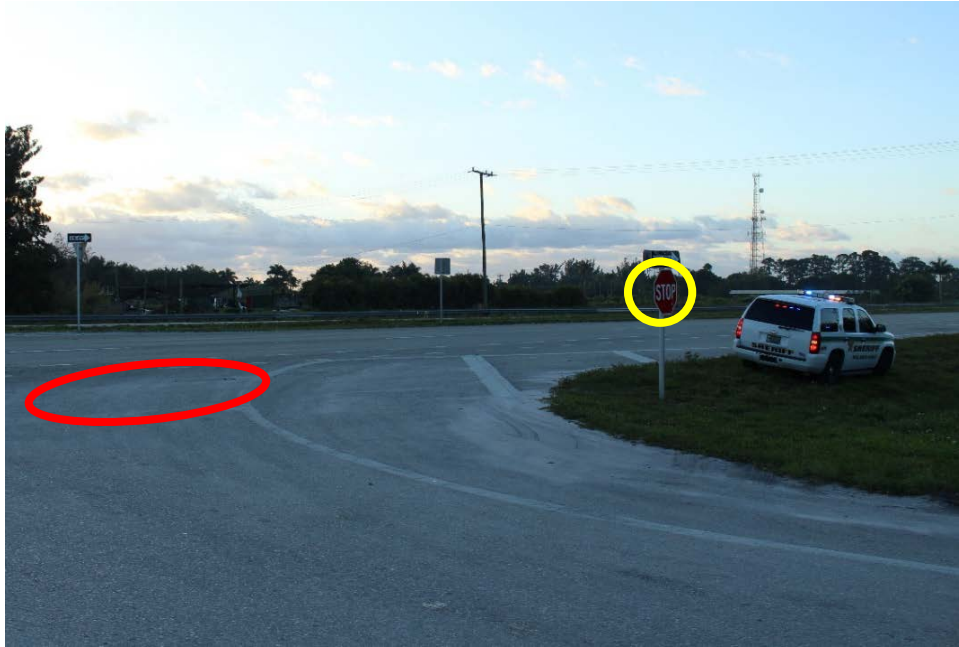
In addition to signs indicating the posted 55 mile per hour speed limit; at the exit to the private driveway and prior to entering the highway, a stop sign was located on the right grassy shoulder of the roadway. At that location, a stop bar was also present to indicate the location vehicular traffic was required to stop before entering the highway. Both traffic control devices were installed and required to be maintained by FDOT. Due to exposure to the environment, the painted stop bar has almost been entirely obliterated. **Figure 6** is a photograph showing a close-up of the private driveway exit, the stop sign, and the faded stop bar.

Figure 6 Photograph showing close-up of private driveway exit, stop sign (circled in yellow) and faded stop bar (circled in red). (PBSO)

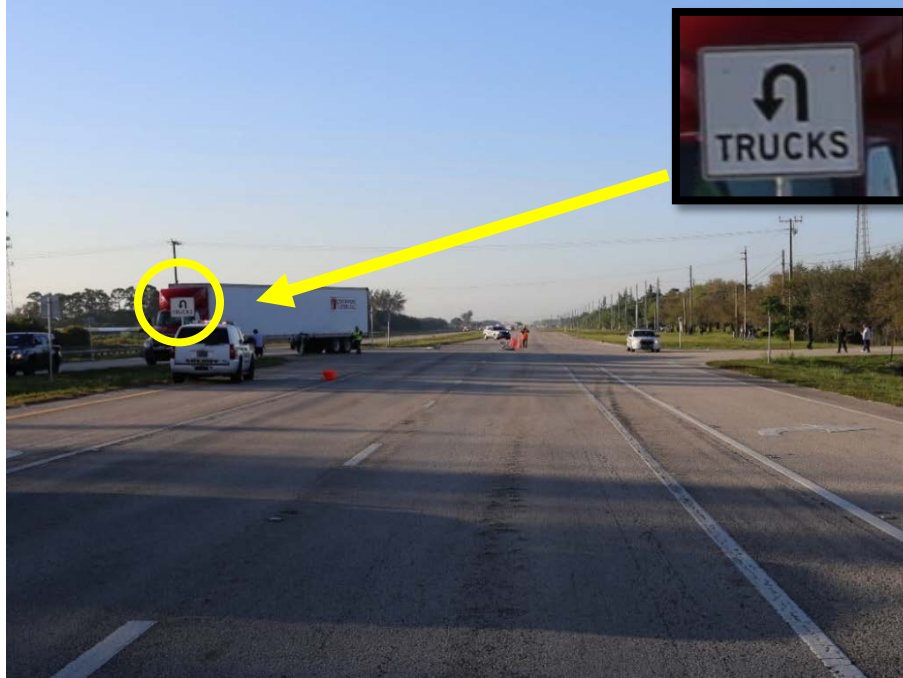
At the location of the highway crossovers in the five-mile crash corridor; a “Designated Truck U-Turn Ahead” sign has been installed by FDOT to facilitate the use of the highway crossovers by trucks and provide warning to other vehicular traffic that trucks will be turning at that location. **Figure 7** shows the “Truck U-turn” sign present at the crash intersection in the southbound direction. **Figure 8** shows the “Truck U-turn” sign present at the crash intersection in the northbound direction. **Figure 9** shows the additional paved surface on the northbound side of US 441 for combination vehicles that require additional space when making wide radius turns when turning from the southbound lanes.

Figure 7 Photograph of the designated “Truck U-turn” sign (shown in the yellow circle and located at the highway crossover in the southbound direction. The inset shows a close-up view of the sign (PBSO)

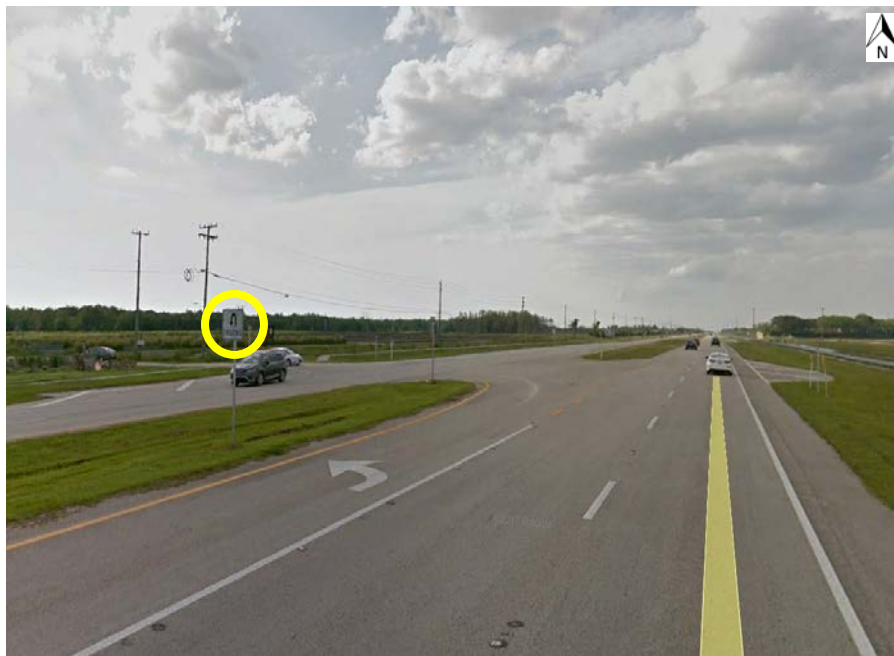
Figure 8 Photograph of the designated “Truck U-Turn” sign (shown in the yellow circle) and located at the highway crossover in the northbound direction.

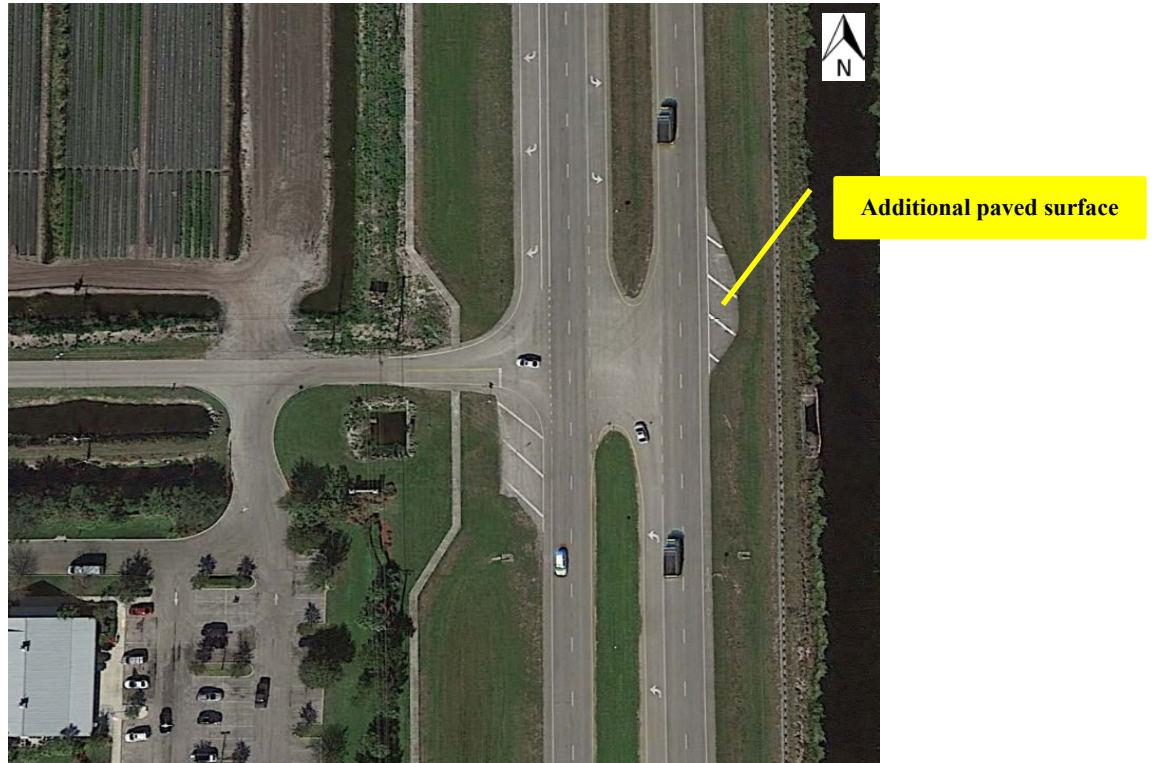
Figure 9 Shows additional paved surface in the northbound direction for combination vehicles that require additional space to make wide radius turns when turning from the southbound lanes.

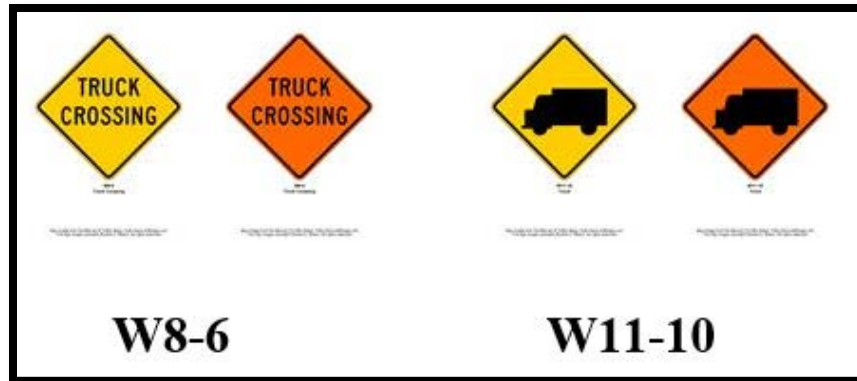
The Manual on Uniform Traffic Control Devices (MUTCD)⁴ defines the minimum standards road managers nationwide use to install, ensure uniformity and maintain traffic control devices. The use of traffic control devices allows road facility managers to mitigate roadway hazards and address safety issues. FDOT installed the “Designated Truck U-Turn Ahead” sign at the intersection of the private driveway and US 44. However, there are no warning signs prior to the location to indicate to motorists that at this intersection, trucks will be frequently crossing the roadway. The MUTCD provides guidance in the use of supplementary warning signs to advise roadway users to expect vehicles entering and crossing over the roadway. An example of a supplemental warning sign that could have been installed by FDOT at the crash location is the “Truck Crossing” sign. The placement of a “Truck Crossing” warning sign, in advance of the approach to the intersection, can assist motorists in anticipating and recognizing traffic hazards by identifying locations where trucks would likely be crossing the highway. An illustration of the MUTCD “Truck Crossing” warning sign designated as W8-6 or W11-10 is shown in **Figure 10**.

Figure 10 Illustration of the MUTCD “Truck Crossing” warning signs designated as W8-6 and W11-10.
