**FACTUAL REPORT OF INVESTIGATION
TESLA MODEL X COLLISION
VEHICAL AND SURVIVAL FACTORS FACTUAL REPORT**

HWY18FH011

**NATIONAL TRANSPORTATION SAFETY BOARD
OFFICE OF HIGHWAY SAFETY
WASHINGTON, D.C.**

VEHICAL AND SURVIVAL FACTORS FACTUAL REPORT

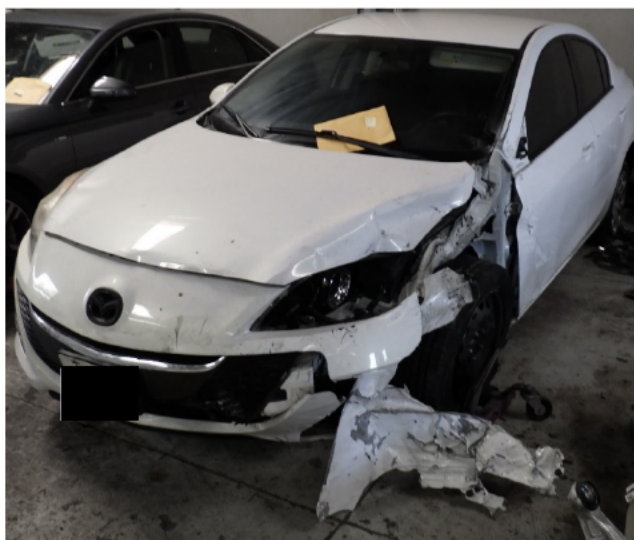
The 2010 Mazda 3 had VIN JM1BL1SG9A1XXXXXX. The Mazda sustained damage on the left front. Figures 1 and 2 show a left front view and right front view of the Mazda, respectively. Figures 3 and 4 show a left rear and right rear view of the Mazda, respectively.

Figure 1: Left front view of the Mazda

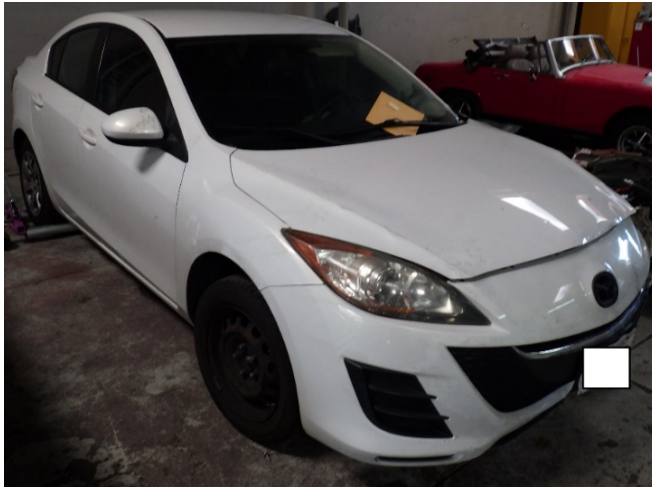
Figure 2: Right front view of the Mazda

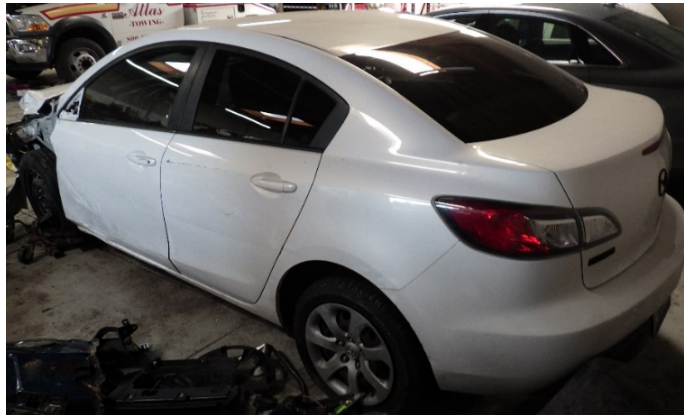
Figure 3: Left rear view of the Mazda

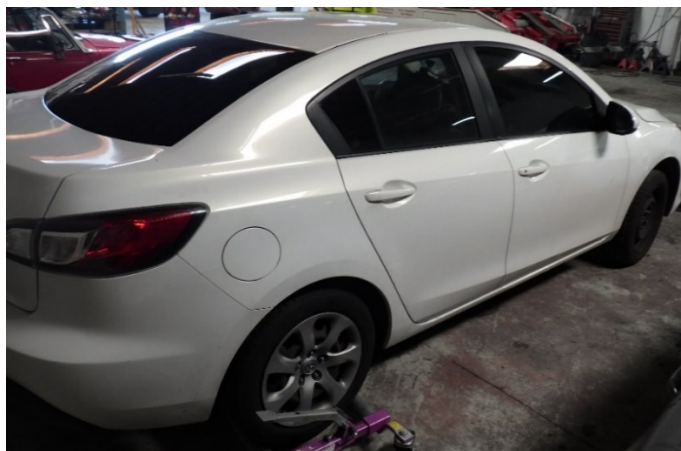
Figure 4: Right rear view of the Mazda

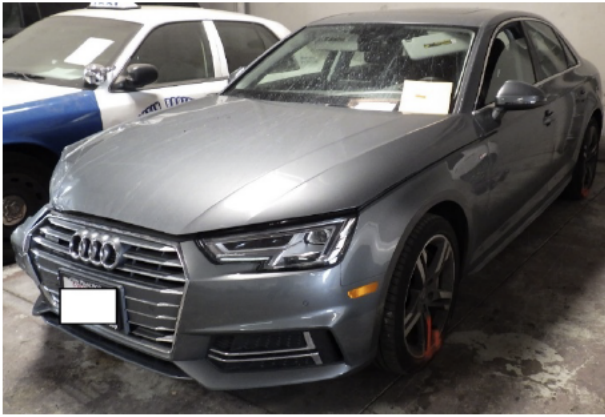
The 2017 Audi A4 had VIN WAUENAF41HNXXXXXX. The Audi sustained minor damage at the right front and right rear. Figures 5 and 6 show a left front view and right front view of the Audi, respectively. Figures 7 and 8 show a left rear and right rear view of the Audi, respectively.

Figure 5: Left front view of the Audi

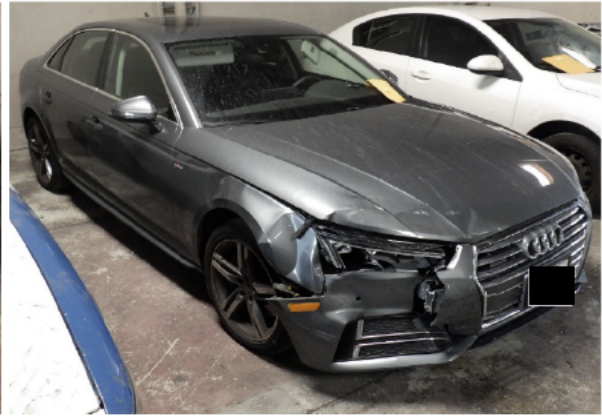
Figure 6: Right front view of the Audi

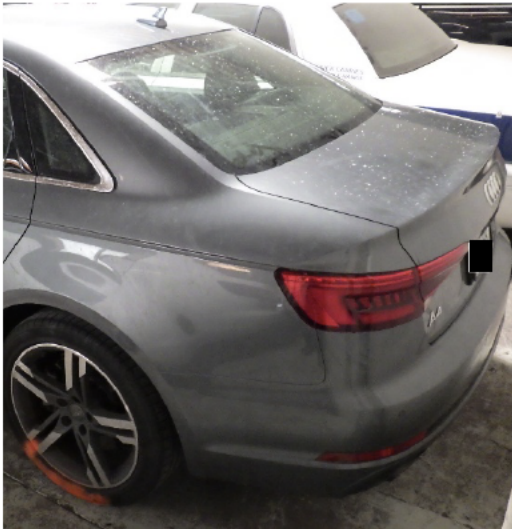
Figure 7: Left rear view of the Audi

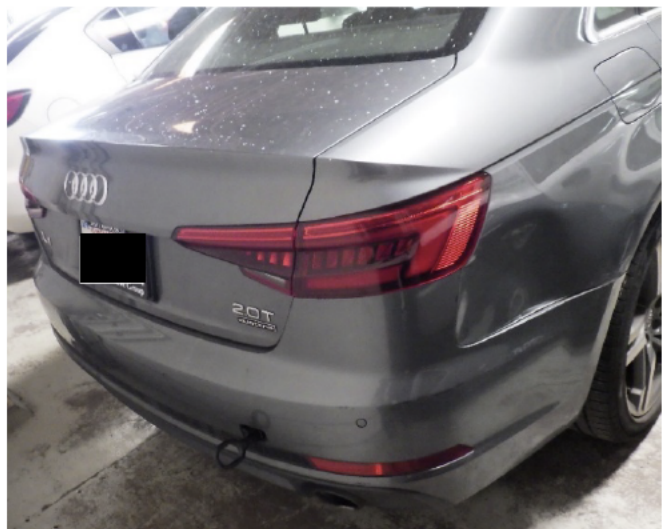
Figure 8: Right rear view of the Audi
