**NATIONAL TRANSPORTATION SAFETY BOARD
OFFICE OF HIGHWAY SAFETY
WASHINGTON, D.C.**

**SURVIVAL FACTORS GROUP CHAIRMAN'S
FACTUAL REPORT**

Location: 14000 block U.S. 441, Delray Beach, Palm Beach County, Florida
Vehicle 1: 2019 International truck-tractor in combination with a 2008 Vanguard semi-trailer
Operator 1: FirstFleet, Inc., Murfreesboro, Tennessee
Vehicle 2: 2018 Tesla Model 3
Operator 2: Private operator
Date: March 1, 2019
Time: Approximately 6:17 a.m. (local time)
NTSB #: **HWY19FH008**

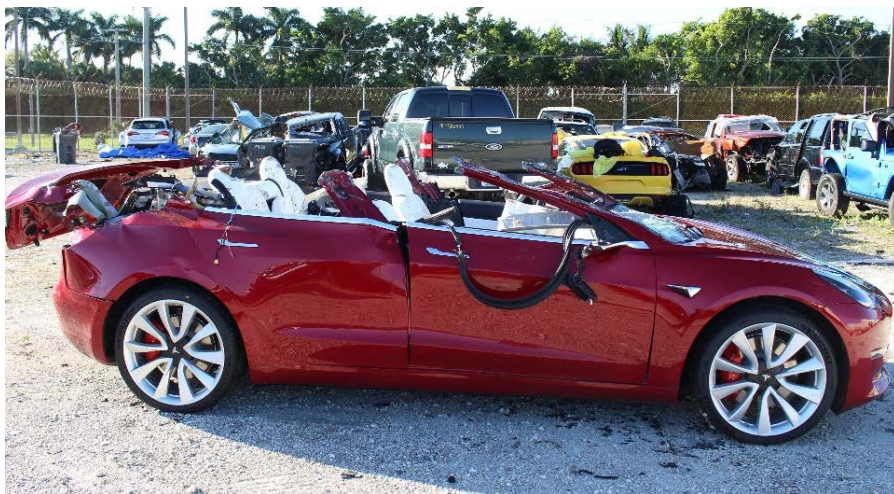
During the crash, the passenger vehicle struck the left side of the semi-trailer approximately 17 feet, 6 inches from the end of the trailer. As the vehicle under-rode the trailer, the glass roof was sheared off, along with the side curtain airbags that were attached to the "A" pillar near the headliner. Components from the vehicle's roof were recovered from both the exterior as well as the interior of the semi-trailer. After the vehicle detected the collision level event, the transmission automatically shifted into neutral, the hazard warning lights activated and began flashing and the vehicle coasted to a stop approximately 1600 feet from the point of impact. Extensive cosmetic damage was incurred by the vehicle in the crash. However, most of the vehicle's systems were still functional and no damage was sustained to the lithium-ion batteries. **Figure 1** shows the Tesla in the tow yard with extensive damage to the roof.

Figure 1: Photograph showing the Tesla Model 3 with extensive roof damage

Most of the damage to the Model 3 was isolated to the roof, windshield and surfaces above the height of the 3 feet 6 inches on the vehicle. This corresponds to the height of the semi-trailer at the point where the vehicle under-rod it. Despite the severity of the impact which “woke up” the “Restraint Control Module”, the airbags did not deploy. A post-crash examination of the vehicle found that the 50-year-old driver was still properly restrained by his lap-shoulder seatbelt. The attachment point, for the seatbelt assembly located on the “B” Pillar, was damaged during the crash but did not affect the securement of the driver. The driver sustained fatal blunt force traumatic injuries to the head consistent with contact with both the vehicle’s roof structure and the semi-trailer. Due to the dynamics of the collision, the crash was not survivable.

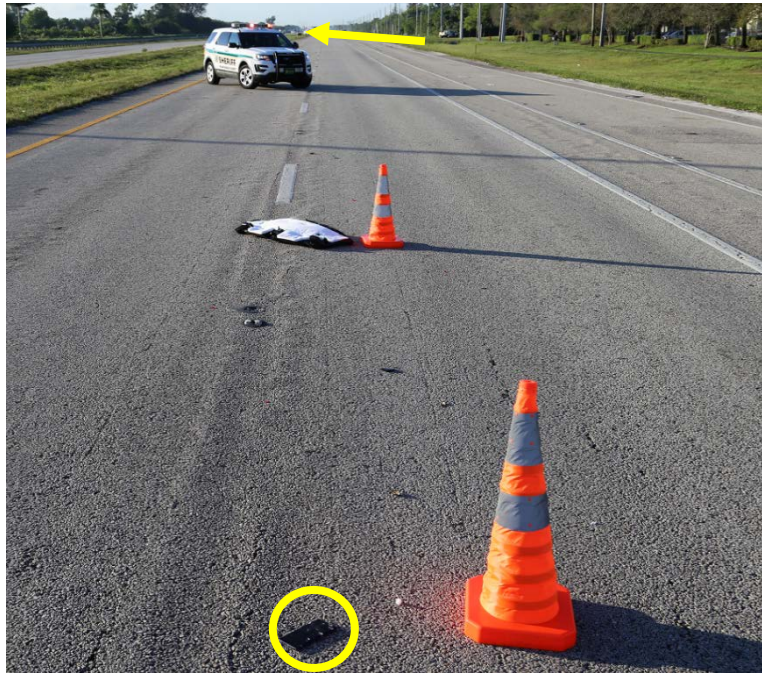
The emergency responders were unfamiliar with the operation of the Model 3 and did not know how to power off the vehicle. Despite the driver's cellphone being ejected from the vehicle during the crash, the car remained powered up because the key card was still inside of the vehicle. **Figure 2** shows the location of the driver's cellphone and its proximity to the Tesla post-crash.

Figure 2: Photograph showing the driver's cellphone, circled in yellow, that was ejected from the car. The yellow arrow indicates the location of the Tesla at final rest. (PBSO)

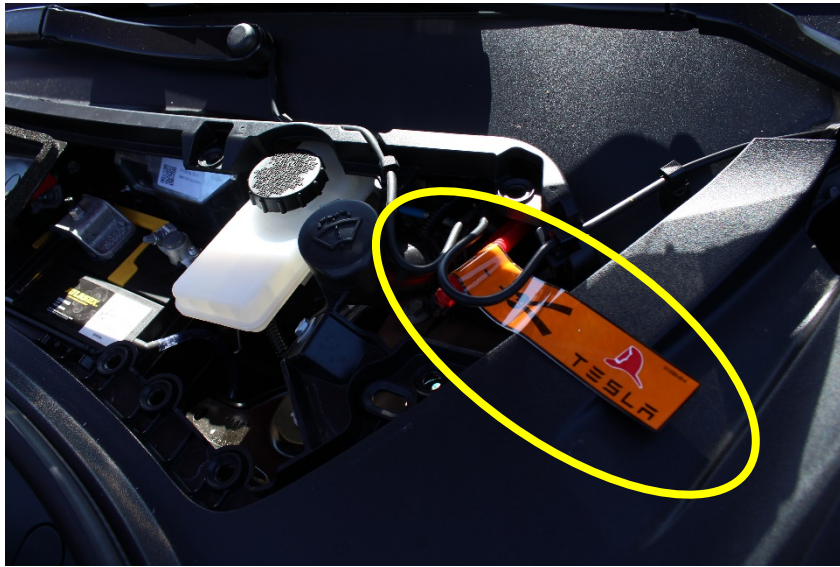
During the post-crash examination of the Tesla Model 3 at the tow yard, a fire department identification tag was observed in the engine compartment. Tesla installed these tags, on their newer model cars, to assist first responders with locating the designated place to cut the power cable in the event of an emergency. The Palm Beach County Fire Department personnel, on the scene, were unaware of the presence of this tag and no attempt was made to disconnect the power to the vehicle. **Figure 3** shows the tag still attached to the power cable in the engine compartment of the crash vehicle.

Figure 3: Photograph of the fire department tag on the power cable inside of the car's engine compartment.
