**NATIONAL TRANSPORTATION SAFETY BOARD  
OFFICE OF HIGHWAY SAFETY  
WASHINGTON, D.C.**

**VEHICLE FACTORS GROUP CHAIRMAN'S  
FACTUAL REPORT**

Location: 14000 block US 441, Delray Beach, Palm Beach County, Florida  
Vehicle 1: 2019 International truck-tractor in combination with a 2008 Vanguard semi-trailer  
Operator 1: FirstFleet Inc., Murfreesboro, Tennessee  
Vehicle 2: 2018 Tesla Model 3  
Operator 2: Private Operator  
Date: March 1, 2019  
Time: Approximately 6:17 a.m. (local time)  
NTSB #: **HWY19FH008**

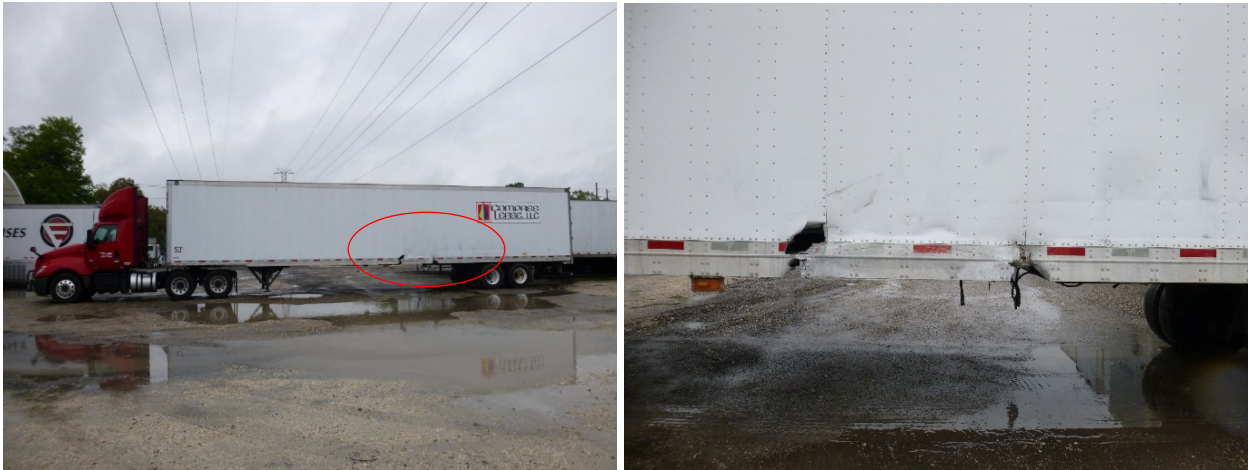
Post collision damage was limited to the semitrailer. There were two main areas of contact damage to the semitrailer as shown in **Figure 1 A-B** depicting the initial area of impact on the left side of the semitrailer. This consisted of impact damage to the lower edge of the sidewall rails on both sides of the semitrailer and the undercarriage between the opposing damaged rails. The height of the lower edge of the trailer was measured at 3’ 6” as shown in **Figure 2-A** and correlated to the damage to the passenger vehicle as shown in **Figure 2-B**.

Damage to the left side exhibited inward intrusion, while damage to the right side exhibited outward deformation.<sup>4</sup> The damage on both sides exhibited two distinct area of contact, that can be correlated to the left and right A-pillars of the Tesla. The undercarriage damage consisted of scrapes and gouges to the transverse floor support rails between the damaged area of the two sides.<sup>5</sup>

**Figure 1 A-B** - Photographs depicting the initial impact on the left side of the 2008 Vanguard semitrailer, area of impact circled in red, photo B is a focused view of the area of impact

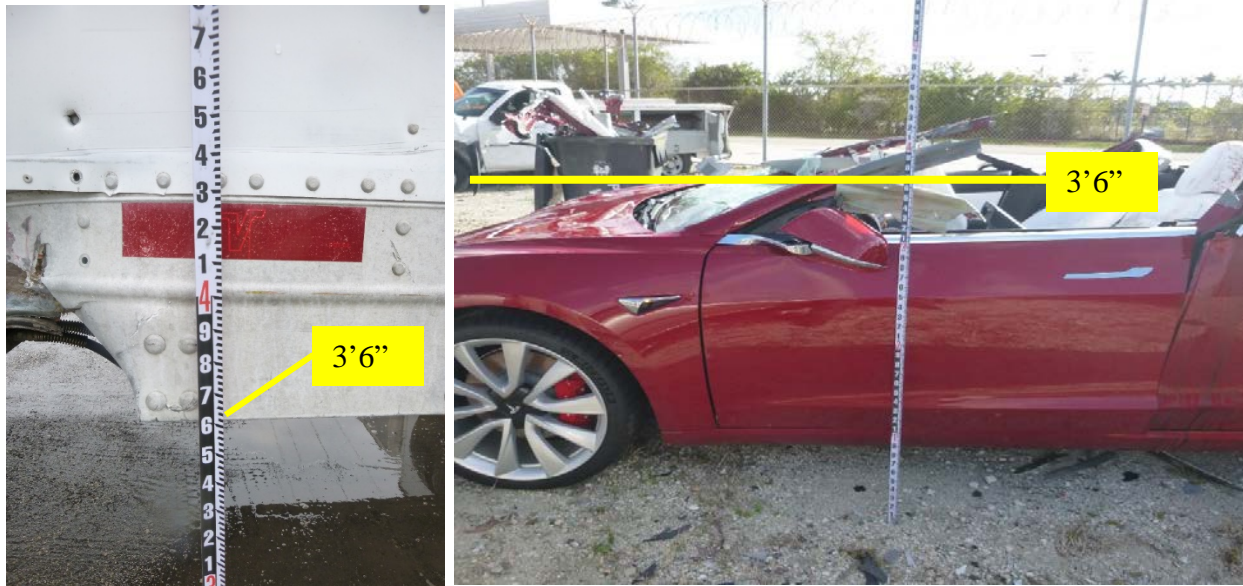
**Figure 2 A-B** - Photographs depicting the height of the lower edge of the trailer, measured at 3' 6" as shown in photo A and correlated to the damage to the passenger vehicle as shown by the yellow line in photo B.

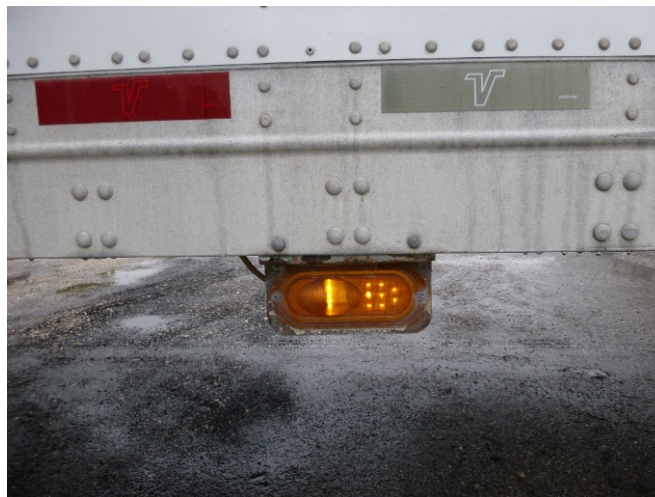
The combination unit's lighting system was illuminated during the inspection, headlights and side center amber marker lights were clearly visible. The trailer was equipped with red and white conspicuity reflective tape also known as *DOT C2 retro reflective tape*, as required along the lower edge on both sides as shown in **Figure 3**.<sup>6</sup>

**Figure 3** - Photograph depicting a view of the 2008 Vanguard semitrailer left side center amber marker light and red and white DOT C2 reflective retro reflective tape

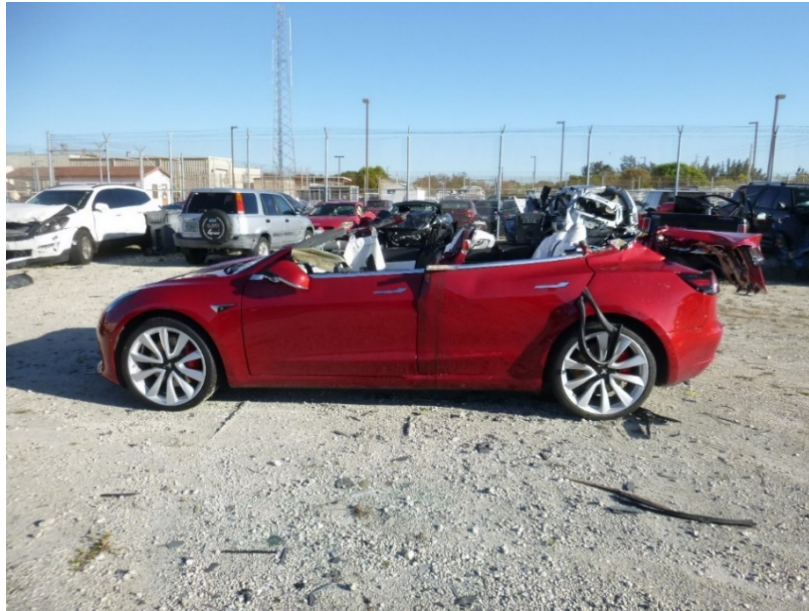
Damage to the Tesla, as shown in **Figure 4**, included separation of the glass roof panel and separation and deformation of the forward-facing surfaces of the vehicles A and B-Pillars just below where the roof met the pillars.<sup>19</sup> The rear trunk lid was displaced aft of its original position,<sup>20</sup>

and there was induced damage to the right rear quarter panel and displacement of the front passenger seat headrest.<sup>21</sup>

**Figure 4** - Photograph depicting the left side view of the 2018 Tesla Model 3, showing collision damage and separation of the glass roof panel

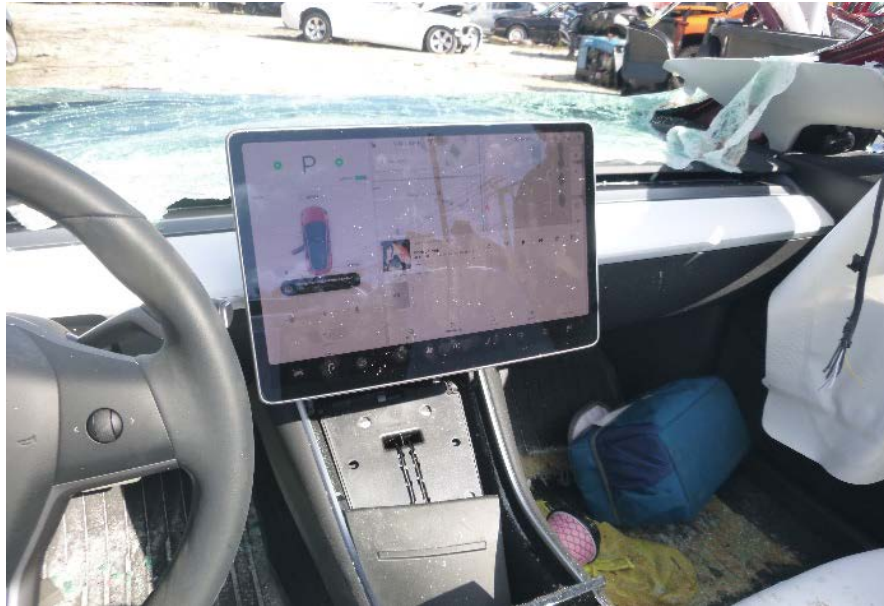
The Tesla Model 3 cabin was mostly free of buttons, switches and knobs. The main interface for most of the vehicle's systems was a 15-inch touchscreen, mounted on the center console as shown in **Figure 5**. The touchscreen was still functional and powered up during examination.

**Figure 5** - Photograph depicting the central 15-inch touchscreen mounted on the center console.
