MAINTENANCE AND POWERPLANT GROUP CHAIRMAN'S FACTUAL REPORT

ERA17MA316

**FAA SAIB SW-18-04, dated November 16, 2017, Subject ENGINE OIL
DRAINAGE SYSTEM**

SUBJ: Engine Oil Drainage System

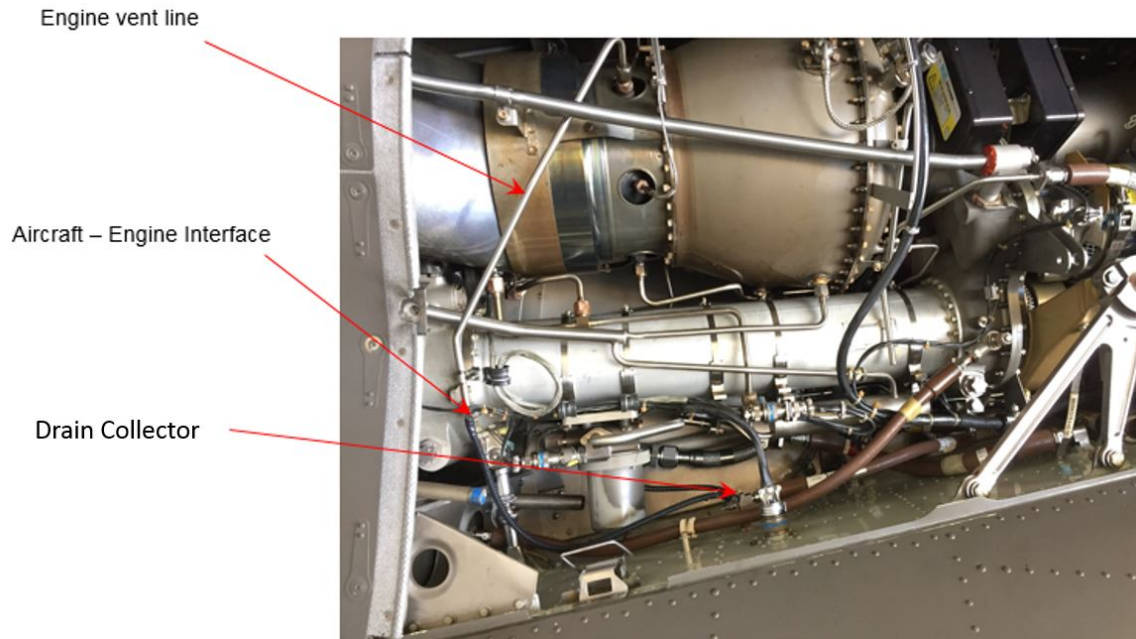
On January 26, 2017 an operator of a BK117 C-2 experienced an in-flight engine fire and made an emergency landing in Sioux Falls, South Dakota. Although still under investigation, the engine fire could be related to engine oil coke chips plugging the return scavenge line for the rear bearing of the gas generator. On September 8, 2017 a BK117 C-2 helicopter was destroyed when it crashed near Hertford, North Carolina. The NTSB preliminary investigation found that the number 2 engine rear turbine shaft bearing exhibited discoloration consistent with overheating and lack of lubrication. Through the course of inspecting the engine issue for scavenge line blockage, a BK117 C-2 operator discovered a separate, airframe-related issue. The operator detected various levels of coking blockage of engine drain lines. Airbus Helicopters prescribes a general visual inspection of the bearing compartment area. There are no prescribed inspections of the drain tube or drain collector to check for blockage. A blocked drain line may, under certain circumstances, present a risk for an engine fire and/or inflight shutdown of the affected engine.

The FAA recommends the actions below for all owners, operators, and maintainers of Airbus Helicopters BK117 C-2 helicopters. The actions should be performed for each engine at intervals not to exceed 100 hours time-in-service (TIS). Refer to Fig. 01 in Airbus Helicopters AMM 71-71-01, dated March 1, 2016 and to Figure 1 of this SAIB.

1. Disconnect the rear bearing lines part numbers AE709636-1 (hose), 117-600381.111 (hose), and 117-600381.105 (hose) from the drain collector part number B717M1028801 or 117-602061 (drain collector) and disconnect the drain collector from the engine deck.
2. Visually check the drain collector and hoses for obstructions. These obstructions may include carbon and coke deposits. Contact Airbus Helicopters for recommended cleaning procedures if there are any obstructions.
3. If there are no obstructions or after performing the above actions, reconnect the drain collector to the engine deck and reconnect the drain/vent lines to the drain collector per approved maintenance instructions.
