National Transportation Safety Board

Dry Ice Sublimation Study

Specialist Report

Location: Bakersfield, California
Date: November 23, 2018
Time: 1733 PST
Airplane: Cessna 208, N781FE
NTSB Number: WPR19IA030

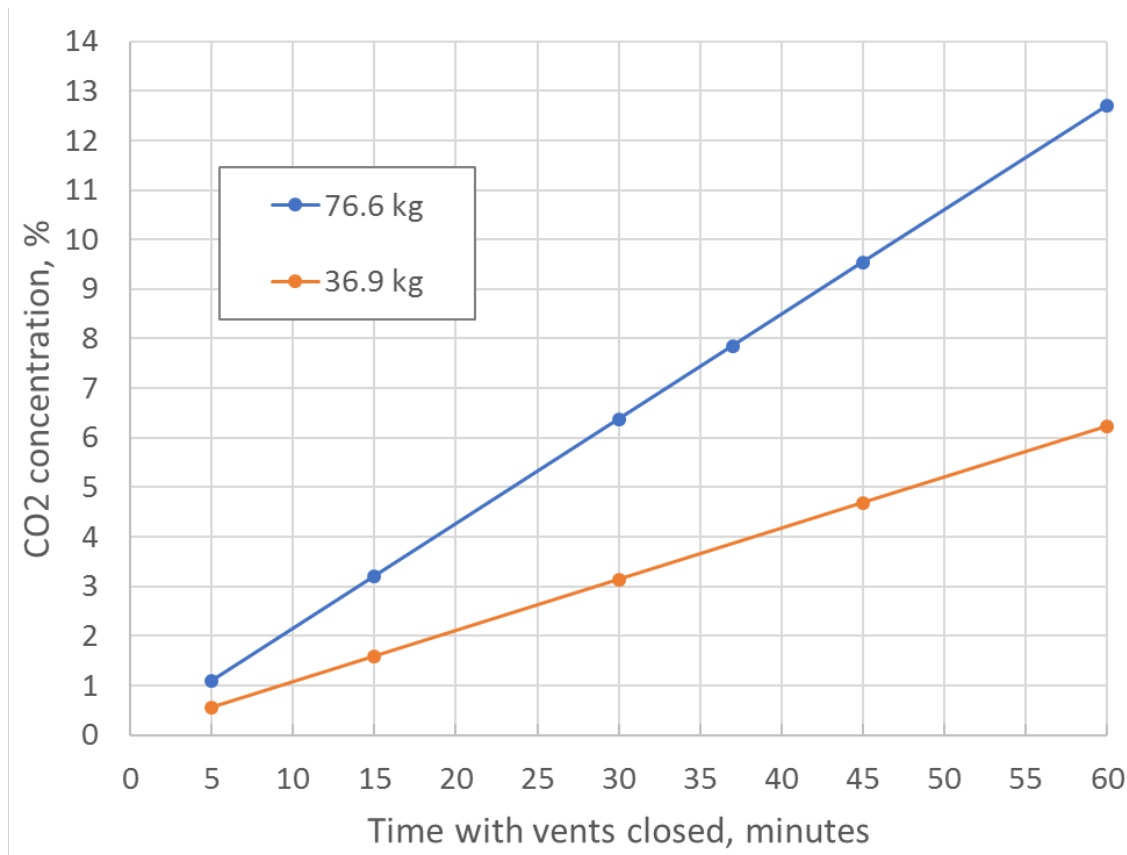
Figure 1. CO₂ concentrations versus time unvented from incident airplane configuration.

These results assume an airtight fuselage and uniform distribution of CO₂ through the air volume, so they should be considered estimates of the concentration. After five minutes in the unvented airplane, the CO₂ concentration was calculated to be above 1%, twice the FAA and OSHA standards. By 30 minutes, the concentration was above 6% and by one hour it could be above 12%.

If the initially reported 36.9 kg of dry ice had been loaded on the airplane the CO₂ concentrations would have been about half that of the 76.6 kg load, as shown in Figure 1. The CO₂ concentration could have exceeded 1% in about 10 minutes of unvented time.
