Brotherhood of Locomotive Engineers and Trainmen

Before the National Transportation Safety Board

NTSB Accident Number: RRD19FR001

Proposed findings, probable cause, and safety recommendations, in connection with the
collision of two Union Pacific Railroad freight trains near
Granite Canyon, Wyoming.

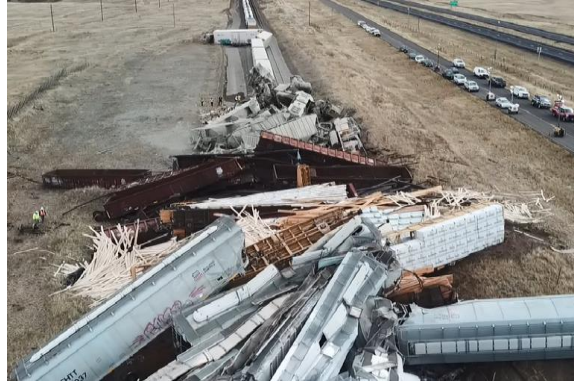
Figure 1 - Overview of collision (*Photo courtesy of UP*)

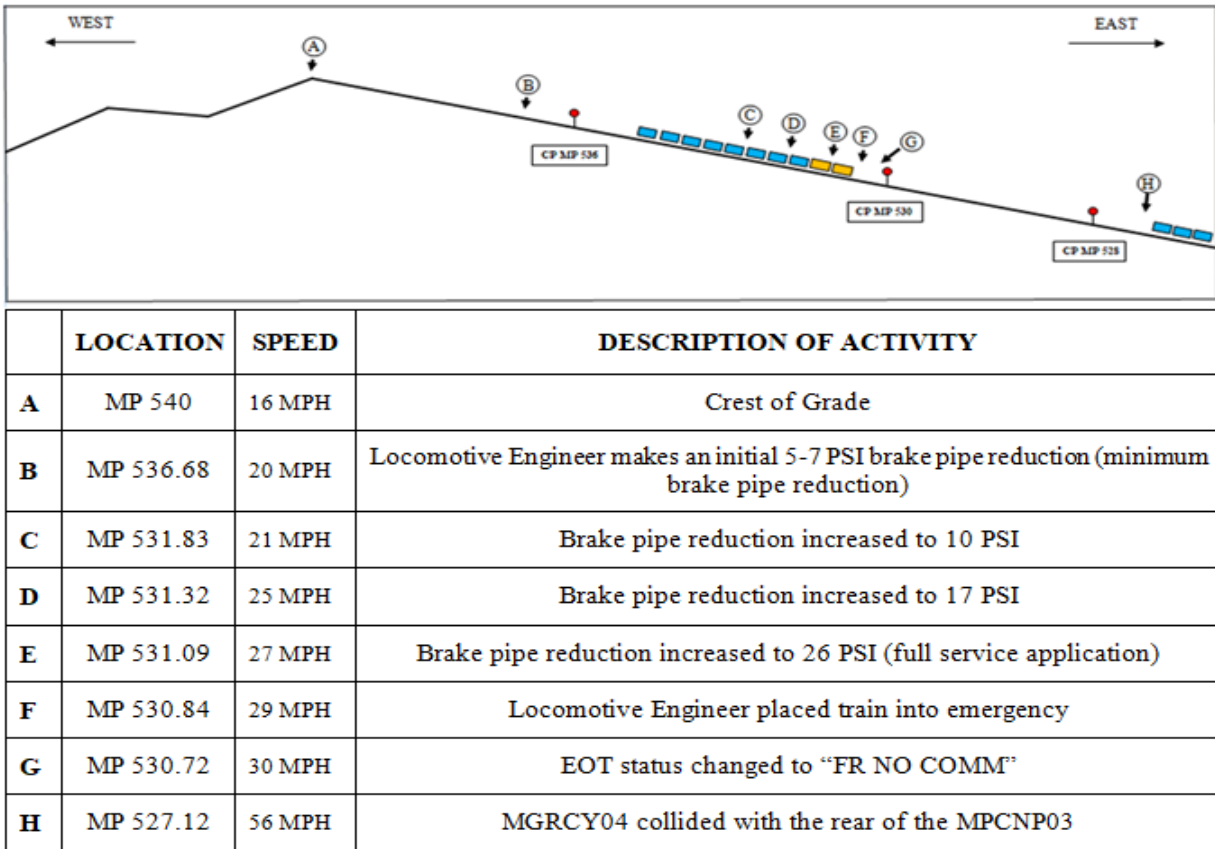
Figure 2 - Schematic of accident events¹⁵

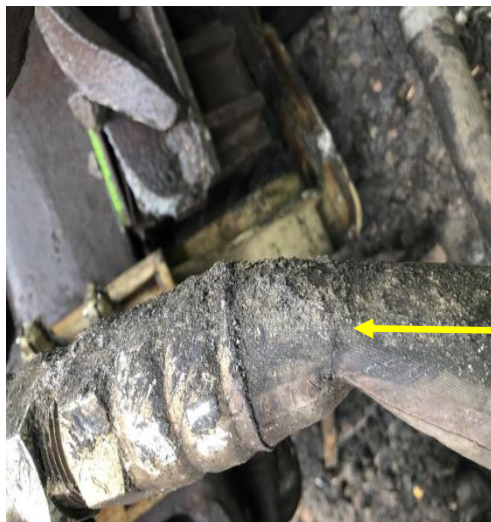
Figure 3 - Photo courtesy of NTSB

The event recorder download data from the UP 5412 reflected that the brake pipe was partially blocked when the train was in a bunched condition (increasing the cubic feet per minute “CFM” on the air flow meter “AFM”), and was subsequently unblocked when the train was in a stretched condition (reduced CFM on the AFM). In the post-accident on scene investigation, investigators recovered the intermediate air hose from the SSW 87597, which was positioned as the 20th railcar in the train. Between Green River and Laramie, this railcar was positioned as the first car in the train. The crew then added nineteen (19) cars to the head end of the train in Laramie, making the SSW 87597 the 20th car in the train. After these cars were added, the MGRCY04 did not stop again until the collision occurred.

Actual intermediate air hose from the end of 20th car (SSW 87597) showing kink in air hose, impeding proper air flow through the brake pipe of train.

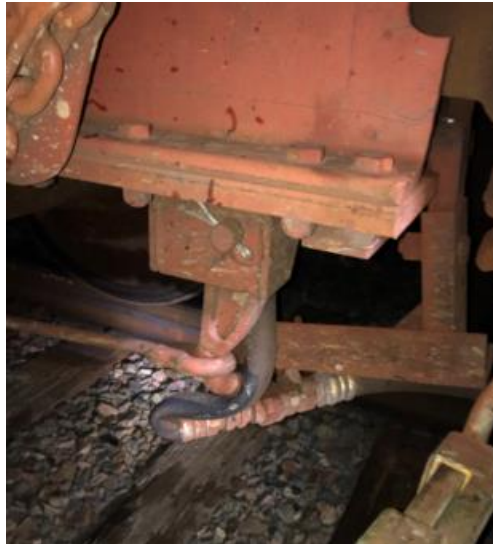
Figure 4 - Example of a kinked air hose found on a similar style freight car that was found between Cheyenne and Laramie, Wyoming after the instant accident at Granite Canyon, Wyoming (*Photo courtesy of UP*)
