NATIONAL TRANSPORTATION SAFETY BOARD

2022

SAFER SEAS Digest

Lessons Learned from
Marine Investigations

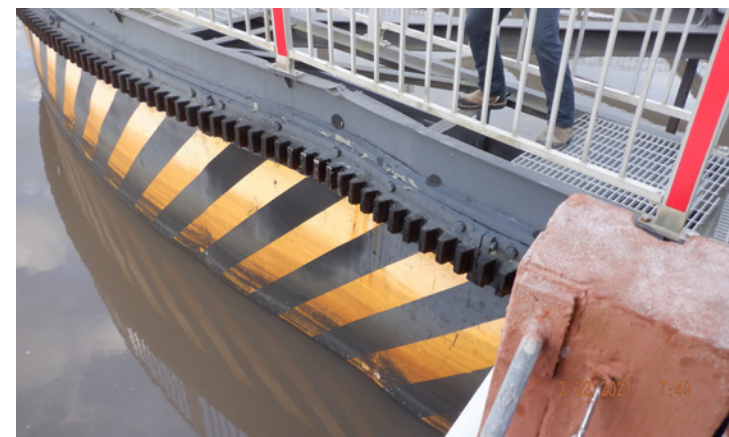
THE PROBABLE CAUSE of the contact of the *Ava Claire* tow with the Leland Bowman Lock gate was the towing vessel captain's decision to assume the helm watch and attempt a predawn transit into the lock immediately after awakening while he was likely impaired by sleep inertia.

Figure 38. Below: Damaged steel plating and rack on gate.

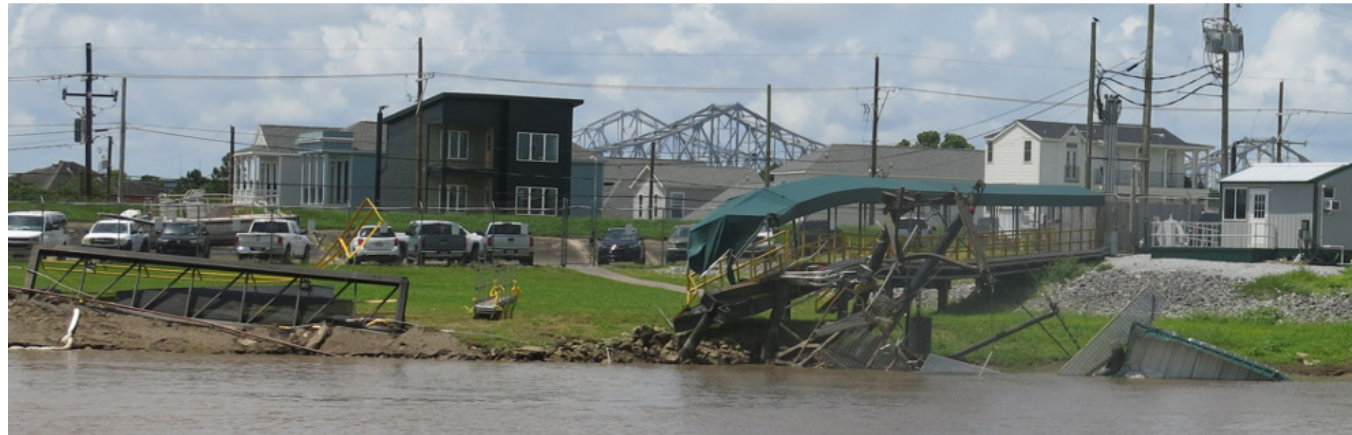
Figure 45. Postcasualty damage to office barge moorings, catwalks, and gangways.

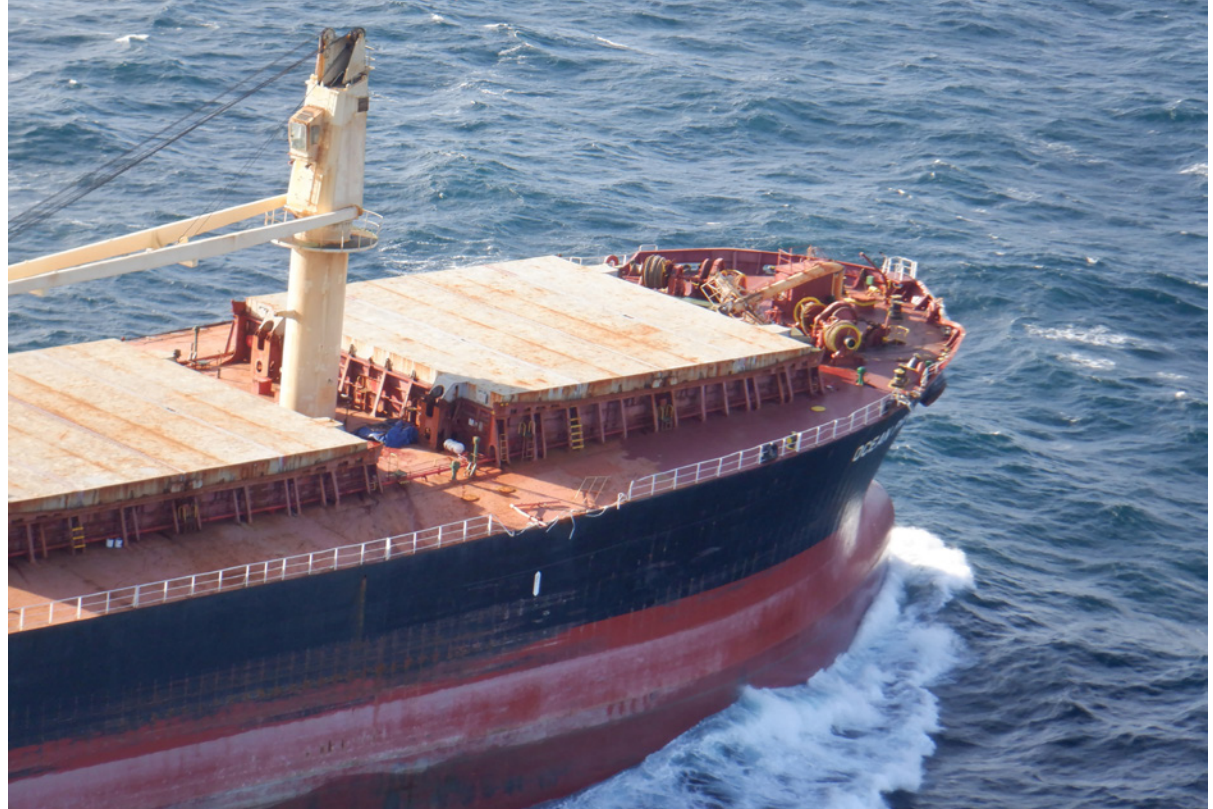
Figure 54. Knocked down mast and damaged bulwark, anchor windlass, and handrails on the *Ocean Princess* following the casualty. SOURCE: BUREAU OF SAFETY AND ENVIRONMENTAL ENFORCEMENT

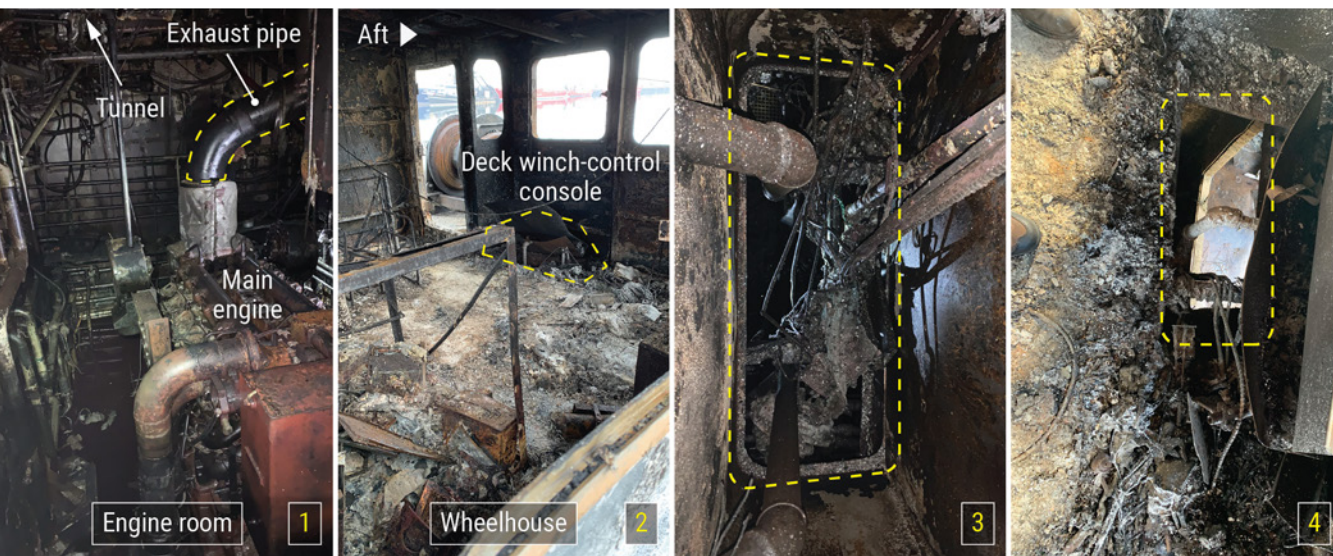
Figure 94. Left to right: Post-fire damage of (1) the engine room, where the crew removed the lagging from the exhaust pipe, as indicated by the dashed line; and (2) the wheelhouse, where the captain observed black smoke emanating from under the deck winch-control console. Damaged pipe/hose tunnel, as identified by dashed rectangles, looking up from the engine room (3), and down onto the deck winch-control console location (4).

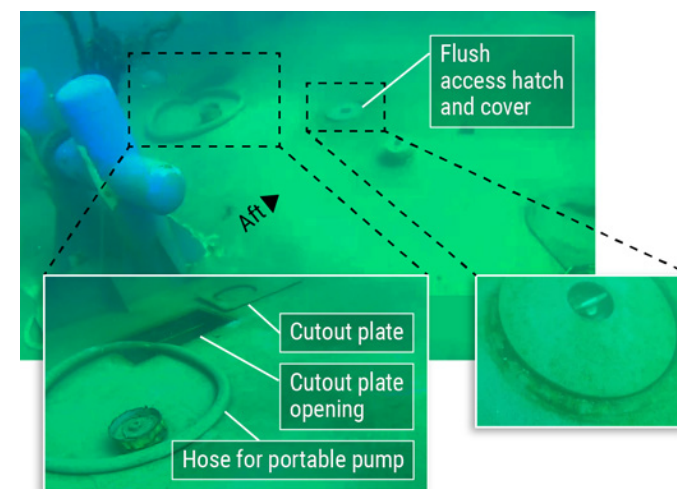
Figure 111. Starboard-side cutout plate with missing quick-acting flush access hatch cover (left close-up) and unseated center quick-acting flush access hatch cover to flanking rudder compartment (right close-up).

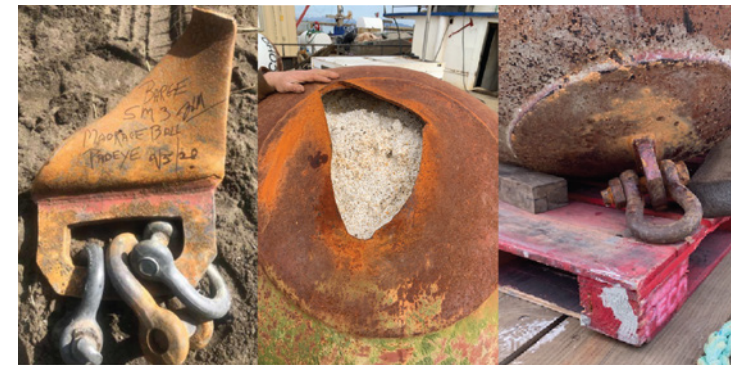
Figure 134. Left to right: *SM-3* mooring buoy: failed weld (with three shackles) that separated from buoy; damaged top with padeye missing; and undamaged bottom padeye.
