NATIONAL TRANSPORTATION SAFETY BOARD

2021

SAFER SEAS Digest

Lessons Learned from
Marine Investigations

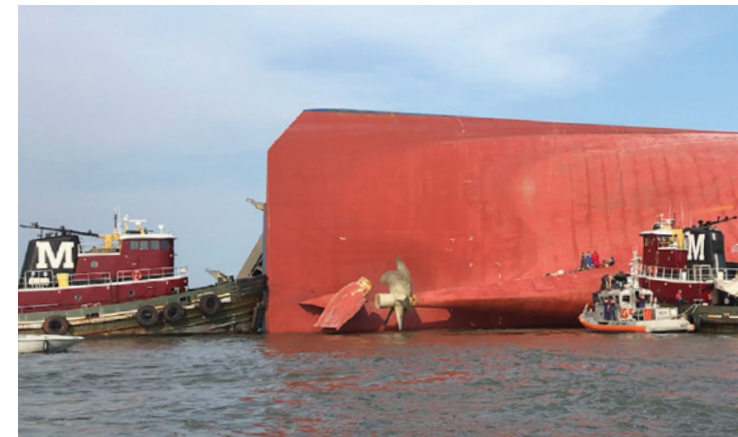
Figure 9. Emergency responders work to rescue the trapped engineers and cadet. SOURCE: COAST GUARD

The NTSB also found that the open watertight doors on deck 5 of the *Golden Ray* allowed flooding into the vessel and blocked the primary egress from the engine room, thus trapping engineering personnel. Watertight integrity is critical to the safety of a vessel and its crew, so the NTSB recommended that G-Marine revise its SMS audit process to verify crew adherence to the company's Arrival/Departure Checklist regarding the closure of watertight doors.

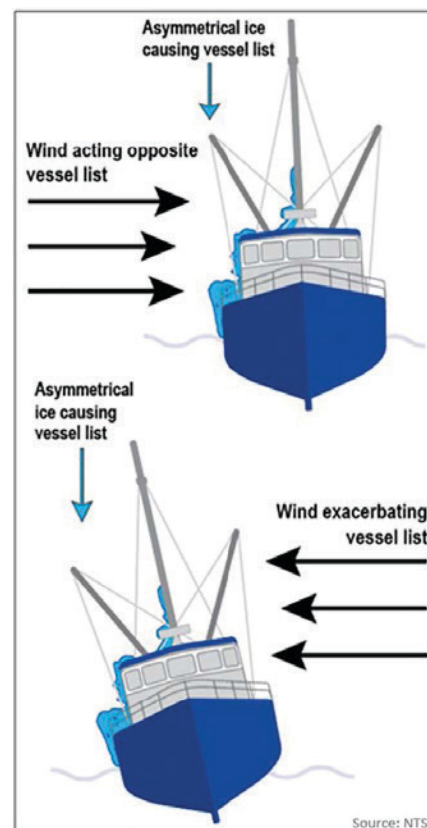
◆ **The effect of extreme icing conditions.** Sea spray icing is a serious hazard to marine vessels because the ice accumulates over exposed decks and exterior surfaces of a vessel, adding weight that may ultimately capsize a vessel. The *Scandies Rose* was carrying a full stack of pots that reached about 20 feet above the main deck, and ice from freezing spray formed asymmetrically on the starboard side and built as the voyage progressed. The added weight of accumulated ice high on a vessel—in this case, up the stack of pots, the fo’c’sle, bulwarks, and portions of the house—rapidly raises a vessel’s center of gravity and diminishes its stability. The asymmetrical icing on the starboard side of the *Scandies Rose* caused the vessel to develop an increasing starboard list, and the course change at 2145 brought the 60–70 knot winds onto the port side, adding to the existing list from icing. The sudden increase in list shortly later indicated that the vessel’s stability had been overcome and that the vessel was capsizing. The added weight from ice accumulating asymmetrically on the vessel and the stacked crab pots on deck raised the *Scandies Rose*’s center of gravity, reducing its stability and contributing to the capsizing.

Figure 15. Right. Diagram of ice and wind acting on the *Scandies Rose*.

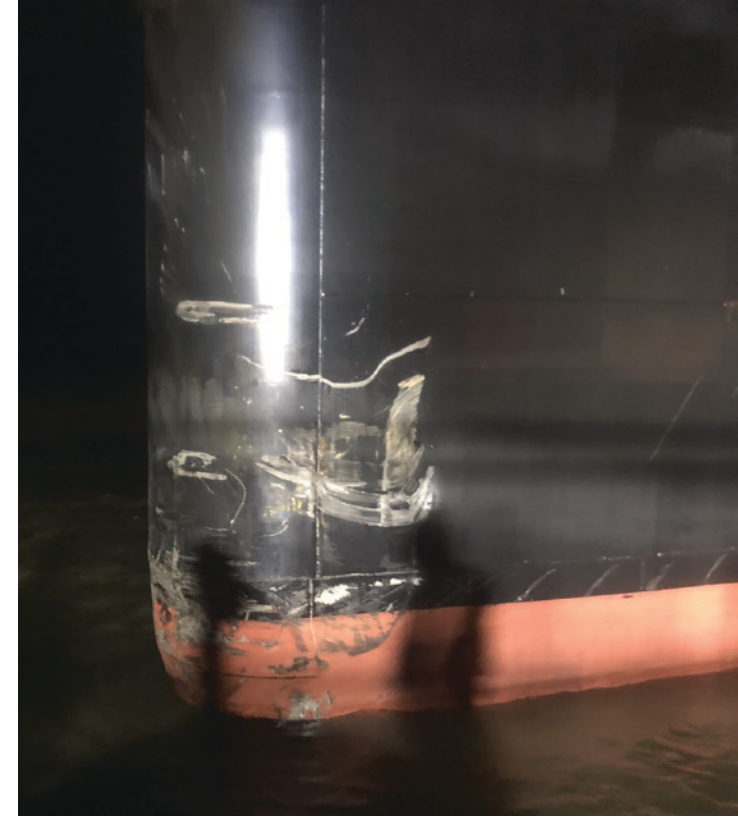
Figure 24. Damaged stem of the barge *Texas*.

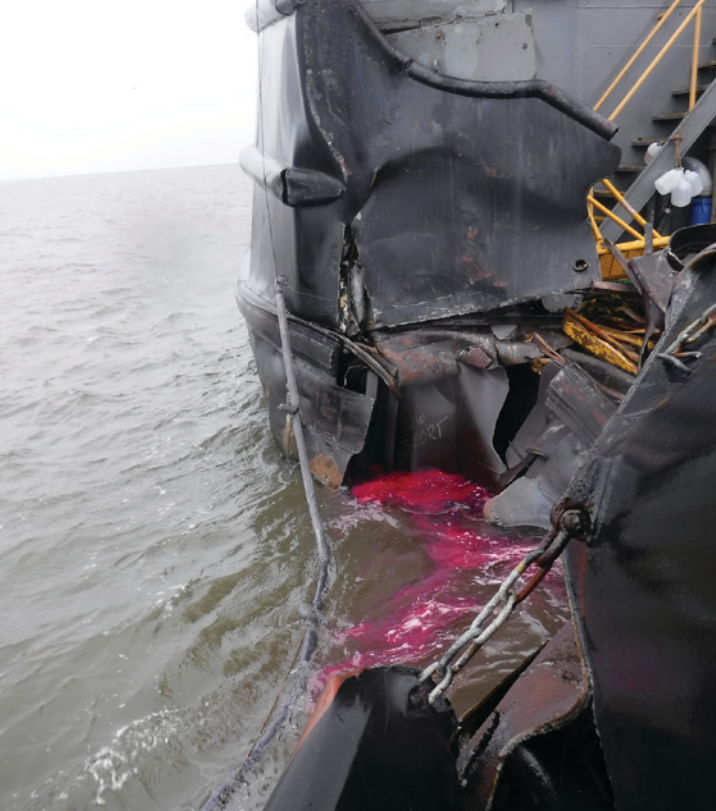
Figure 25. The port side of the *Cheramie Bo Truc No 22*, post-collision, showing the compromised no. 1 port fuel tank and oil spillage. SOURCE: COAST GUARD.

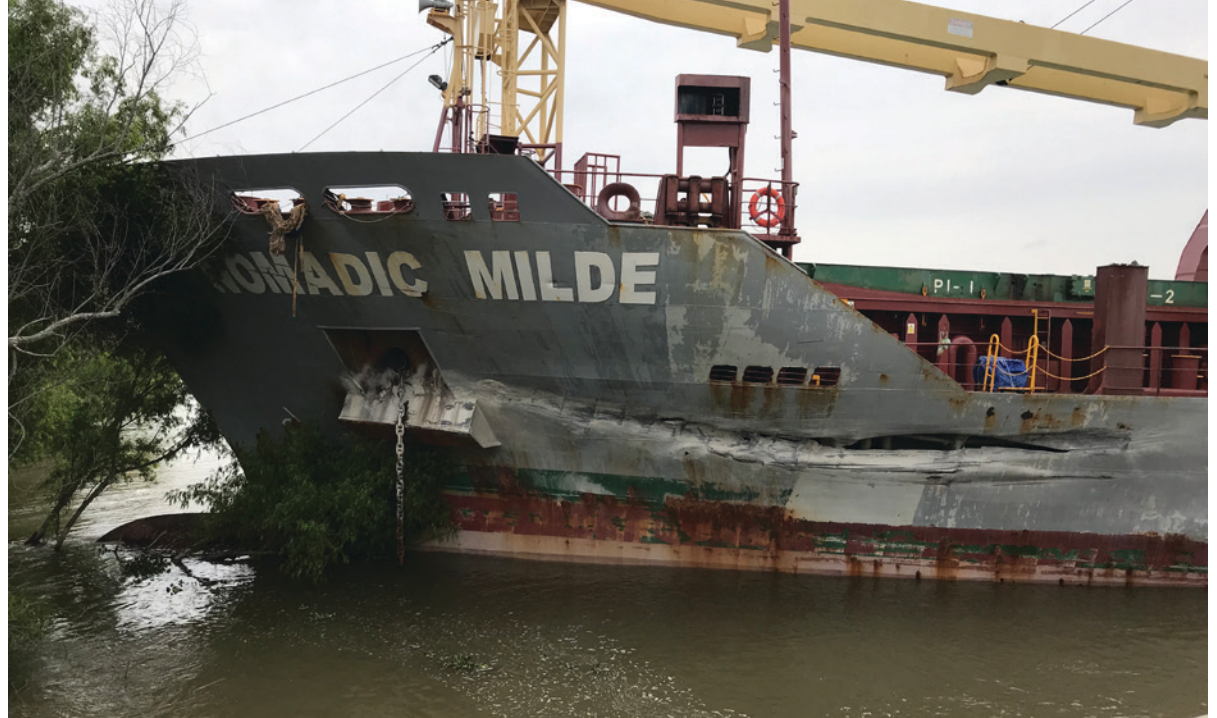
Figure 41. *Nomadic Milde* on the right descending bank at the Cornerstone Dock showing a gash in the hull aft of the port anchor pocket. SOURCE: COAST GUARD

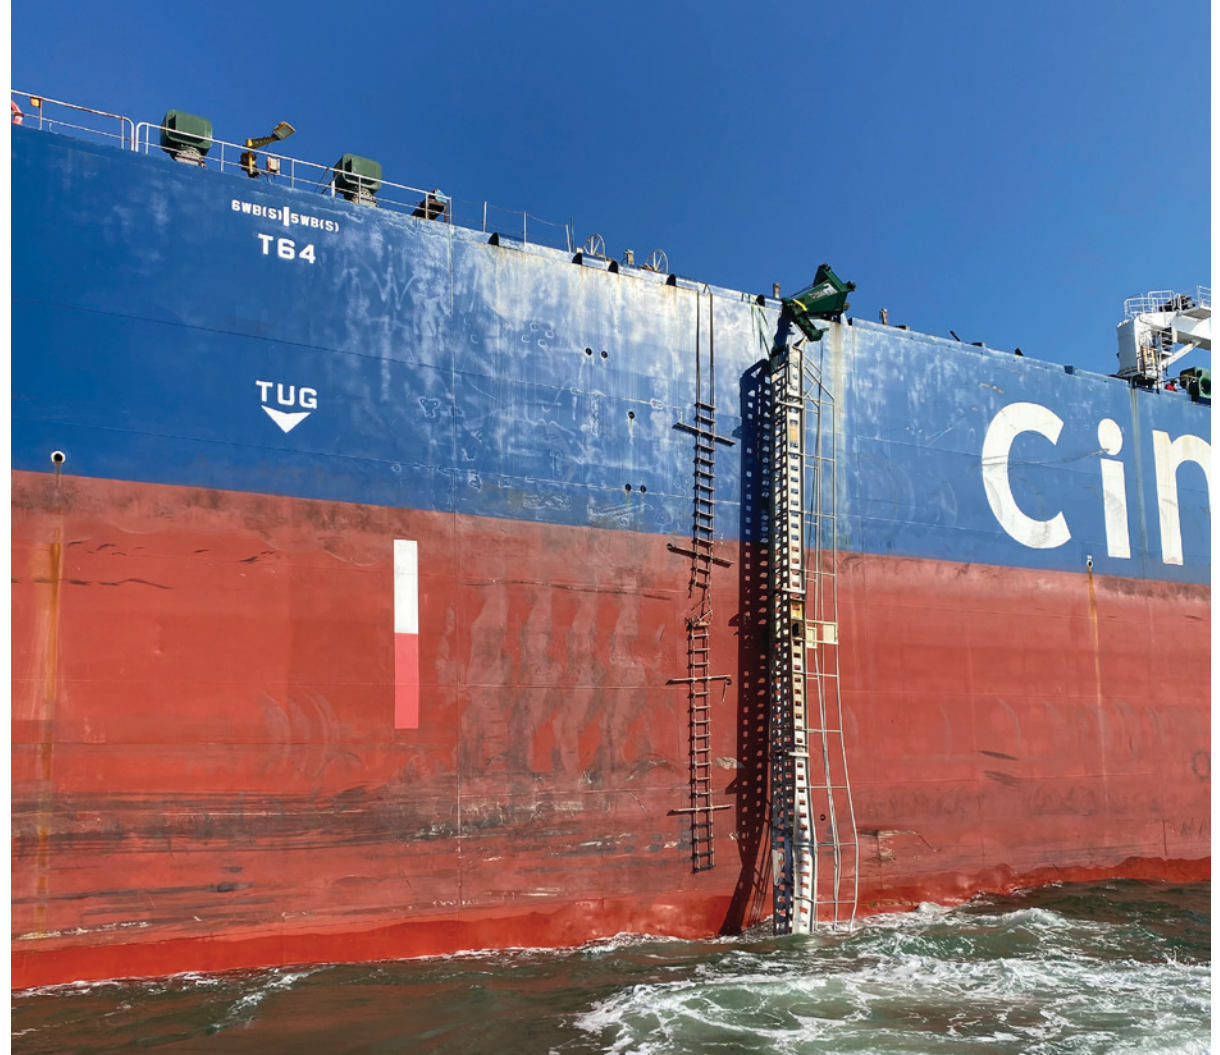
Figure 45. The *Atina*'s damaged accommodation ladder. SOURCE: COAST GUARD

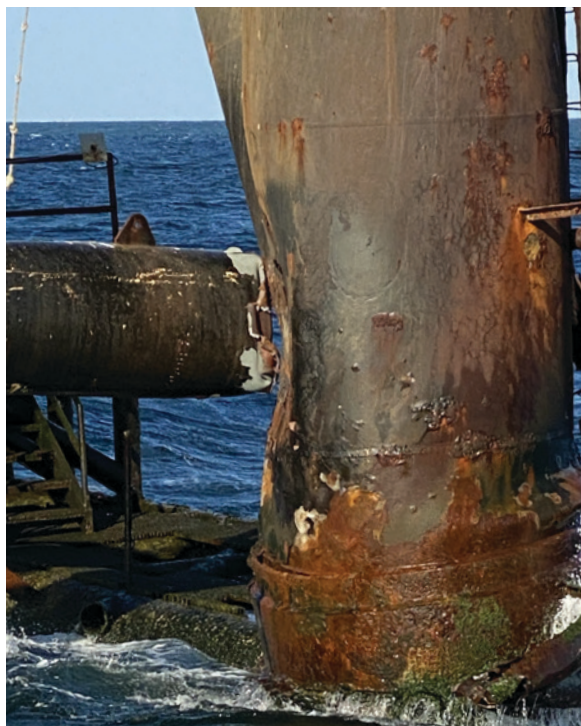
Figure 46. SP-57B's fractured horizontal and damaged leg.

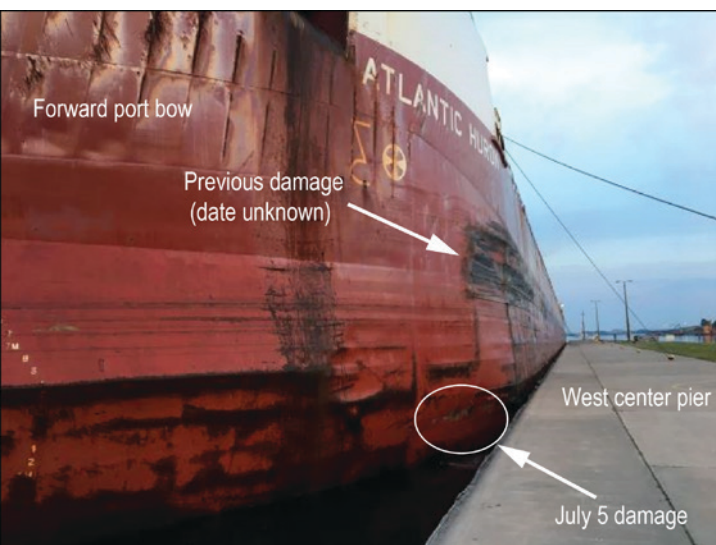
Figure 48. Postaccident photo of the *Atlantic Huron* alongside the west center pier. Point of contact and damage indicated by arrows. SOURCE: COAST GUARD

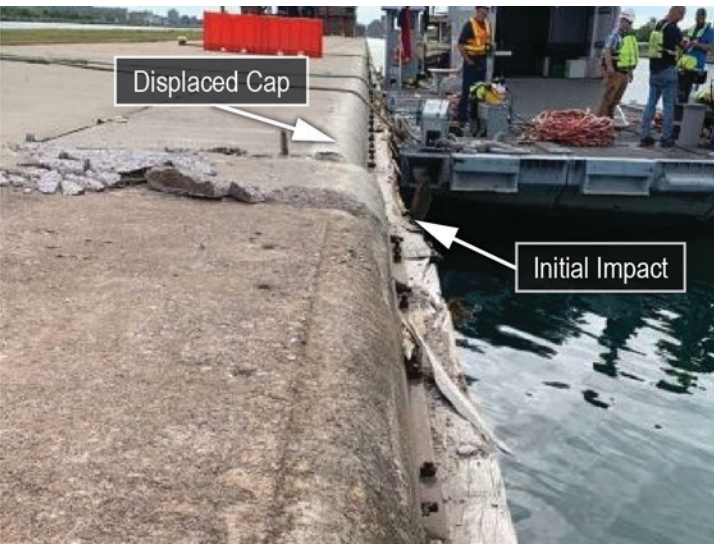
Figure 50. Postaccident photo of the west center pier. The location of initial impact is labeled and evident by a crushed timber fender. Displacement of a timber crib wall concrete cap is also labeled.

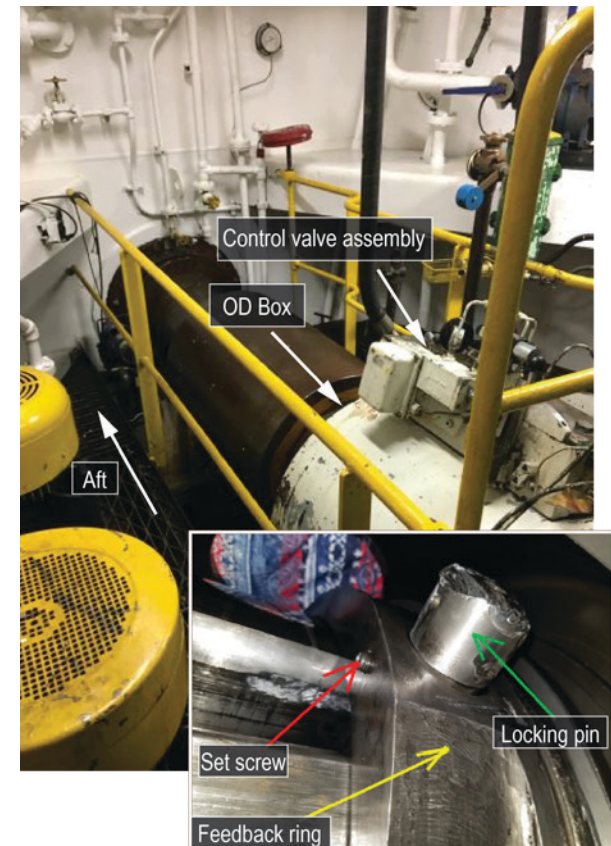
Figure 51. Postaccident photo of vessel's OD box and control valve assembly as viewed looking aft. Lower right: Postaccident photo showing damage to backed-out locking pin. BACKGROUND SOURCES: COAST GUARD, CSL

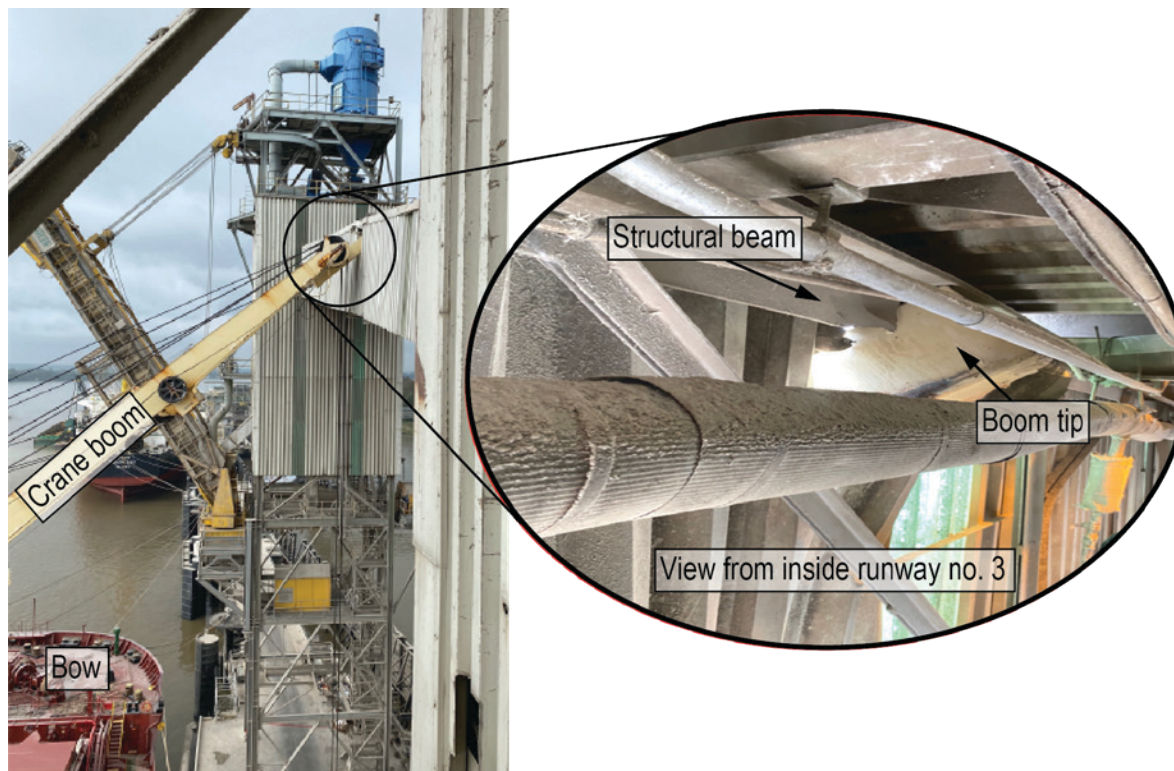
Figure 63. Point of contact of *GH Storm Cat*'s crane boom and ZGC runway no.3. BACKGROUND SOURCE: ZGC

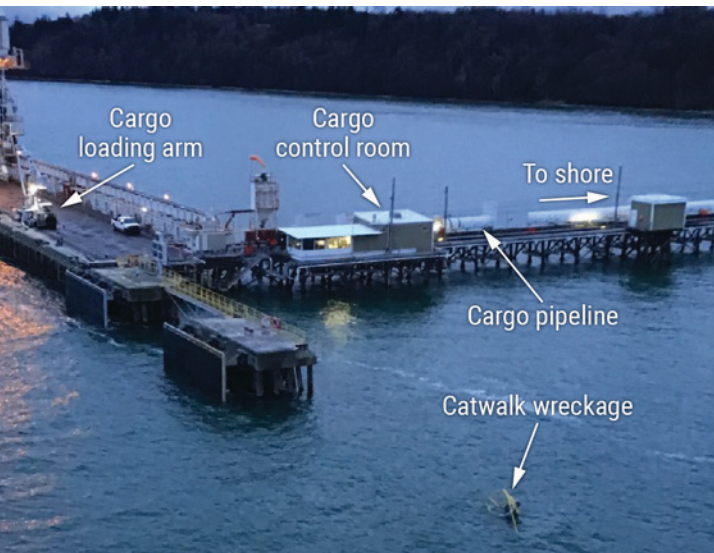
Figure 68. Petrogas Wharf on the morning of December 15 with the catwalk and south mooring dolphin missing.

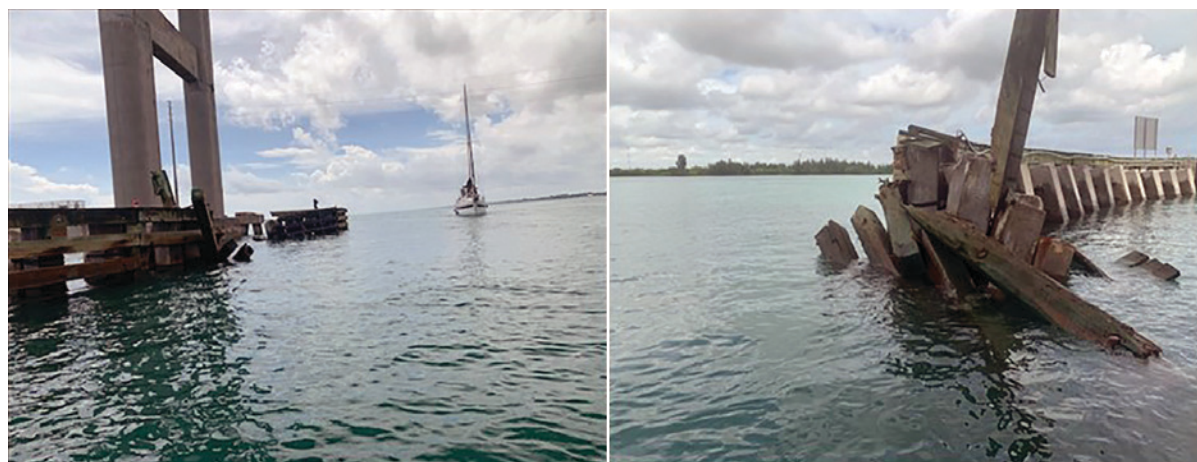
Figure 74. Postaccident damage to the eastern fendering of the bridge looking to the south (left) and to the north (right).
SOURCE: COAST GUARD

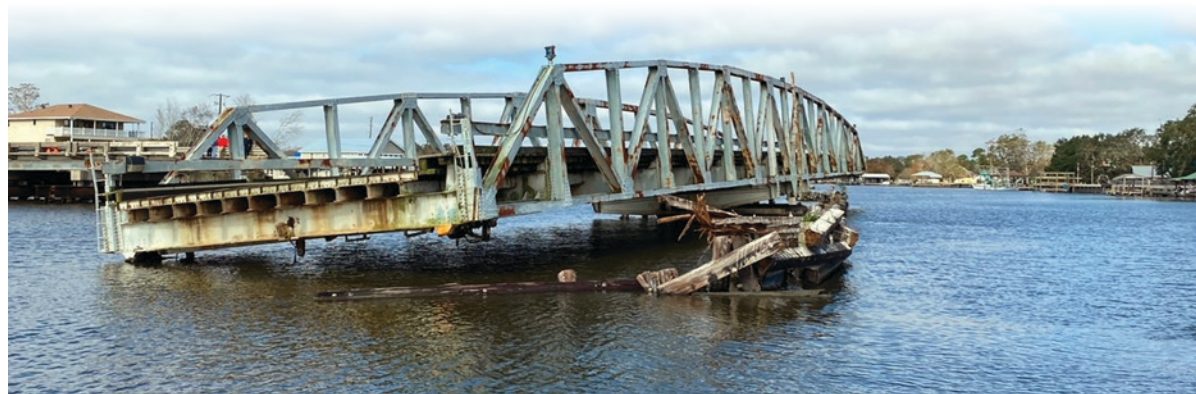
Figure 82. Postaccident damage to Barataria Bridge looking north. SOURCE: ANONYMOUS

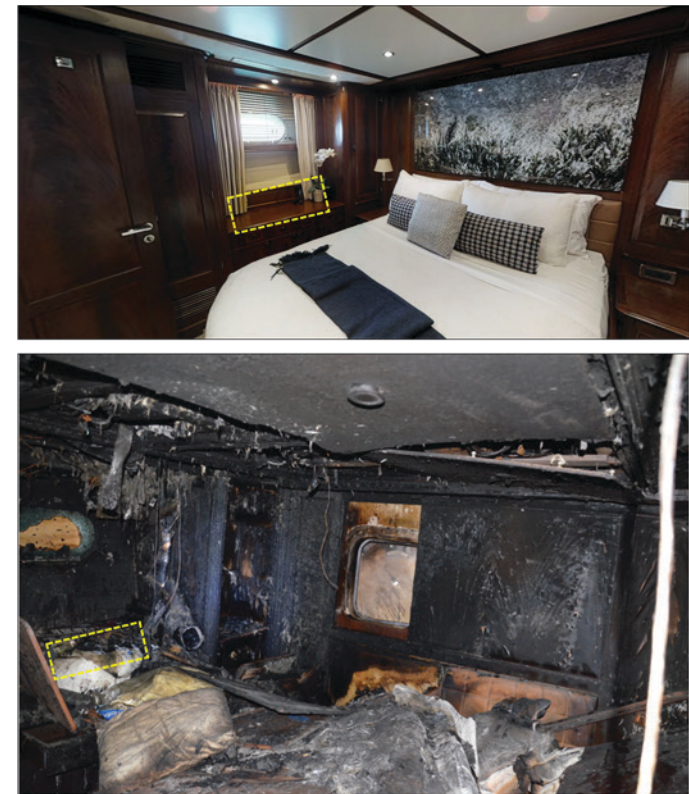
Figure 88. Promotional and postaccident photos indicate location of the candles (yellow rectangle) in the unattended port VIP suite. SOURCE [TOP PHOTO]: MCA YACHTS

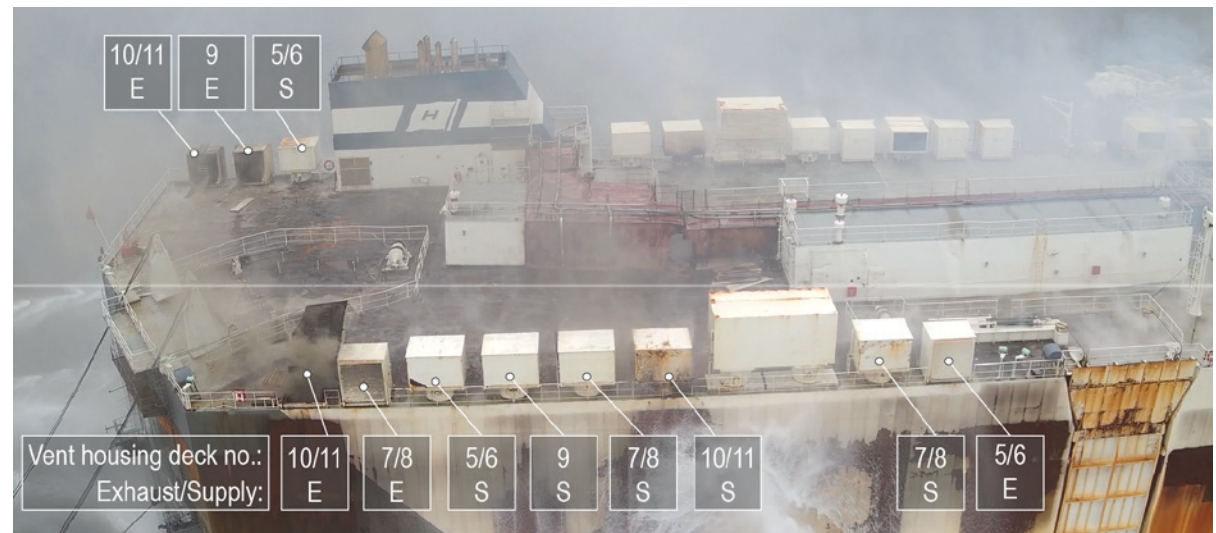
Figure 99. Damaged aft ventilation housings after the reported explosion of portside vent housing for deck 9 (9E in the photo). BACKGROUND SOURCE: JACKSONVILLE FIRE AND RESCUE DEPARTMENT

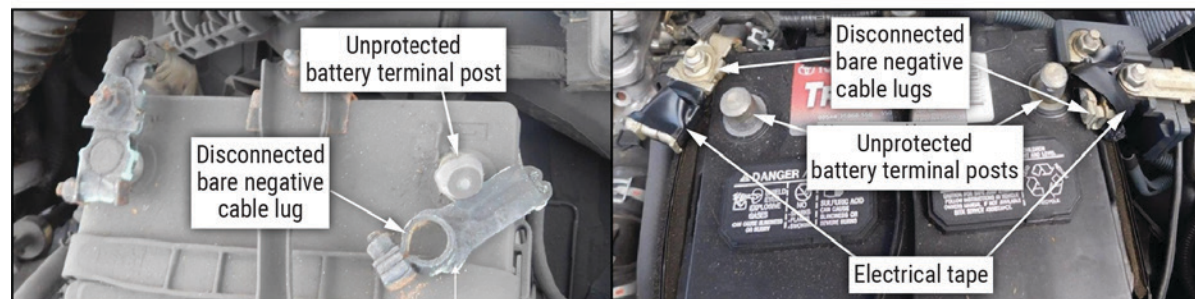
Figure 101. Left: Battery in towed vehicle removed from deck 7. The disconnected bare cable lug was in physical contact with unprotected battery terminal post. **Right:** Battery in forklift vehicle removed from deck 5. The disconnected battery cable lugs were located near terminal posts, and the battery terminal posts were unprotected.

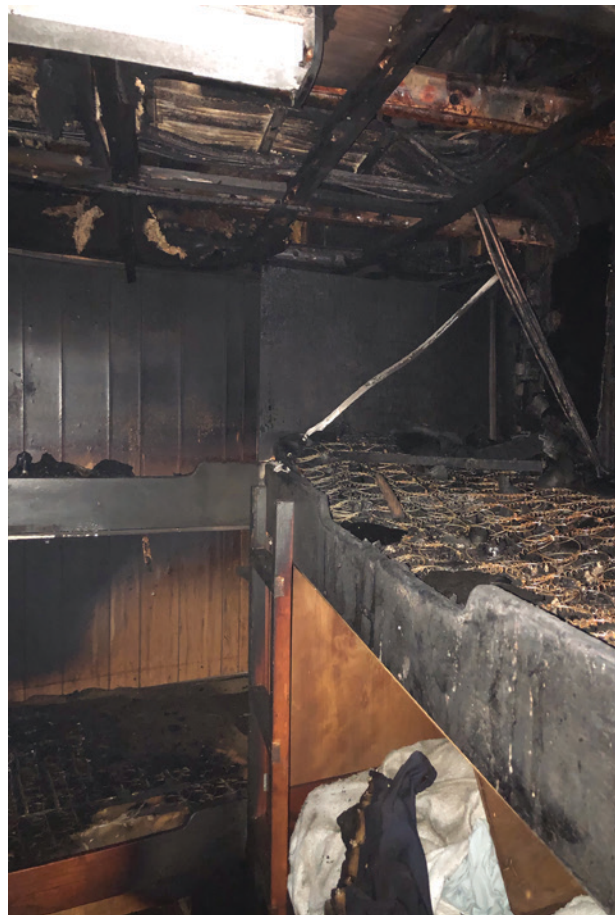
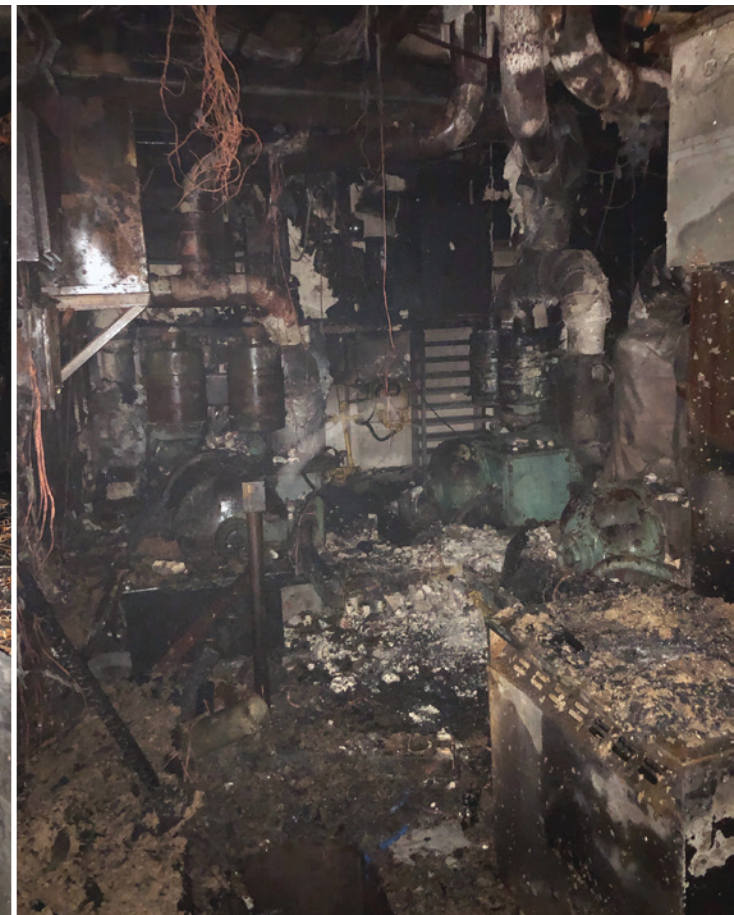
Figure 106. Fire damage to living quarters (left) and generator room (right). SOURCE: COAST GUARD

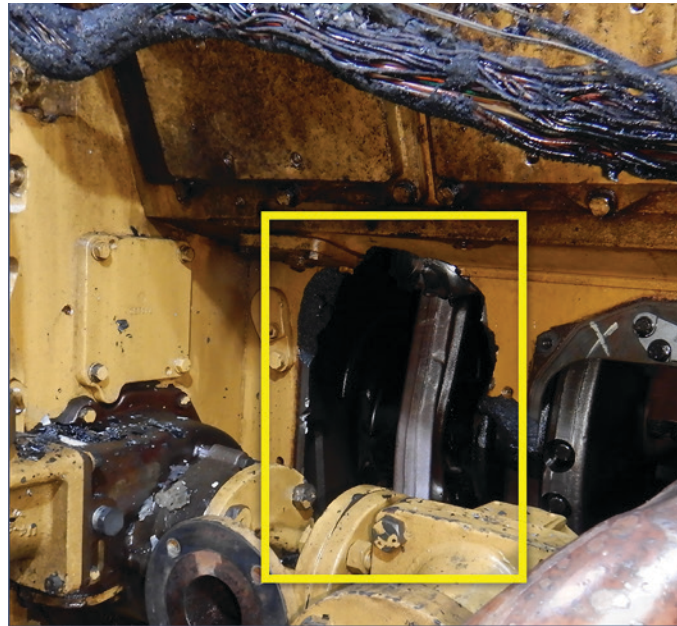
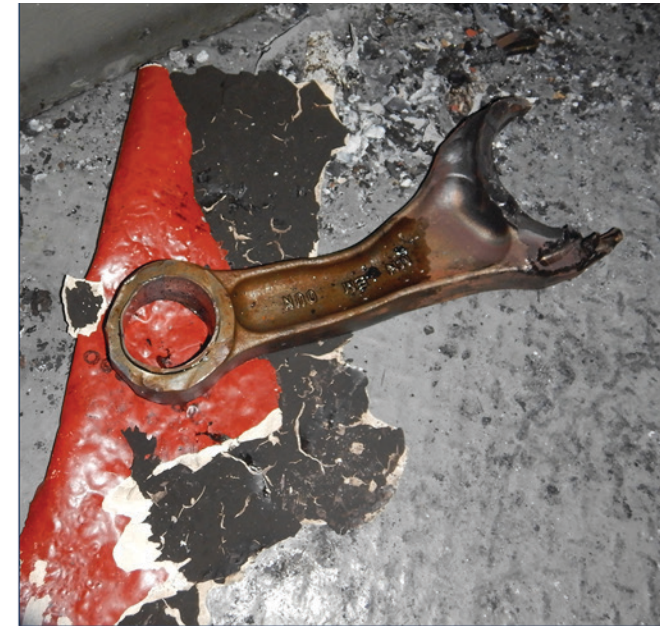
Figure 115. The damaged section of the engine (left), as indicated by the yellow square, from where the connecting rod from the no. 3 DG (right) was ejected. SOURCE: OCEANEERING INTERNATIONAL, INC.; COAST GUARD

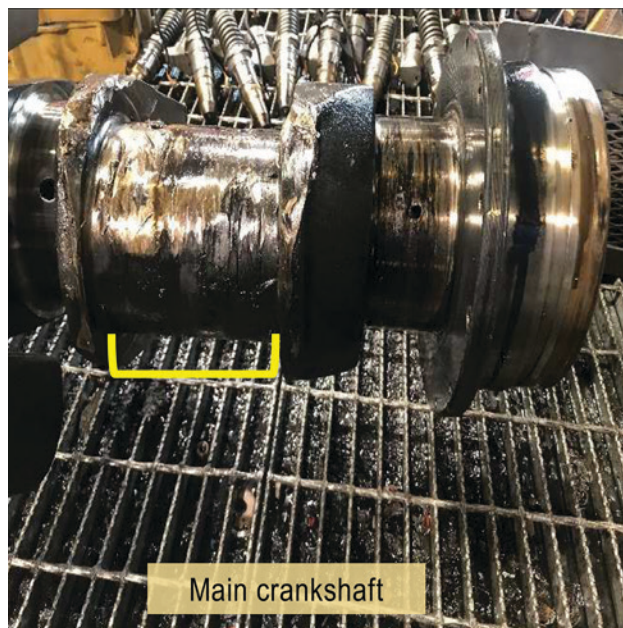
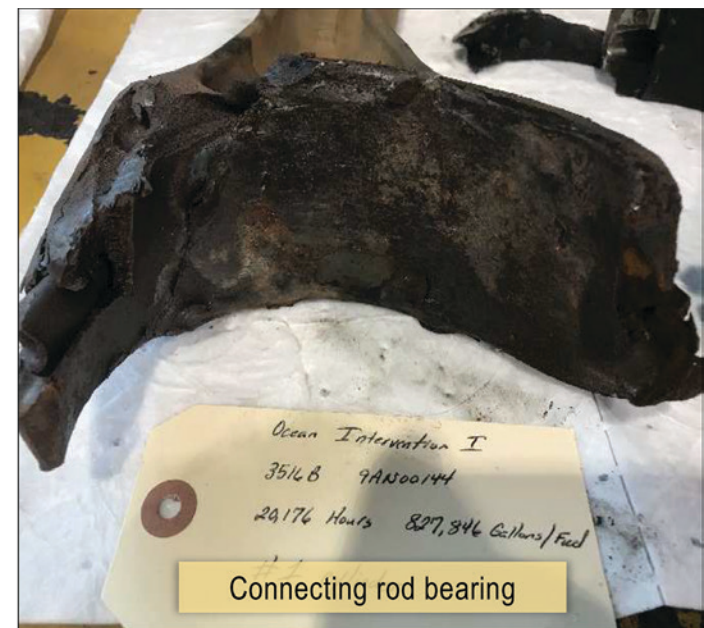
Figure 117. The yellow bracket identifies the damaged area of the main crankshaft of the no. 3 DG (left), where the no. 1 connecting rod bearing failed (right). SOURCE: OCEANEERING INTERNATIONAL, INC.

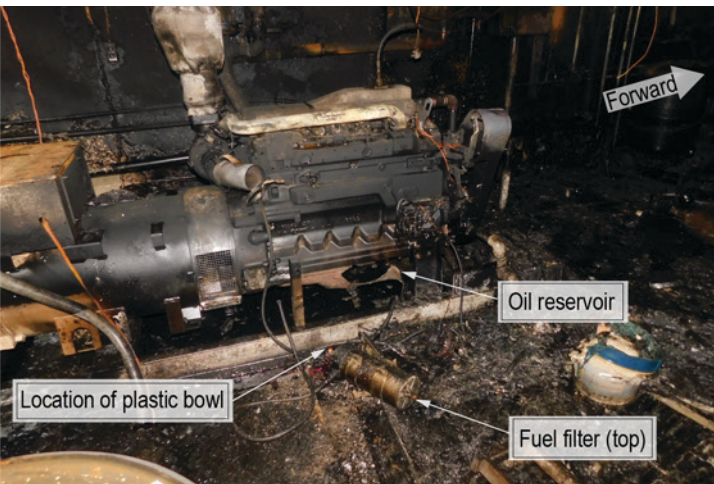
Figure 120. The *Susan Lynn* port generator and lower engine room following the fire. BACKGROUND SOURCE: LOUISIANA OFFICE OF STATE FIRE MARSHAL

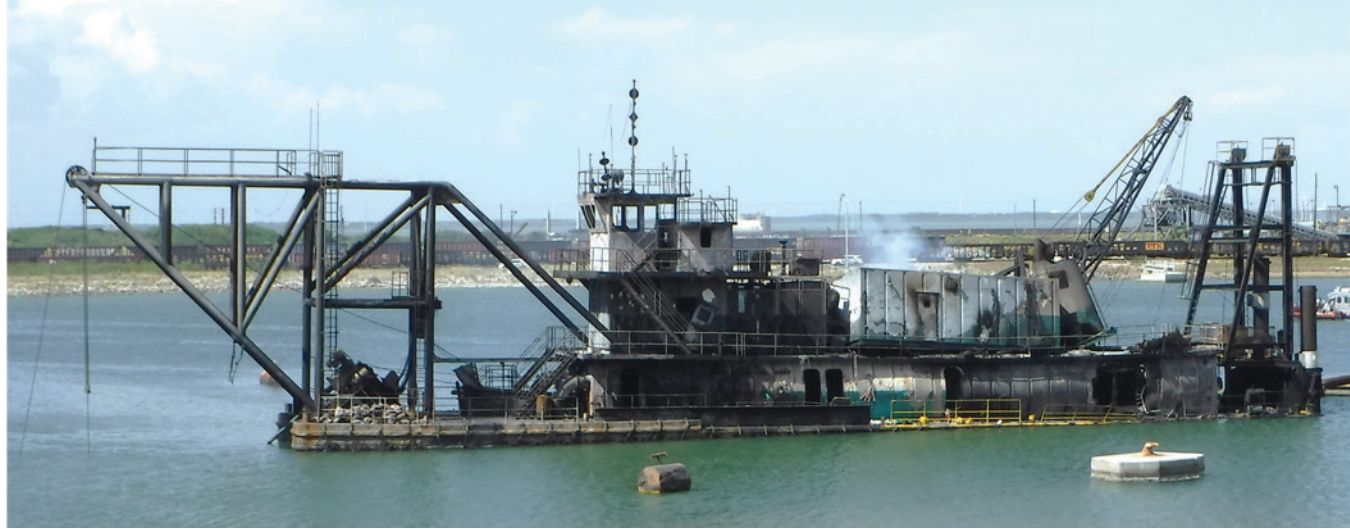
Figure 125. Post-fire photo of the *Waymon Boyd*, before sinking. SOURCE: COAST GUARD

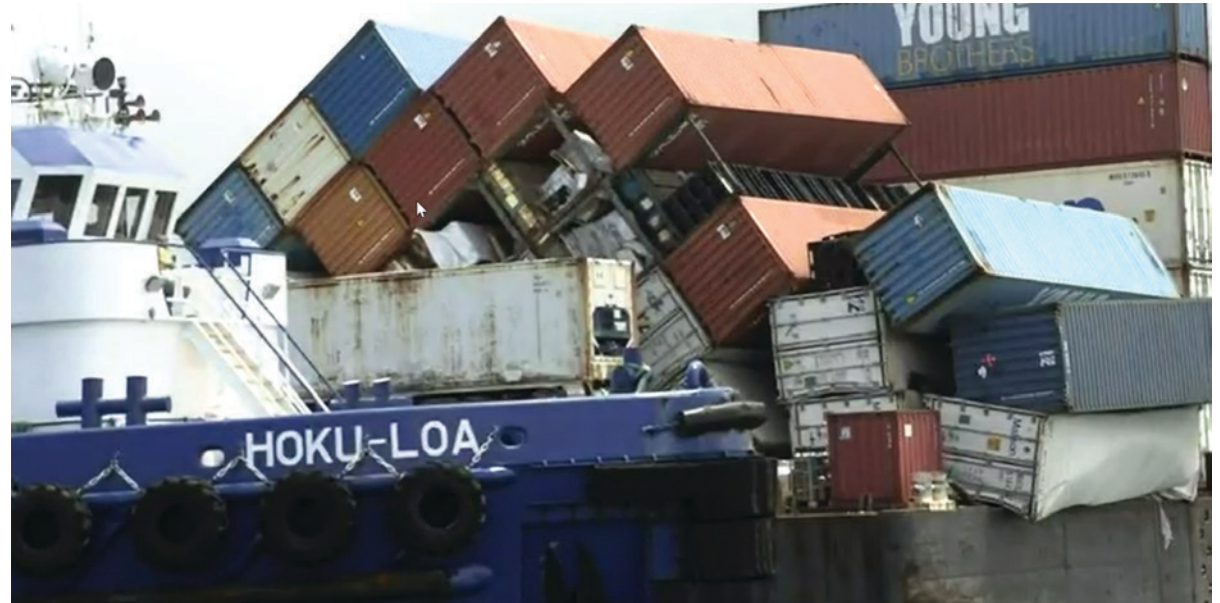
Figure 156. The collapsed row of containers, from the starboard quarter of the *Ho'omaka Hou*. SOURCE: COAST GUARD
