Aviation Investigation Factual Report

Location:	Eden, Utah	Accident Number:	WPR21FA211
Date & Time:	May 29, 2021, 10:00 Local	Registration:	N1727T
Aircraft:	TEXTRON AVIATION INC 172S	Aircraft Damage:	Destroyed
Defining Event:	Loss of control in flight	Injuries:	2 Fatal
Flight Conducted Under:	Part 91: General aviation - Instructional

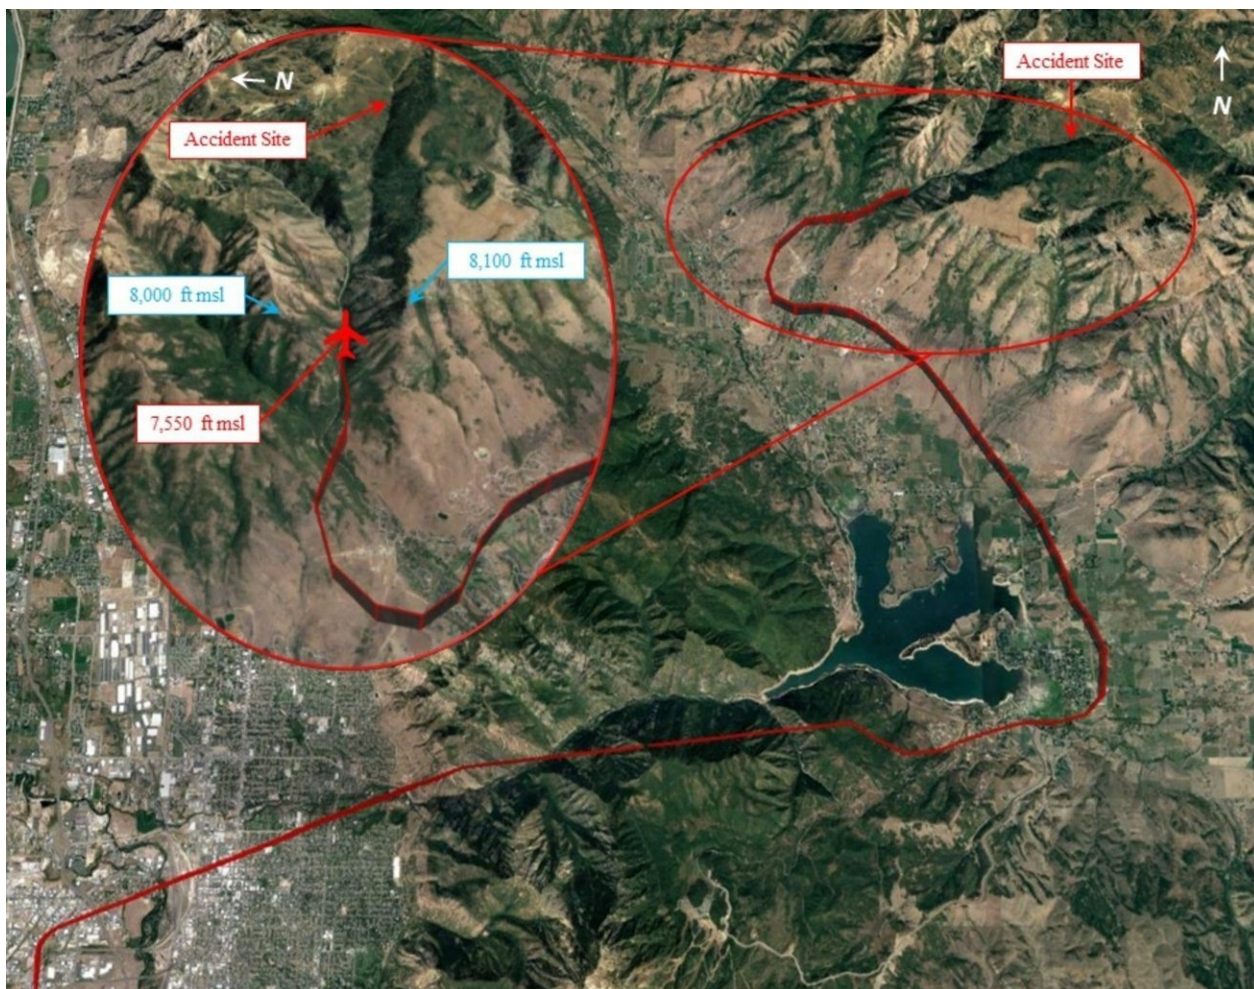
Figure 1. Flight track of accident airplane.

According to the airplane operator, ATP Flight School (ATP), the accident flight was an introductory training flight designed to assess the student pilot's skill level. Federal Aviation Administration automatic dependent surveillance-broadcast (ADS-B) data showed that the flight departed ATP's local base at Ogden-Hinckley Airport (OGD), Ogden, Utah, about 0941 and immediately turned onto an easterly heading. The ADS-B data ceased 5 miles east of the departure airport about 0946, when the airplane entered Ogden Canyon at an altitude of 6,600 ft mean sea level (msl), which was about 1,000 ft above ground level (agl). The airplane was subsequently tracked by radar 9 miles east of OGD starting about 0949. The airplane flew south and then turned northwest while maintaining an altitude of about 2,000 ft agl. About 0955, the airplane turned to the northeast into a canyon where it began a climb over rising terrain. The last ADS-B targets showed that the airplane maintained an altitude of about 7,550 ft msl (1,000 ft agl), as shown in figure 1. At that altitude, the airplane would have been below ridgelines on both sides of its flightpath, as shown in figure 2. The ADS-B track data ceased at 0956:40.
