# Aviation Investigation Factual Report

<b>Location:</b>	San Diego, California	<b>Incident Number:</b>	OPS21LA003
<b>Date &amp; Time:</b>	June 10, 2021, 17:45 Local	<b>Registration:</b>	N8674B (A1); N197SY (A2)
<b>Aircraft:</b>	Boeing 737-8H4 (A1); EMBRAER S A ERJ 170-200 LR (A2)	<b>Aircraft Damage:</b>	None (A1); None (A2)
<b>Defining Event:</b>	Comm system malf/failure	<b>Injuries:</b>	177 None (A1); 77 None (A2)
<b>Flight Conducted Under:</b>	Part 121: Air carrier - Scheduled (A1); Part 121: Air carrier - Scheduled (A2)

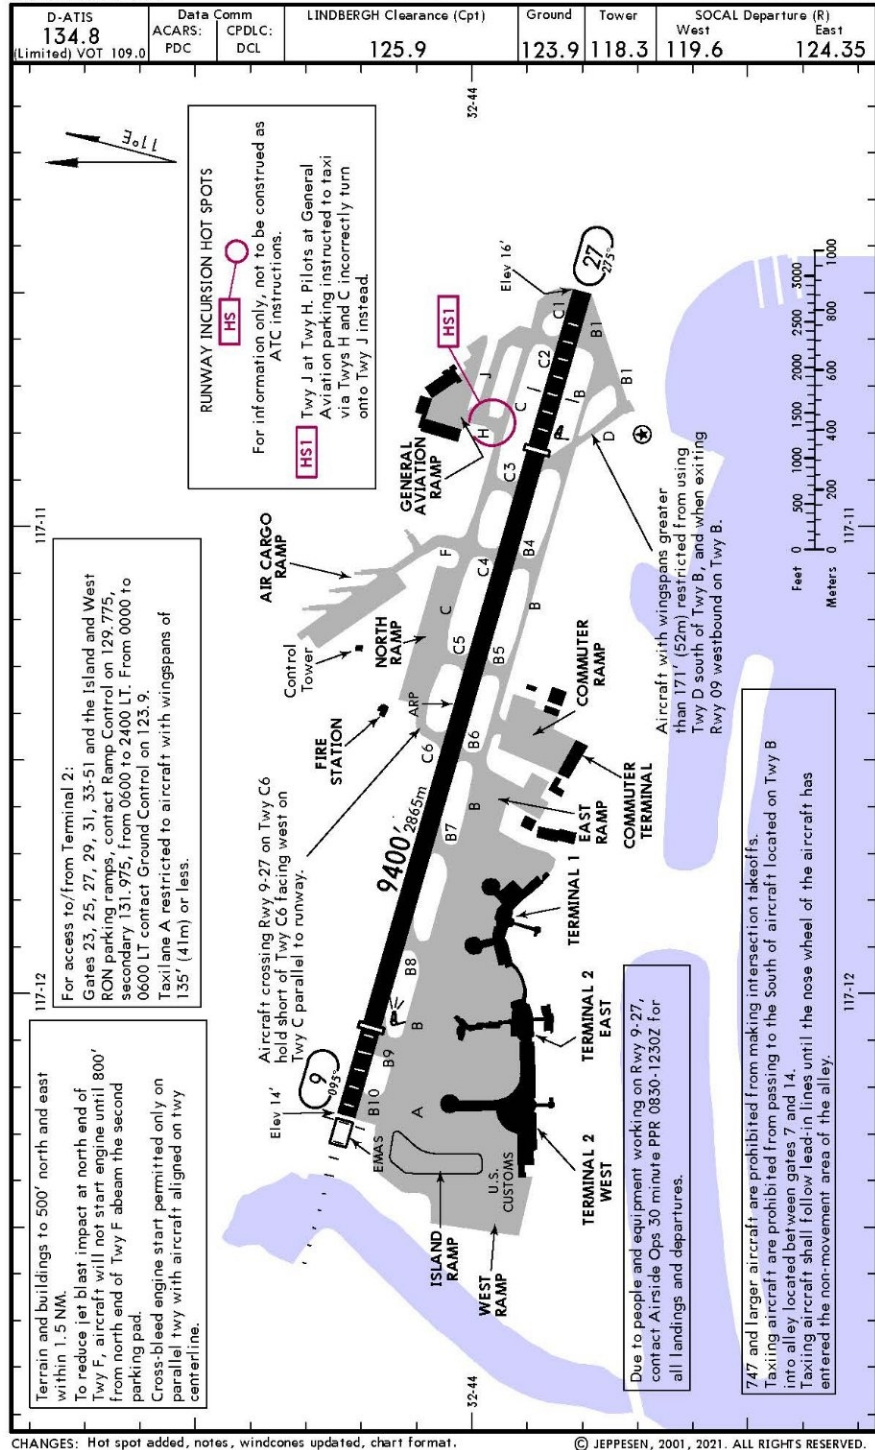
Figure 3: SAN Airport Diagram (Source: Jeppesen)

According to the FAA Chart Supplements, runway 9/27 was a 9,401-foot-long and 200-foot-wide, grooved, asphalt, and concrete runway. Runway 27 was equipped with 4-light PAPI system and had 7,591 ft of runway available for landing and 9,401 ft available for takeoff. The runway had an 1,810-foot displaced threshold.
