Aviation Investigation Factual Report

Location:	Newport Beach, California	Accident Number:	WPR22FA101
Date & Time:	February 19, 2022, 18:34 Local	Registration:	N521HB
Aircraft:	McDonnell Douglas 500N	Aircraft Damage:	Substantial
Defining Event:	Loss of tail rotor effectiveness	Injuries:	1 Fatal, 1 Minor
Flight Conducted Under:	Public aircraft

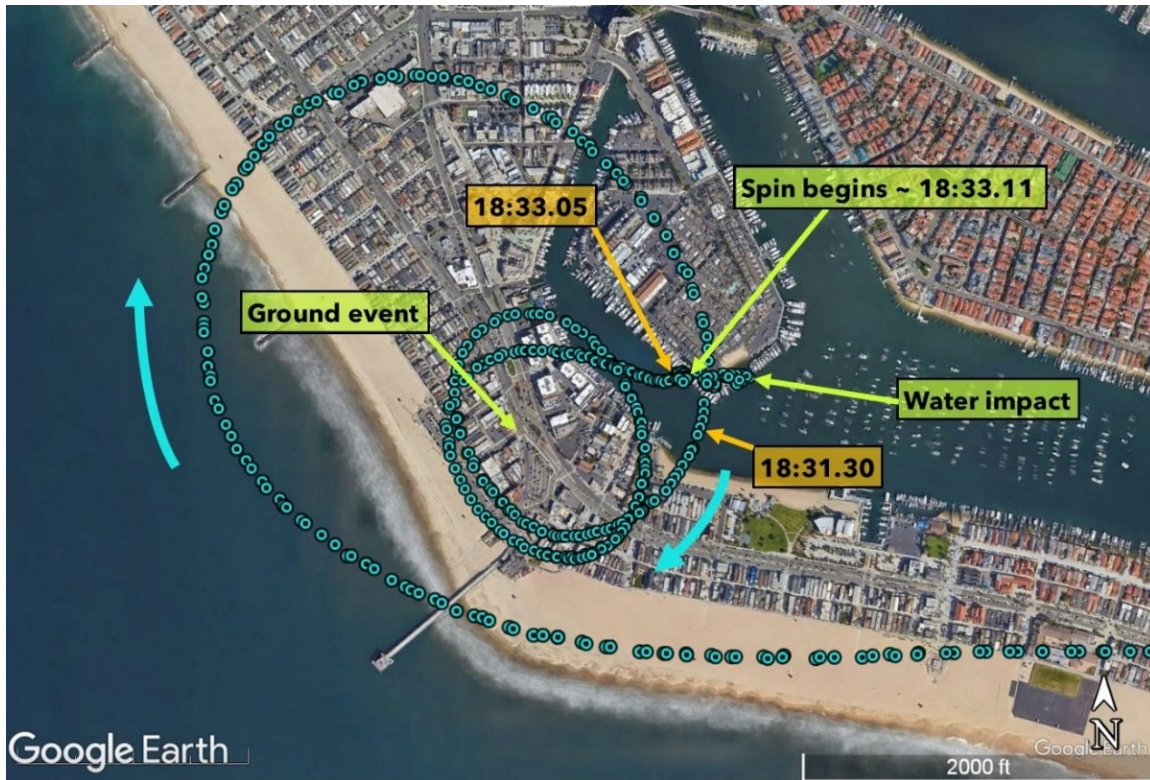
Figure 1 – Final flight path segment

The pilot reported that as they were about to depart the Newport Beach area, they received a transmission over the primary police radio channel that there was a fight taking place just south of their location. The pilot stated that he redirected the helicopter toward the area and began a right orbit between 500-600 ft above ground level (agl) while the TFO (who was seated in the right seat) turned on the infrared camera and began searching the ground. The TFO spotted a group fighting, and the pilot began to maneuver the helicopter in a tighter orbit while the TFO relayed his observations over the police radio channel.

Ground patrol officers arrived on the scene, and the pilot continued the orbits about 500 ft above ground level, while simultaneously viewing the activity through his monitor, and maneuvering the helicopter so the TFO could continue to observe the altercation. The pilot stated that he watched as ground patrol officers got out of their car and approached the group, who by this time had mostly dispersed. He was concerned that one person was about to start fighting with an officer, and he slowed the helicopter to about 50 knots (kts) indicated airspeed to keep the camera aimed at the scene longer, so that they would not lose sight of it behind a building.

The pilot stated that, suddenly, the helicopter yawed aggressively to the right, and he immediately applied full left foot pedal and forward cyclic to arrest the rotation, but there was no response. He then applied right pedal to see if the pedals had malfunctioned, and observing no change, he reverted to full left pedal. He continued to apply corrective control inputs, but the helicopter did not respond and began to progress into a spinning descent. (see Figure 1.) The TFO transmitted over the police radio channel, "We're having some mechanical issues right now", followed by, "we're going down, we're going down".

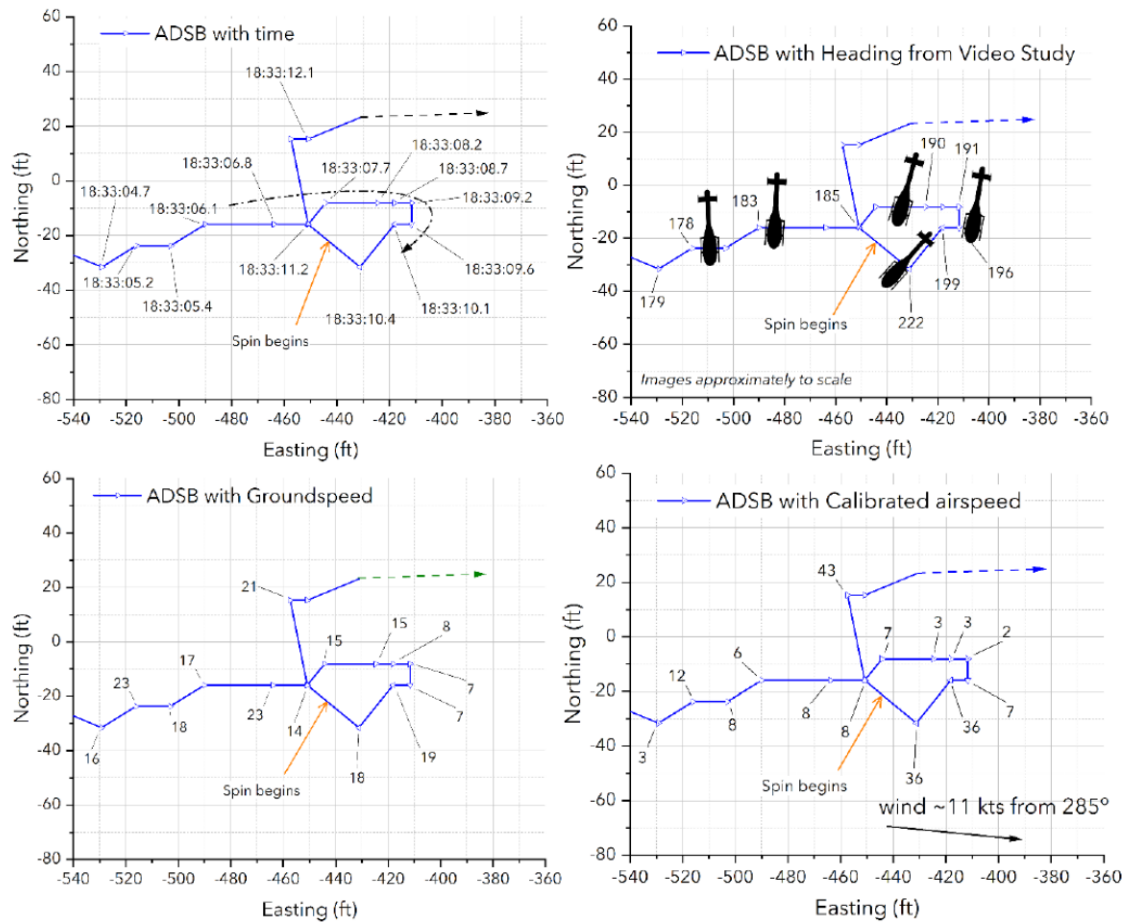
The results indicated that, after performing two orbits, the helicopter slowed to a ground speed of between 15-23 kts as it moved east, which correlated to a calibrated speed of between 3-12 kts. During the next 5 seconds, the helicopter was pointing perpendicular to the direction of

travel, on a heading of about 180°. The helicopter then held its position over the ground and started to move west while still pointing south, and two seconds later, it began to spin to the right as the imaging system's camera pitched up. The spin progressed at a rate of about 130° per second, and ground-based security video footage indicated that the rate remained about the same until the helicopter impacted the water. (See Figure 2.)
