# Aviation Investigation Factual Report

<b>Location:</b>	Vancouver, Washington	<b>Accident Number:</b>	WPR22FA235
<b>Date &amp; Time:</b>	June 28, 2022, 07:40 Local	<b>Registration:</b>	N444PM
<b>Aircraft:</b>	Beech V35B	<b>Aircraft Damage:</b>	Destroyed
<b>Defining Event:</b>	Aerodynamic stall/spin	<b>Injuries:</b>	1 Fatal
<b>Flight Conducted Under:</b>	Part 91: General aviation - Personal

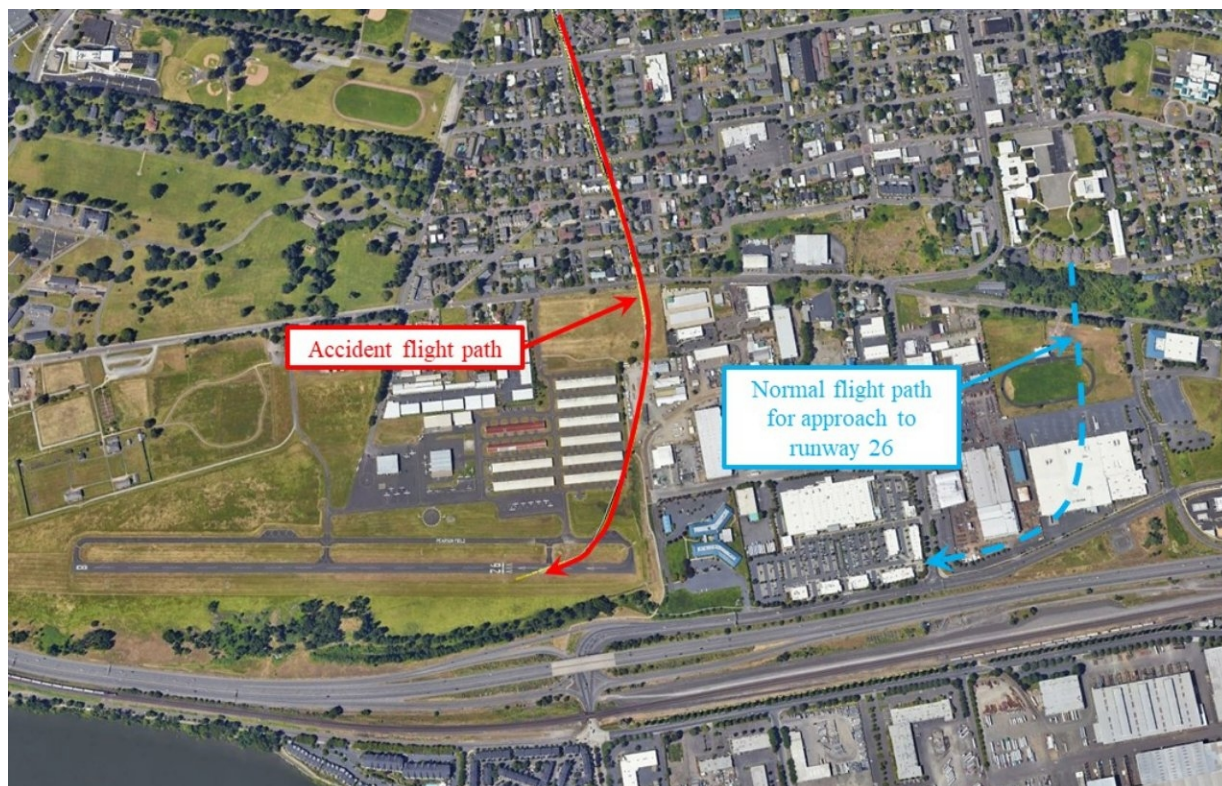
Figure 1: Accident flight path versus pilot's usual flight path to runway 26

The pilot's flight logbooks could not be located. A friend who had flown at least 30 hours with the pilot in the accident airplane reported that he had helped the pilot purchase the airplane and had given him his most recent flight review. He stated that they normally turned onto the final approach leg of the traffic pattern over a large white building (about a 0.5 nm distance from the runway). He further remarked that he had previously taught the pilot normal and accelerated stalls in the accident airplane.

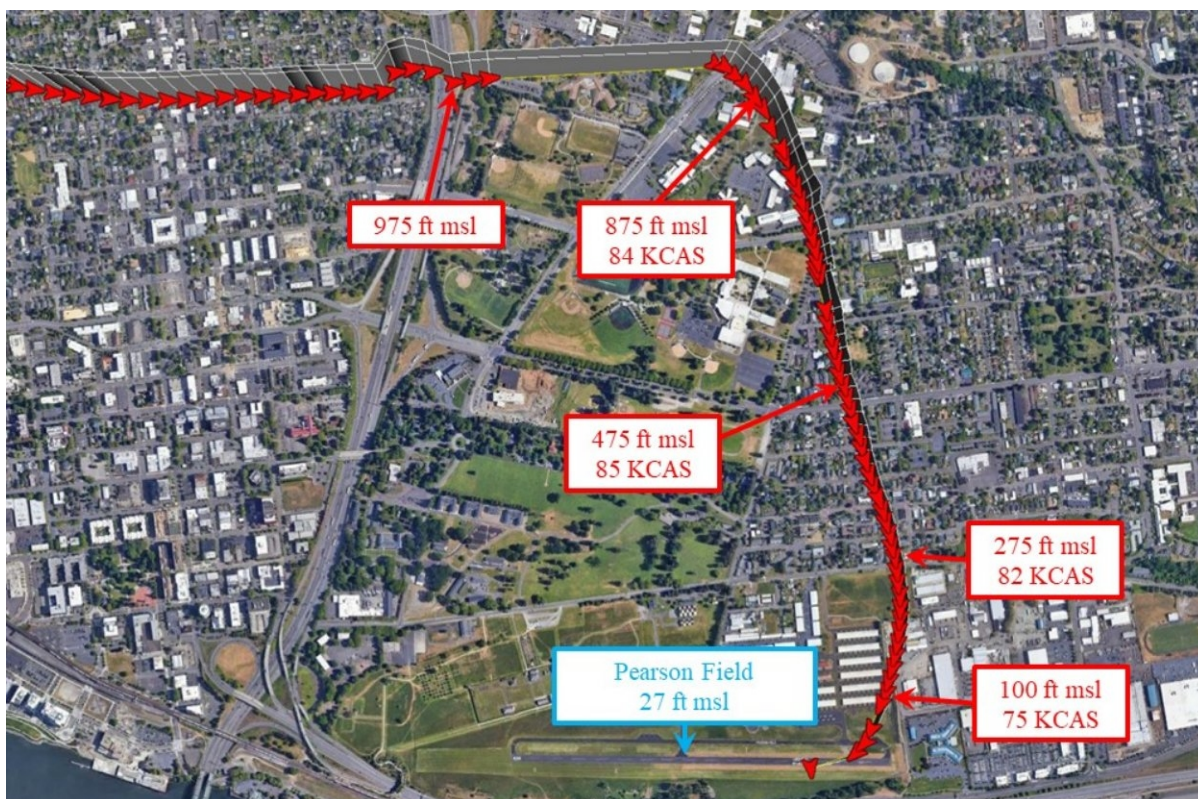
Figure 2: Airplane's flight path with altitude and airspeeds

An analysis of the ADS-B data from 0736 to the time of the accident combined with winds aloft data showed that the airplane had an average descent rate of about 1,000 fpm, an average airspeed of about 80 knots calibrated airspeed, bank angles of about 7°, and an average angle of attack of about 5° on the base leg of the traffic pattern.

The airplane's stall speed was computed using the stall chart from the airplane POH. The stall chart incorporates a maximum bank angle of 60°, which the airplane exceeded during its turn to final approach. According to the stall chart, the airplane's stall speed as it turned to final approach would have been exceeded 80 kts. An analysis of the ADS-B data showed that the airplane's airspeed at this time would have been about 73 KCAS.
