Aviation Investigation Factual Report

Location:	Hanover Township, Pennsylvania	Accident Number:	ERA23FA045
Date & Time:	October 29, 2022, 14:52 Local	Registration:	N964RS
Aircraft:	Bearhawk Patrol	Aircraft Damage:	Substantial
Defining Event:	Collision with terr/obj (non-CFIT)	Injuries:	2 Fatal
Flight Conducted Under:	Part 91: General aviation - Personal

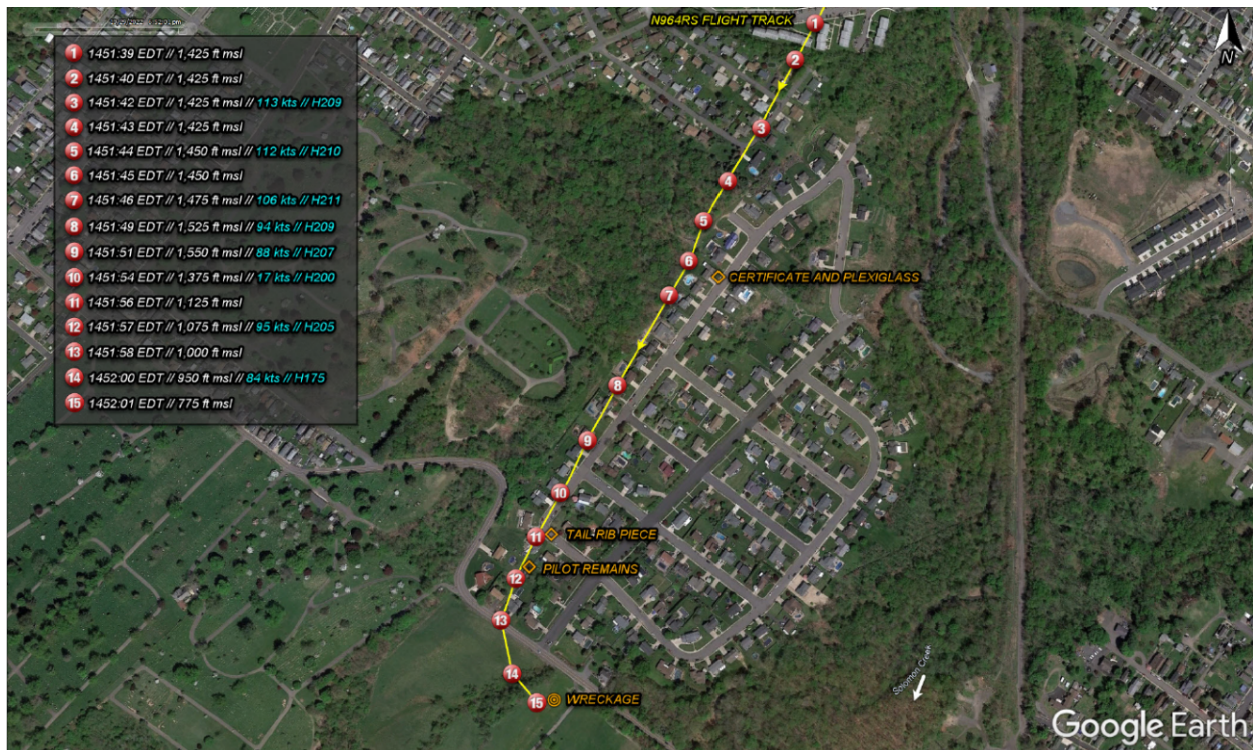
The airplane impacted a grass field about 5.2 nautical miles southwest of WBW. A linear ground scar, consistent with the length of the left wing, extended from the center of the wreckage with the scar oriented toward a magnetic heading of 338°, and the wings came to rest oriented on a magnetic heading of 319°. All major airplane components were located on site; however, paint chips, the airworthiness certificate, and portions of the cockpit ceiling or side window Plexiglas were the first items along the 1,900-ft-long debris path leading to the main wreckage, followed by a portion of a tail rib at 900 ft and the pilot at 530 ft from the main wreckage (see figure 1.)

Figure 1 - Flight path (yellow line) with annotated position, time, altitude, ground speed, and path heading. The locations of recovered debris are also plotted.
