Aviation Investigation Factual Report

Location:	San Diego, California	Accident Number:	WPR23LA045
Date & Time:	November 22, 2022, 17:57 Local	Registration:	N160AQ (A1); 166583 (A2)
Aircraft:	Sikorsky UH-60A (A1); Sikorsky MH-60R (A2)	Aircraft Damage:	Substantial (A1); Substantial (A2)
Defining Event:	Collision during takeoff/land	Injuries:	2 None (A1); 3 None (A2)
Flight Conducted Under:	Part 91: General aviation - Instructional (A1); Armed Forces (A2)

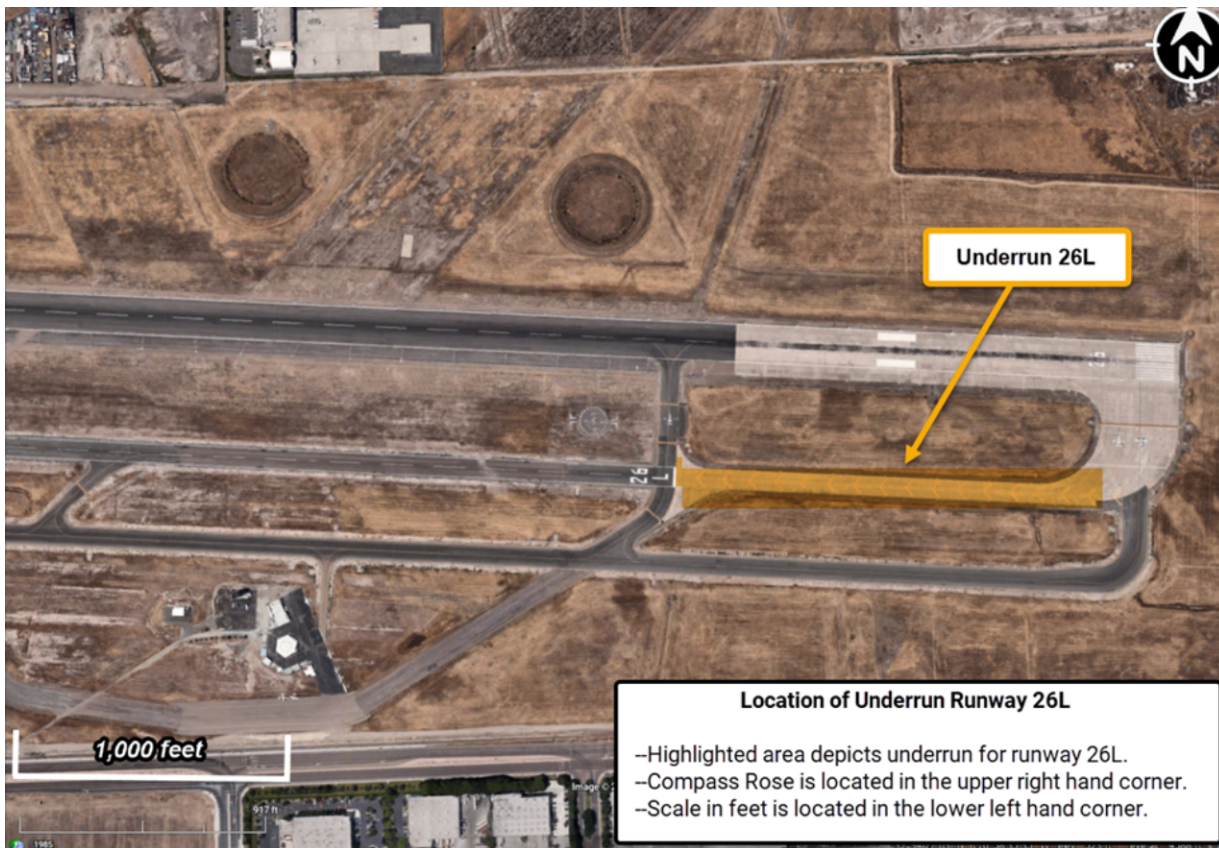
Figure 1. Google Earth image of SDM, showing the underrun runway 26L.

During postaccident interviews, ATCT personnel explained that the underrun was a non-movement portion of runway 26L, about 1,800 to 2,000 ft long, that was neither maintained by the airport nor lighted. The underrun was used for helicopter operations by civilian and military helicopters without written procedures. According to the air traffic manager, runway 26L was not approved for UH-60 helicopters to touch down on the runway because of the weight restriction. A review of airport data revealed the weight bearing capacity for runway 26L was 12,500 pounds.
