Aviation Investigation Factual Report

| Location: | Oakdale, Illinois | Accident Number: | CEN23FA340 |
| Date & Time: | July 31, 2023, 13:11 Local | Registration: | N567VF |
| Aircraft: | RICHARDS HEAVYLIFT HELO INC UH-1H | Aircraft Damage: | Substantial |

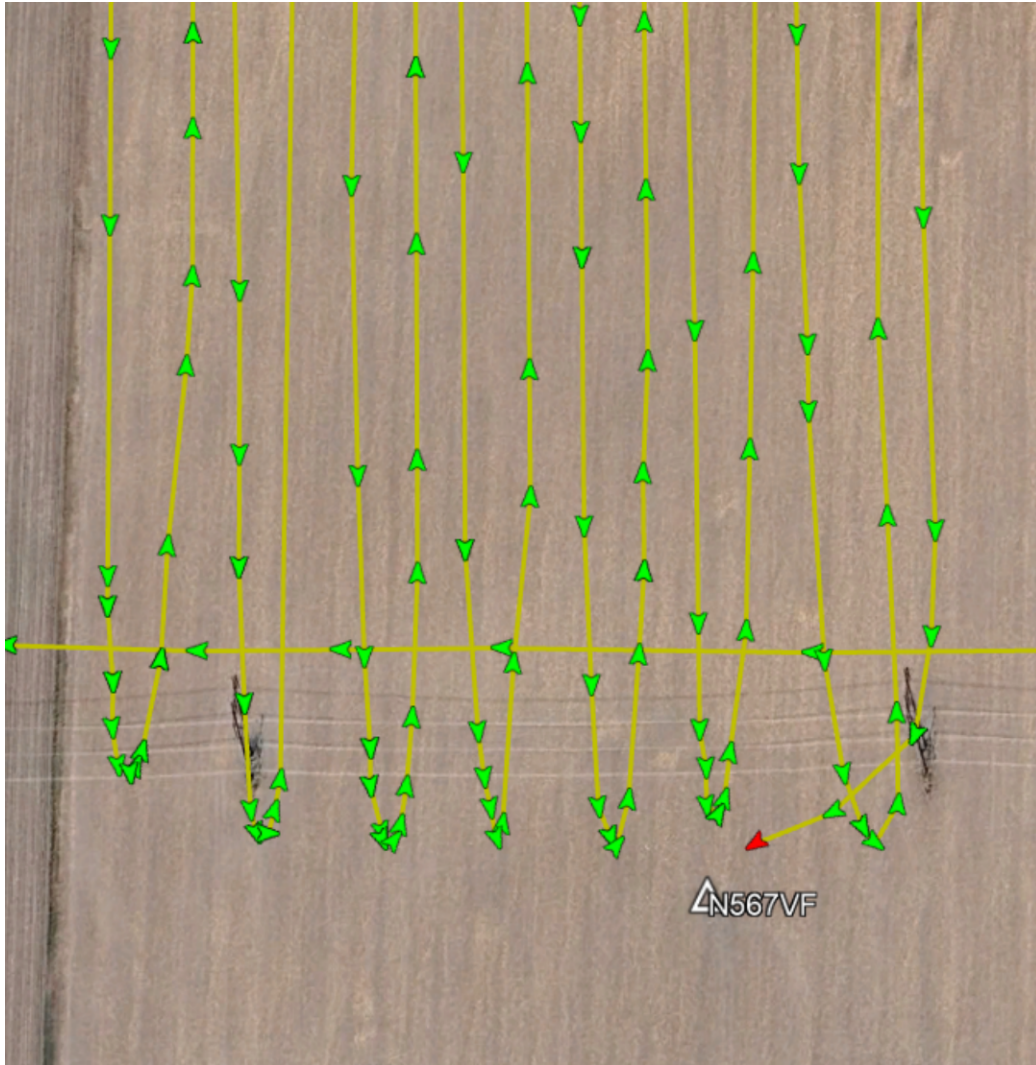
Figure 1. ADS-B Data with Wreckage Location

ADS-B data showed the helicopter departed the Mount Vernon Airport, Mount Vernon, Illinois, about 0714 CDT (all times CDT unless noted). After spraying several fields, the helicopter began to work the field closest to the accident site at 1305. The helicopter made several passes over the field from the north and south. Each pass appeared consistent with turns to the east to continue spraying the field. At 1310, the helicopter made a turn to the west over the powerlines and then impacted terrain.

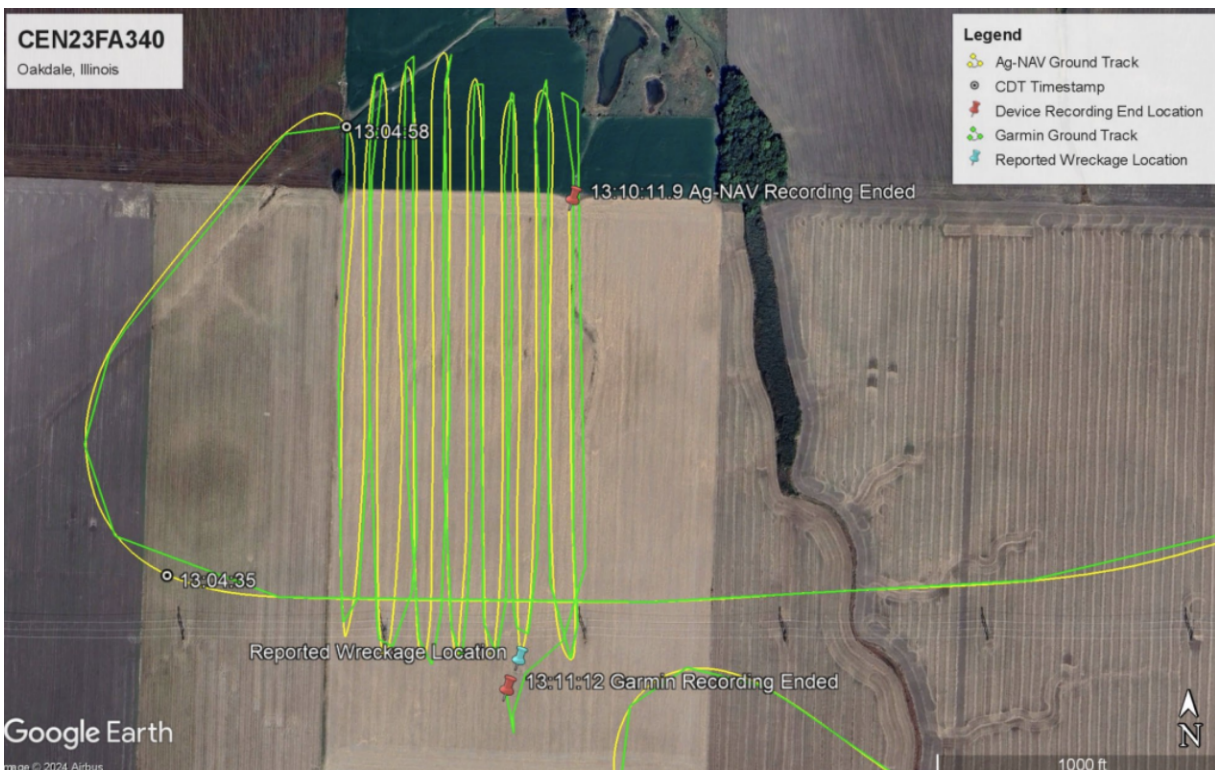
Figure 2. Charted Ag-Nav & Garmin GPS Data

Altitude data recorded by both devices were consistent with the pilot flying over the southern power lines for each turn to reverse course. The Ag-Nav did not record the helicopter’s final climb.

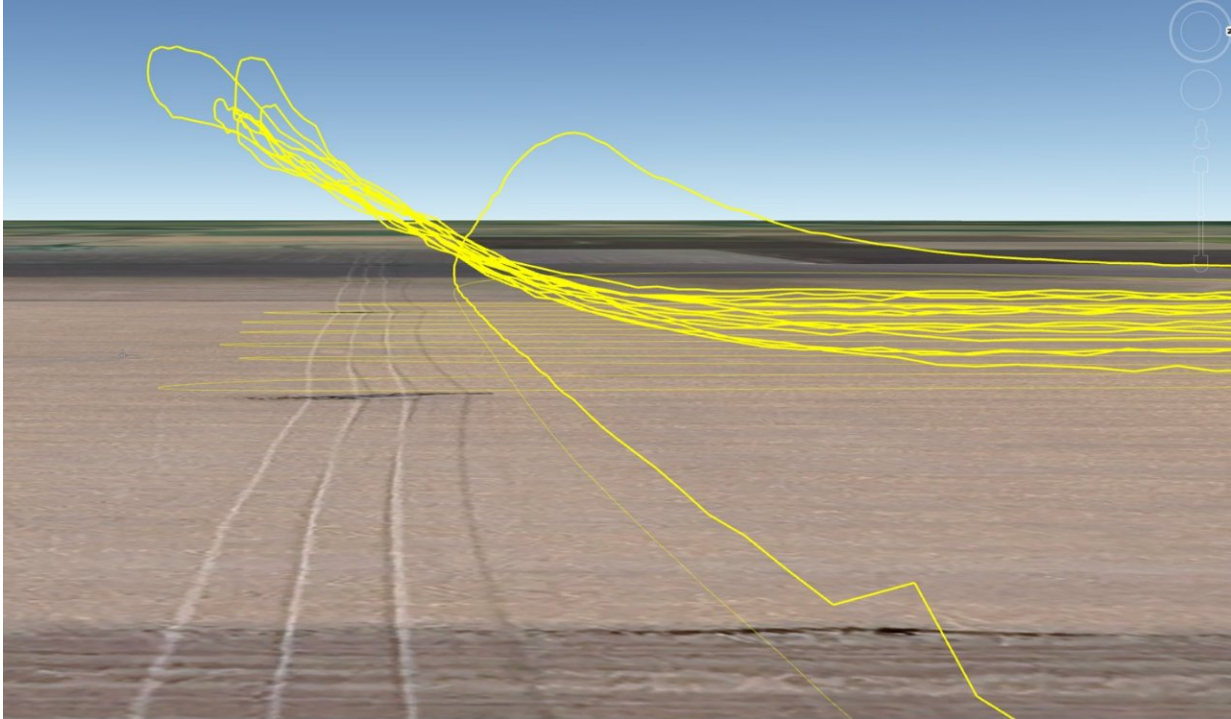
Figure 3. AgNav data plots

The Garmin recorded the helicopter's climb and westerly turn and showed a close path near a power pole; however, no wire damage or signatures of arcing were observed on the power lines that were located about 45 yards north of the accident site. No electrical arcing or evidence of a wire strike was seen on the wreckage.
