# Aviation Investigation Factual Report

<b>Location:</b>	Durkee, Oregon	<b>Accident Number:</b>	WPR25LA034
<b>Date &amp; Time:</b>	November 7, 2024, 08:37 Local	<b>Registration:</b>	N4361R
<b>Aircraft:</b>	ROBINSON HELICOPTER COMPANY R44 II	<b>Aircraft Damage:</b>	Substantial
<b>Defining Event:</b>	External load event (Rotorcraft)	<b>Injuries:</b>	1 None
<b>Flight Conducted Under:</b>	Part 133: Rotorcraft ext. load

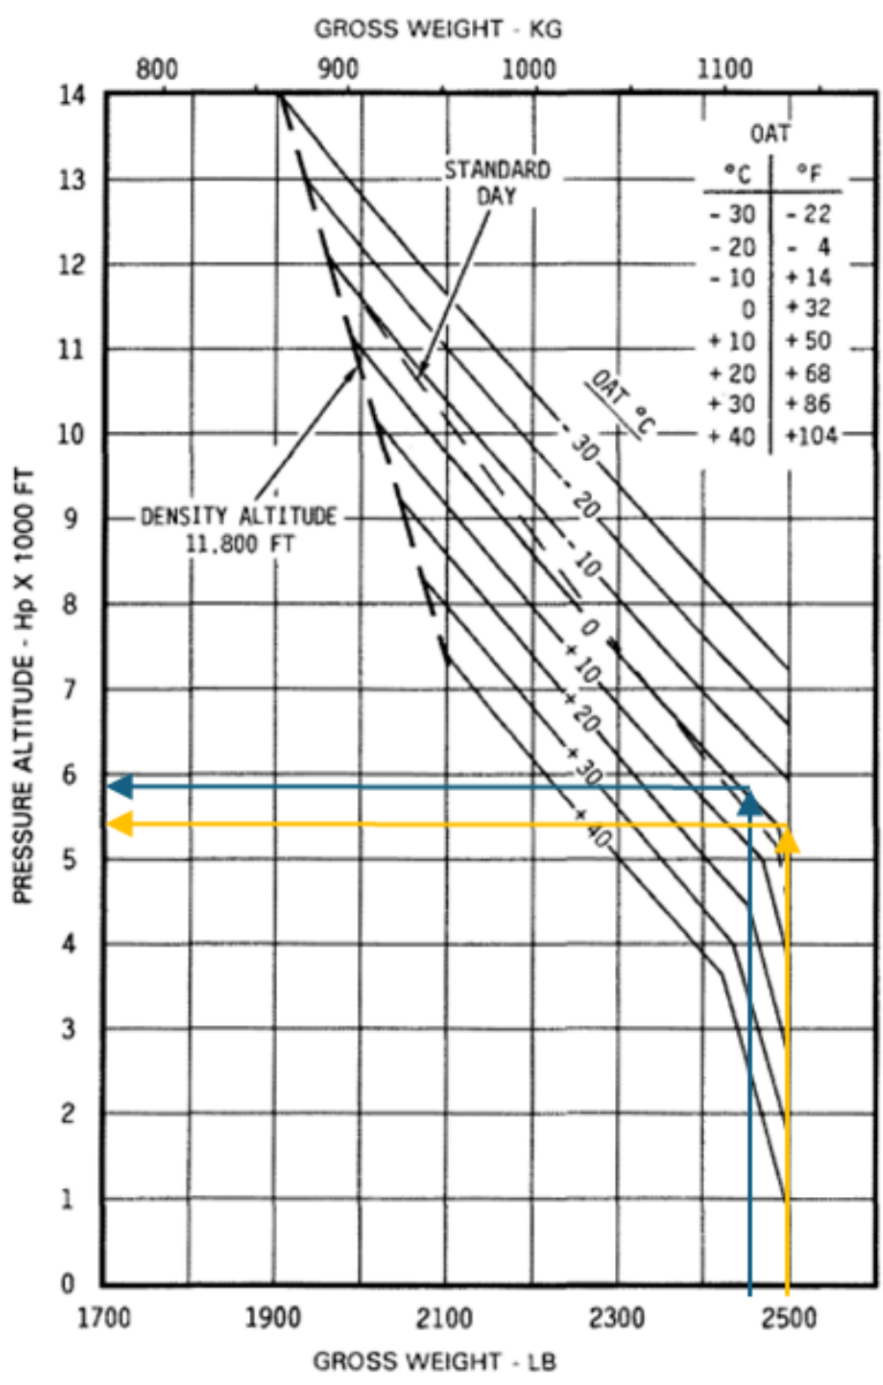
**OGE HOVER CEILING VS. GROSS WEIGHT**

The pilot estimated the weight of the helicopter at the time of the accident to be about 2,450 lbs, 50 lbs less than its maximum gross weight. Performance calculations revealed that, at 2,450 lbs, along with the estimated environmental conditions of the accident site, the helicopter was capable of a hover OGE up to 5,800 ft msl. The helicopter’s chart for hover OGE performance also showed that engine performance is reduced at gross weights above 2,480 lbs. The chart showed that a helicopter that, at 2,500 lbs gross weight under the same environmental conditions, the helicopter could hover OGE up to 5,300 ft msl (see figure 1).

Figure 1. Out of ground effect hover chart for the R44 II helicopter, showing OGE hover capability for 2,450 pounds (blue arrows) and 2,500 pounds (orange arrows).
