Aviation Investigation Factual Report

Location:	Mogadore, Ohio	Accident Number:	ERA25LA144
Date & Time:	March 14, 2025, 07:08 Local	Registration:	N262LH
Aircraft:	Schweizer 269C	Aircraft Damage:	Substantial
Defining Event:	Low altitude operation/event	Injuries:	1 Fatal
Flight Conducted Under:	Part 91: General aviation - Personal

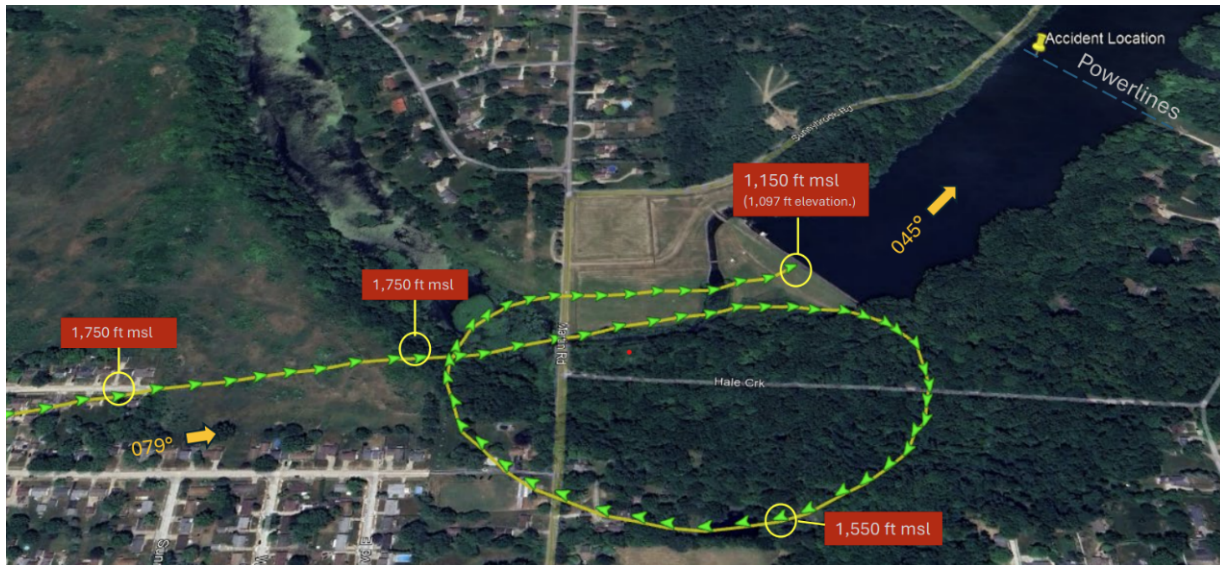
ADS-B data indicated that after takeoff from 3G3, the helicopter climbed to about 1,700 ft msl and turned left on a track of about 070° for 15 nautical miles. As the helicopter approached a reservoir, it began a right 360° descending turn, leveled off, and reestablished a northeast track before the data ended (see the figure).

Figure. Final part of the flight path as the helicopter approached the reservoir.
