# Aviation Investigation Factual Report

<b>Location:</b>	Hancock, Wisconsin	<b>Accident Number:</b>	CEN15LA399
<b>Date &amp; Time:</b>	August 26, 2015, 11:30 Local	<b>Registration:</b>	N2005C
<b>Aircraft:</b>	Weatherly Aviation Company Inc 620B	<b>Aircraft Damage:</b>	Destroyed
<b>Defining Event:</b>	Part(s) separation from AC	<b>Injuries:</b>	1 Fatal
<b>Flight Conducted Under:</b>	Part 137: Agricultural

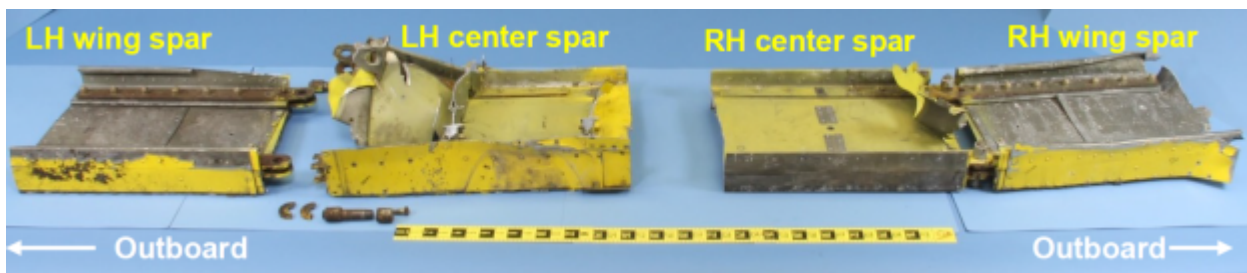
Examination revealed that the left center section forward spar lower hinge brackets were fractured

vertically through the pin holes (Figure 1). The pin remained installed through the left wing forward spar lower hinge brackets with the fractured ends of the center section brackets captured by the pin. All the remaining spar attach points on the left and right wings were intact. The left wing spars, interspar structure, and skins were recovered at the main wreckage site with varying amounts of damage. The left wing leading edge, left wing tip and left fixed trailing edge section separated during the accident sequence and were recovered in the field. There was mechanical damage and deformation noted on the left wing and center section upper spar caps adjacent to the forward spar attach point. The damage was consistent with the outboard wing having rotated up more than 120° with respect to the center wing. The left wing rear spar was fractured through the outboard wing hinge bracket holes even though the brackets remained intact. The left wing structure was crushed downward between the spars and curled upward with yellow paint transfer noted on the internal wing ribs. The left aileron control tubes and left wing spray bar displayed significant upward deformation.

Figure: The sections of the left and right forward wing spar assembly sections, viewed aft looking forward angled from below, as received. The figure shows the separated pieces of the left center section forward spar lower hinge brackets, which are placed at the bottom of the left wing spar and left center section spar for the photo.

The left center section forward spar lower forward hinge bracket exhibited a visible, flat, thumbnail-shaped crack containing crack arrest marks consistent with progressive fracture, which was determined to be fatigue. The crack arrest marks emanated from the aft corner of the pin hole. The fatigue crack measured 0.15 inch on the aft (inside) face, 0.19 inch along the pin hole, and 0.24 inch deep from the crack initiation corner. Examination of the crack in a scanning electron microscope revealed fatigue striations. The areas outside of the fatigue crack exhibited dimple rupture, consistent with subsequent overstress fracture.

A closer view of the initiation site revealed a small corrosion pit containing non-conductive deposits. Examination of the rest of the pin hole found multiple features consistent with corrosion pits along the surface, as well as shallow circumferential gouging. The upper side of the lower forward hinge bracket revealed a small flat region, absent shear lips, in the aft corner, as well as microscopic thumbnail cracks. These small fatigue cracks exhibited striations and ratchet marks consistent with multiple crack initiation sites on the pin hole surface. Cross-sectional metallographic inspection found corrosion pits on the pin hole surface.
