Aviation Investigation Factual Report

Location:	Mt Hood, Oregon	Accident Number:	WPR19FA077
Date & Time:	January 25, 2019, 14:59 Local	Registration:	N1332J
Aircraft:	Rockwell 112	Aircraft Damage:	Destroyed
Defining Event:	Loss of control in flight	Injuries:	1 Fatal
Flight Conducted Under:	Part 91: General aviation - Personal

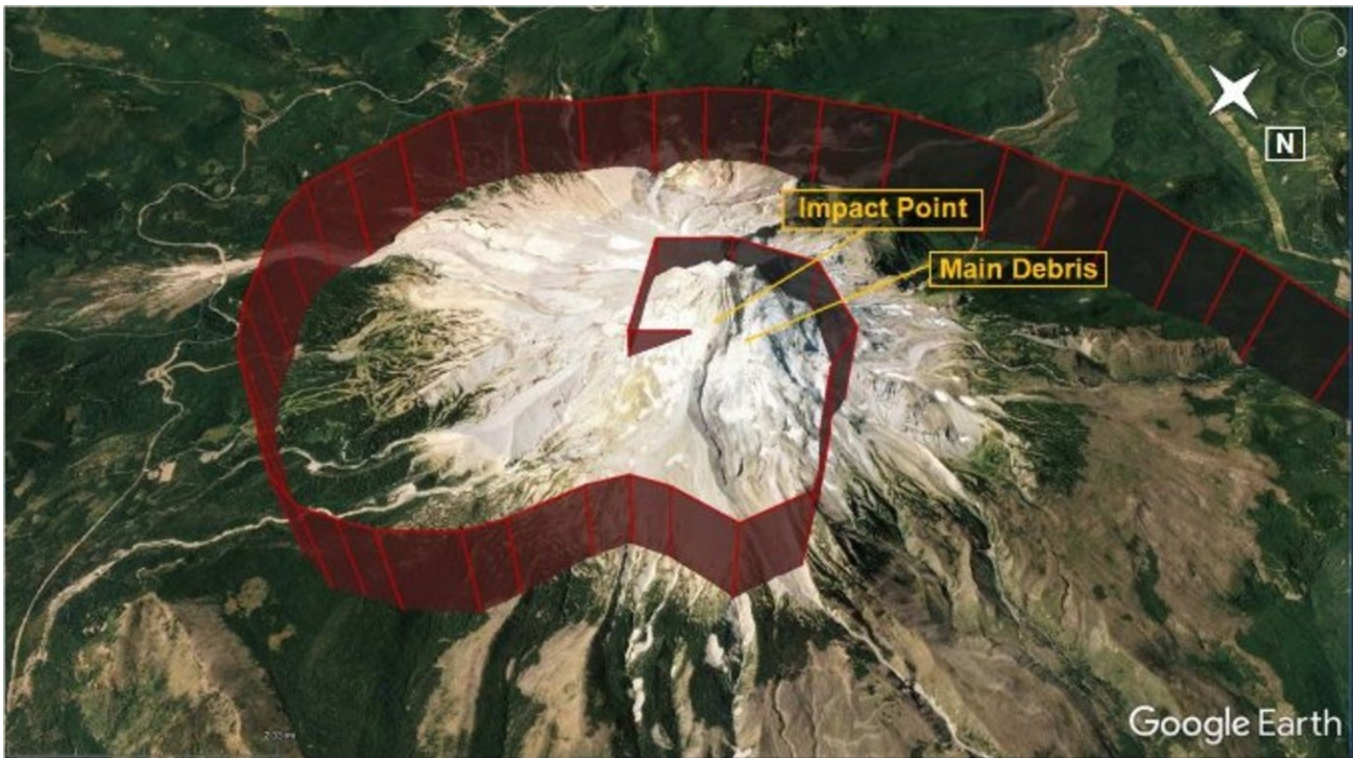
Figure 1. Radar-Derived Flight Path

Radar data provided by the FAA indicated that the accident airplane passed over the Cascade Locks area at 1439 and followed the Columbia River eastbound. About 5 minutes later, the airplane began a right turn to the south, and by 1451, it was approaching Mount Hood from the north at a Mode C-reported altitude of about 10,000 ft mean sea level (msl). The airplane then followed a counterclockwise, 6-mile-wide orbit around the 11,239-ft summit. As the airplane circled south around the summit, its ground speed was about 147 knots; as it transitioned northbound, the ground speed reduced to about 107 knots. The airplane then began to get closer to the summit as it rolled out on a west heading. A few seconds later the airplane then turned back to the north, before turning back west one minute later, to continue the orbit.

By this time, it had reached its highest altitude of 11,900 ft msl about 1.5 miles north of the summit. The airplane continued to track around the mountain, coming to within about 1,500 ft of the summit horizontally as it passed to the west. As it reached the southern face, it began to rapidly descend, with the final two radar targets indicating a vertical speed of about 2,500 ft per minute (fpm). The last radar target was recorded at 1459:09, and indicated an altitude of 9,600 ft msl, about 400 ft northwest of the impact location. (see Figure 1.)

The vertical velocity data indicated that when the airplane was making its first pass south of Mount Hood, the flight path was in a location of updrafts, with speeds between 100 and 300 fpm. By the time the airplane made its second closer pass to the south, the flight path was in a location of downdrafts, with speeds greater than 2,000 fpm.

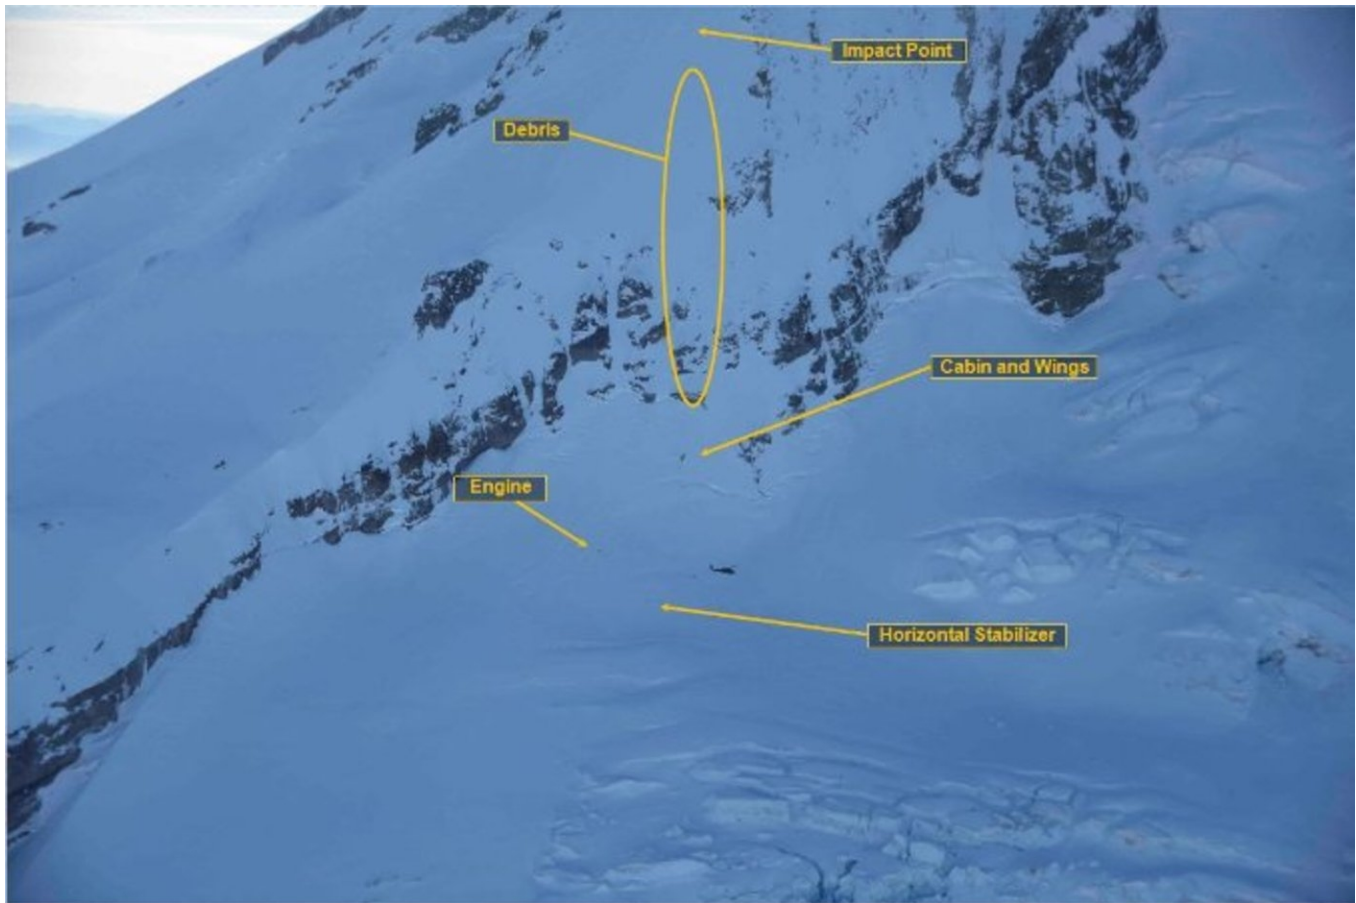
Figure 2. Accident Site

Due to the treacherous and remote nature of the accident site and the immediate threat of avalanches, an on-scene examination could not be performed. First response personnel, who recovered the pilot, were not able to gain access to the main wreckage; therefore, a description of the accident site was compiled using photographs provided by first responders.

Fragmented sections of the airplane were spread along the 70° slope of Eliot Glacier, on the northeast flank of Mount Hood. The first identifiable point of impact was represented by a horizontal slice in the snow and ice at an elevation of about 9,700 ft msl. Debris and slide marks in the snow extended down toward the main wreckage, which was located at an elevation of about 8,700 ft msl, and comprised the crushed fuselage, fragments of the left wing, and the entire right wing. The engine and horizontal stabilizer were identified about 200 ft below, with the lowest debris located around 8,000 ft msl. The entire area was strewn with crushed and fragmented airframe and engine components and surrounded by crevasses and deep, unstable snow. (see Figure 2.)
