Aviation Investigation Factual Report

Location:	New York, New York	Accident Number:	ERA19FA191
Date & Time:	June 10, 2019, 13:40 Local	Registration:	N200BK
Aircraft:	Agusta A109	Aircraft Damage:	Destroyed
Defining Event:	Loss of visual reference	Injuries:	1 Fatal
Flight Conducted Under:	Part 91: General aviation - Executive/Corporate

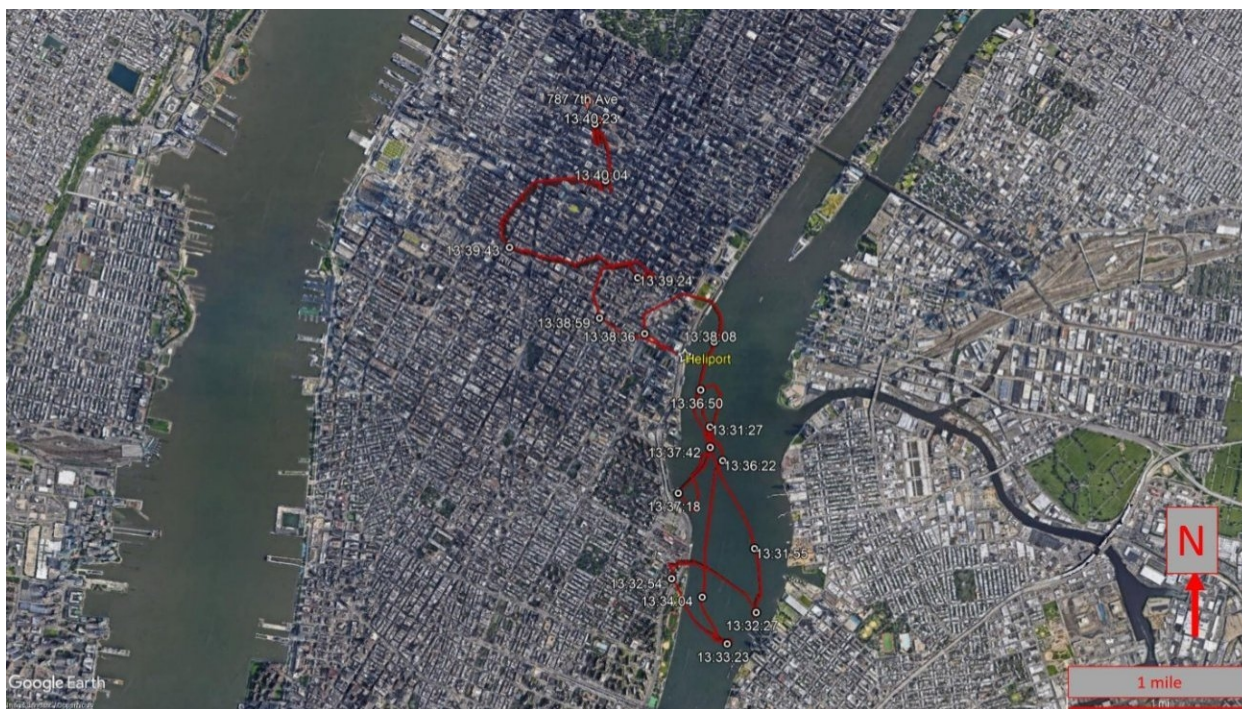
Figure 1 - Helicopter Ground Track

A review of automatic dependent surveillance - broadcast (ADS-B) data from the Federal Aviation Administration (FAA) revealed that the helicopter departed and initially flew south over the East River before changing course northward. About 5 to 7 minutes after departure, the pilot contacted the FBO and requested to return to the heliport. He was advised to land on pad No. 4. The pilot then radioed that he “did not know where he was.” The helicopter flew erratically over the East River, changed course and altitude several times before making a 270° turn, which approached 6N5 from the west. About 500 ft west of 6N5, at an altitude of 600 to 700 ft mean sea level (msl), the helicopter reversed course and flew erratically over Manhattan before impacting the roof of a 54-story building at 787 7th Avenue. The last recorded position of the helicopter was about 0.1 nautical mile southeast of the building at an altitude of about 1,570 ft msl. The overall height of the building above the street was about 790 ft msl, with the roof section where the helicopter came to rest (below the exterior walls and catwalks surrounding the perimeter of the roof), about 765 ft msl.
